CITY OF CONCORD, NEW HAMPSHIRE FACILITY CONDITIONS ASSESSMENT

BEAVER MEADOW GOLF COURSE CLUB HOUSE

NOVEMBER 5, 2021

TTG PROJECT No. 4980

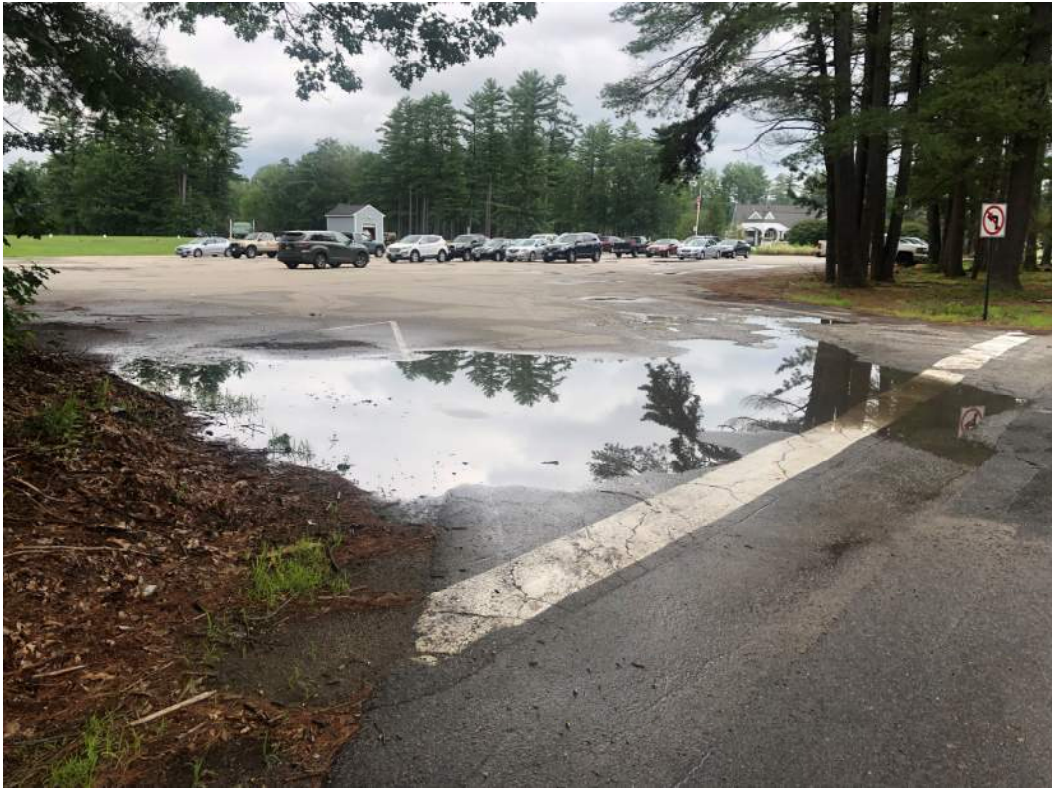
All of the paved areas suffer from a significant amount of cracking, deterioration, pavement edge collapsing, and areas of ponding and can be considered to be in bad condition. This is particularly true for the public parking lot, the main walkway from the parking lot to the Club House entrance, and many of the access roads and walkways around the Club House and towards the Maintenance Building.

Significant Ponding – Parking Lot Exit onto Beaver Meadow Drive

Assuming that the storm water system in the area can take the additional flow, increase the size of the underground storm water collection system in the parking lot to relieve the flooding that occurs during a heavy rain event.

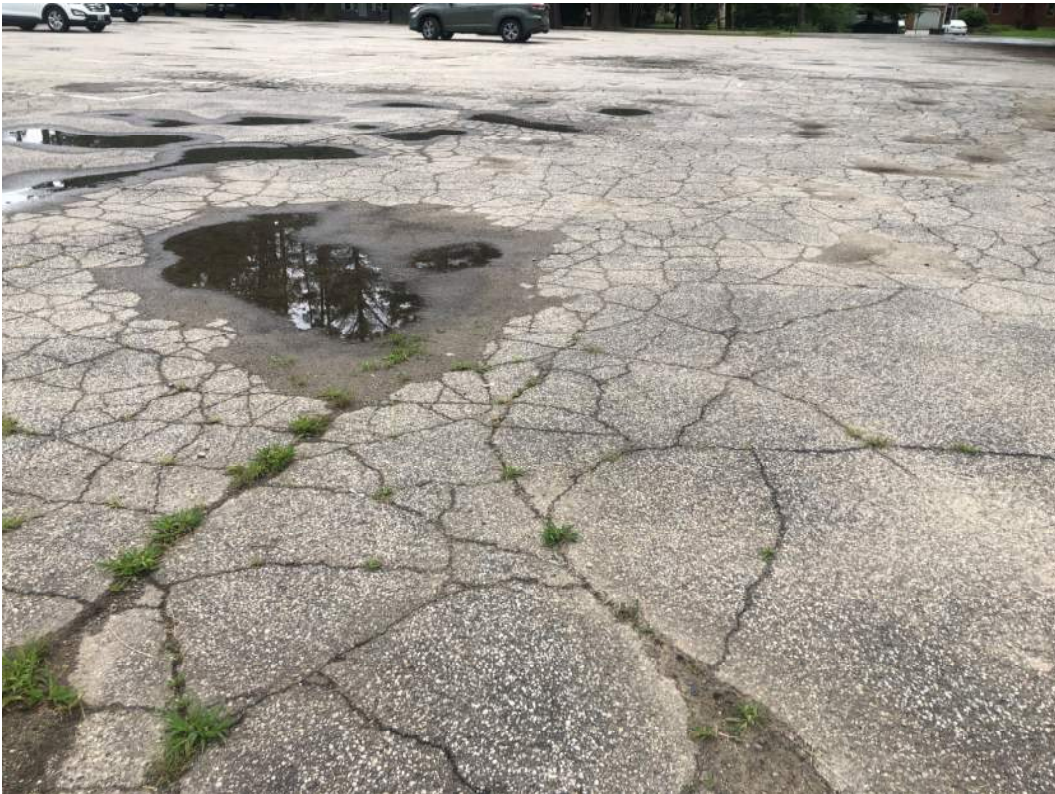
Badly Cracked and Deteriorated Pavement - Typical for All Areas of Parking Lot

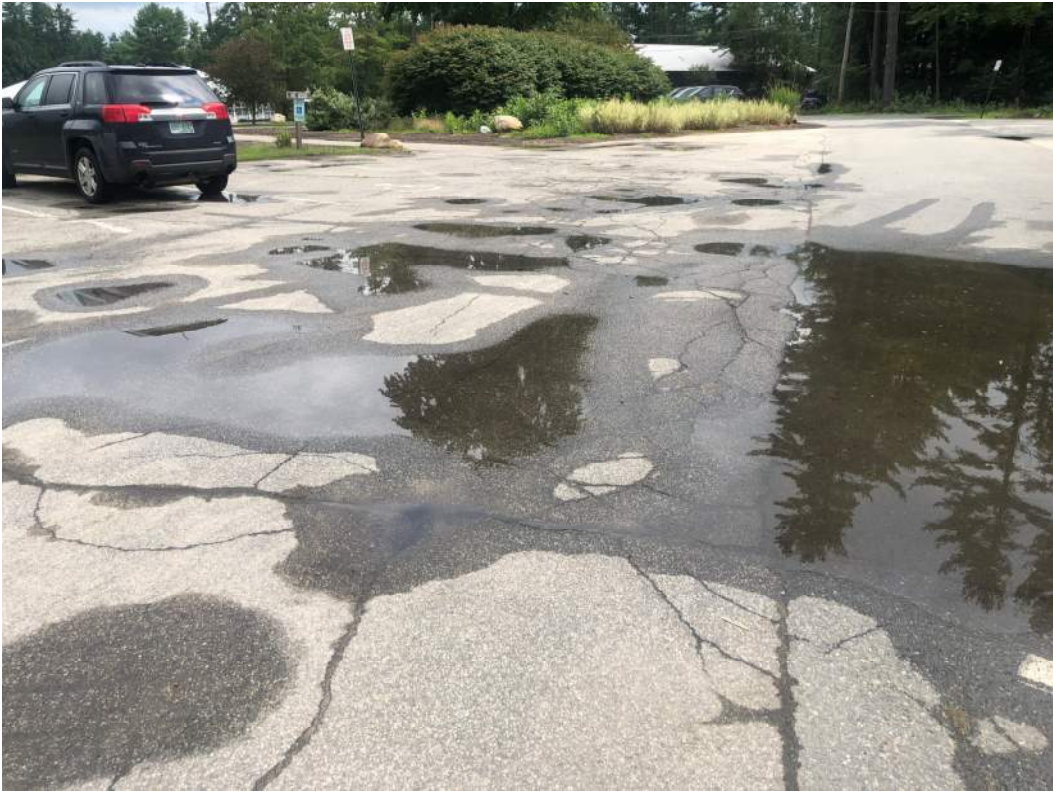
Typical Ponding and Cracked Pavement in Parking Lot – All Areas

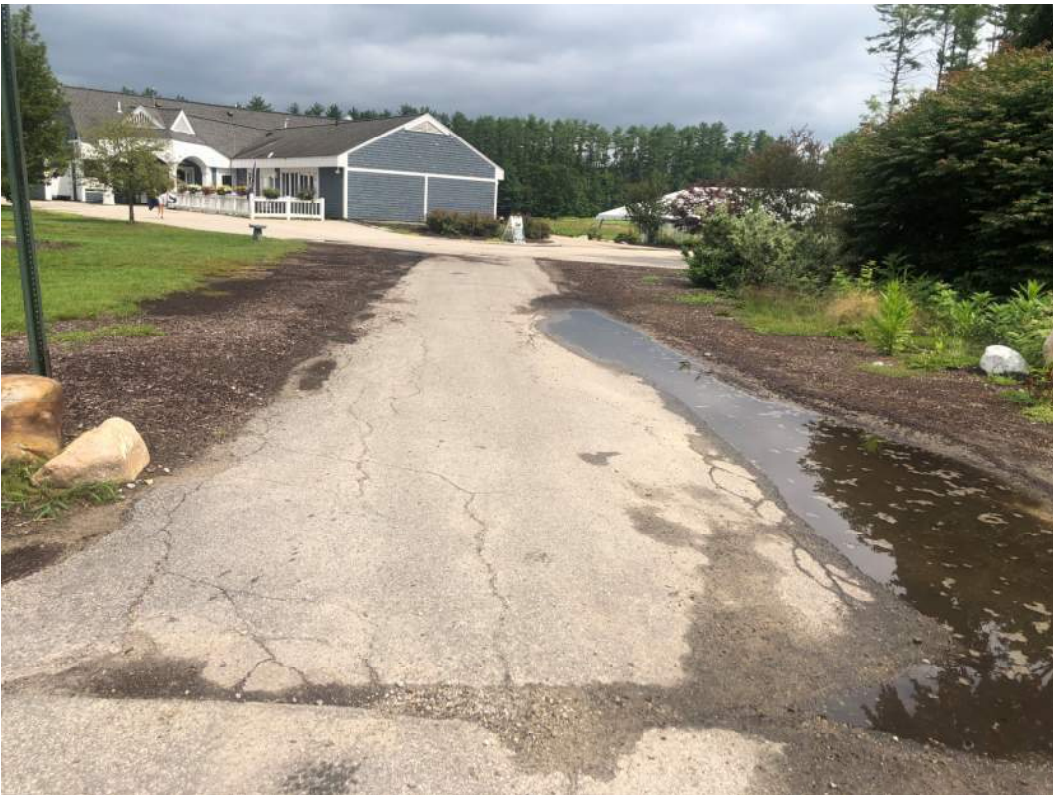
Ponding, Cracked Pavement and Collapsed Edges at Main Access Walk to Club House

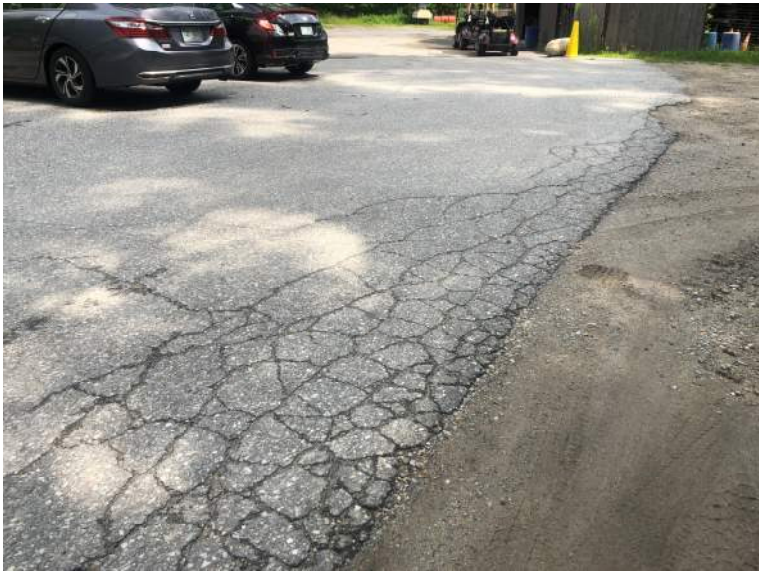
Typical Collapsed Edge of Bituminous Pavement Around Perimeter of Most Paved Areas

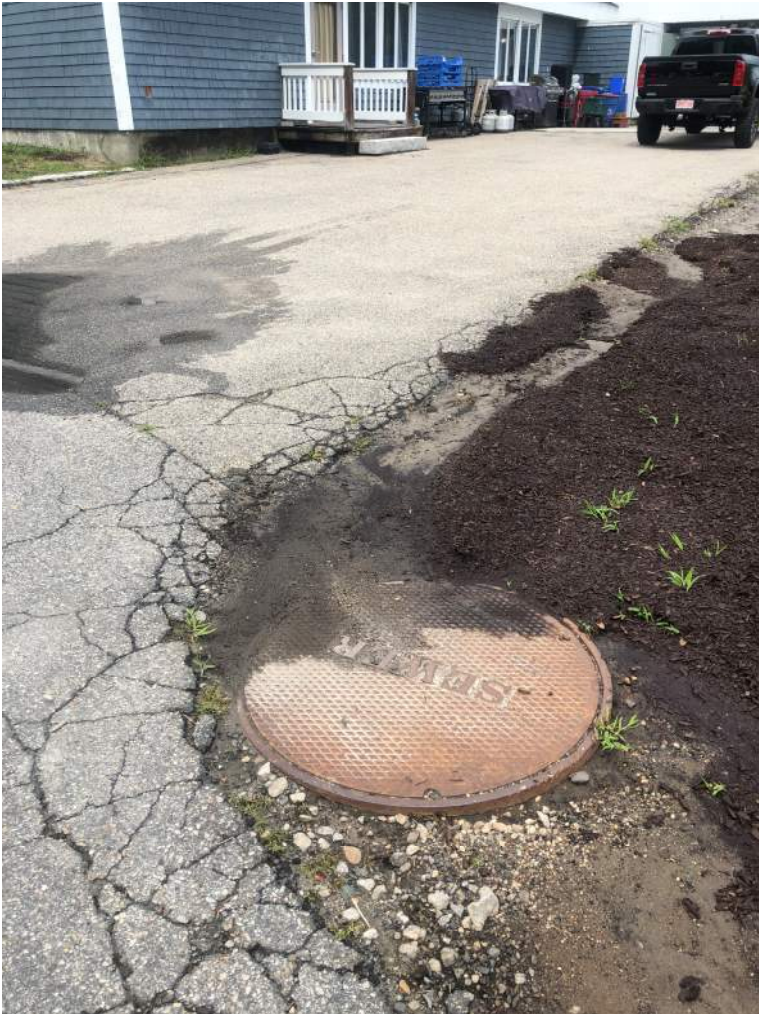
Collapsed Edge of Pavement Southwest of Club House towards Maintenance Building

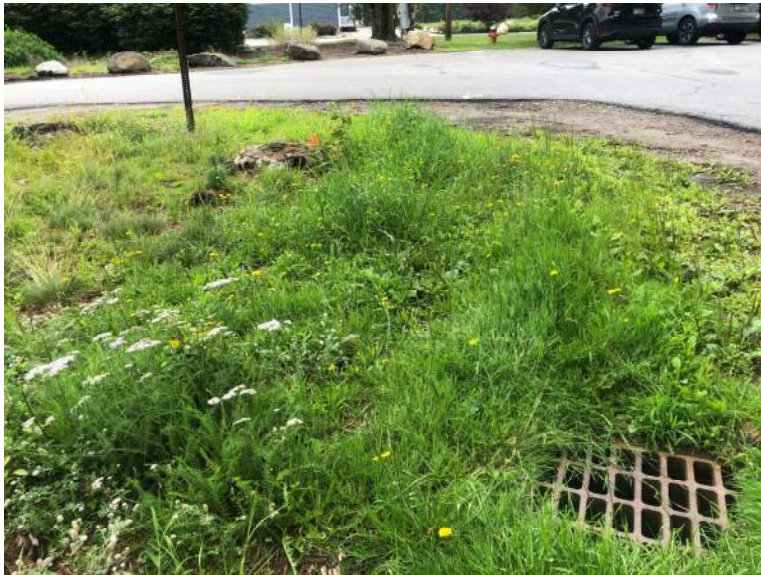
Only one (1) catch basin was observed in the proximity of the Club House and is located in a small grass area north west of the building. The sump in the catch basin should be cleaned of internal silt.

Catch Basin Located Southwest of Club House

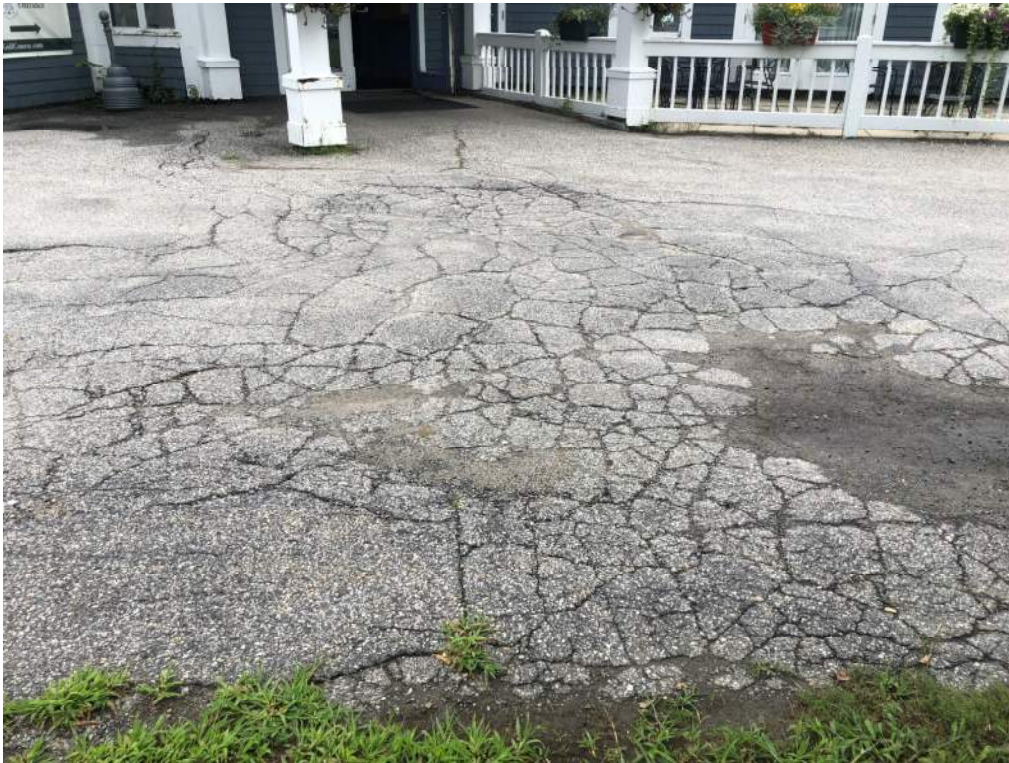
Badly Cracked and Deteriorated Pavement Located Near Main Entrance – North of Club House

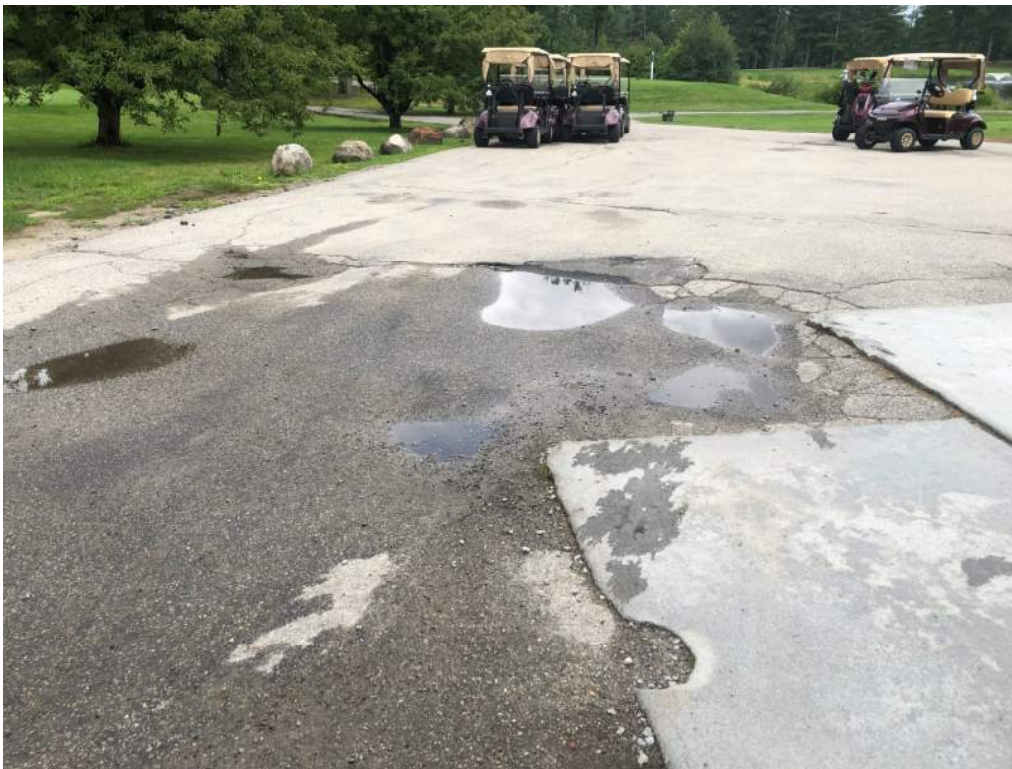
Ponding, Cracked Pavement, Collapsed Edges, Broken Hardscaping, Tripping Hazard – Northeast of Club House

The hardscaped areas at the east and south sides of the Club House should be regraded, re-set and or re-sloped to accommodate positive drainage and to eliminate any projections causing potential tripping hazards.

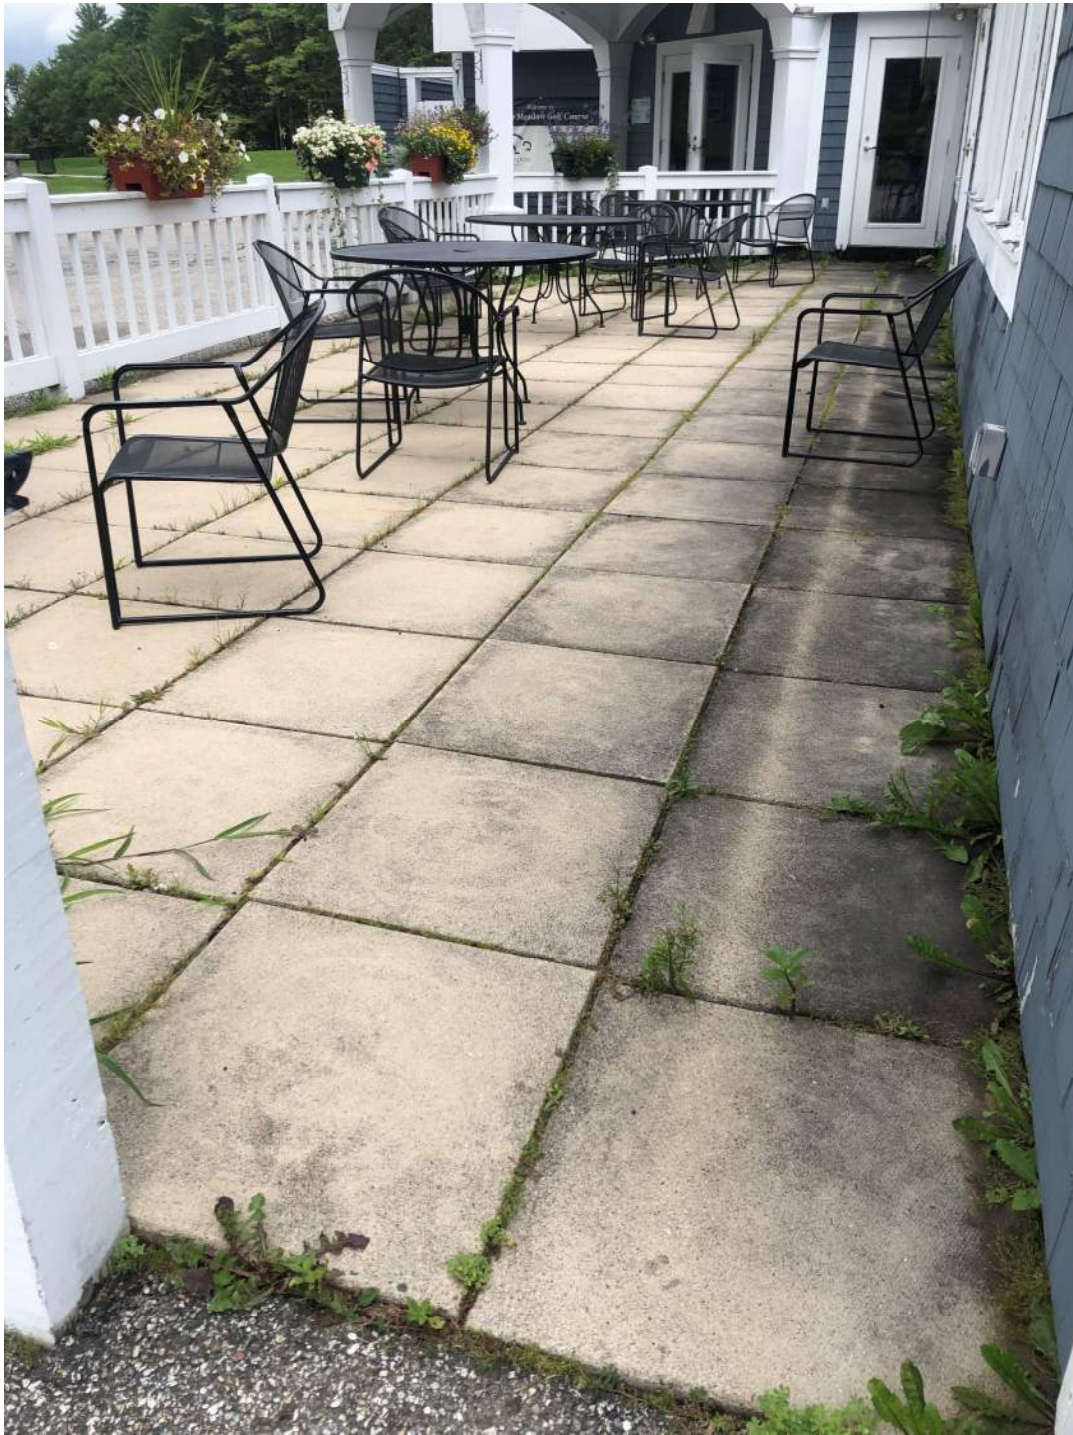
Hardscaping Southeast of Club House – Possible Tripping Hazard Entry at Bituminous Pavement

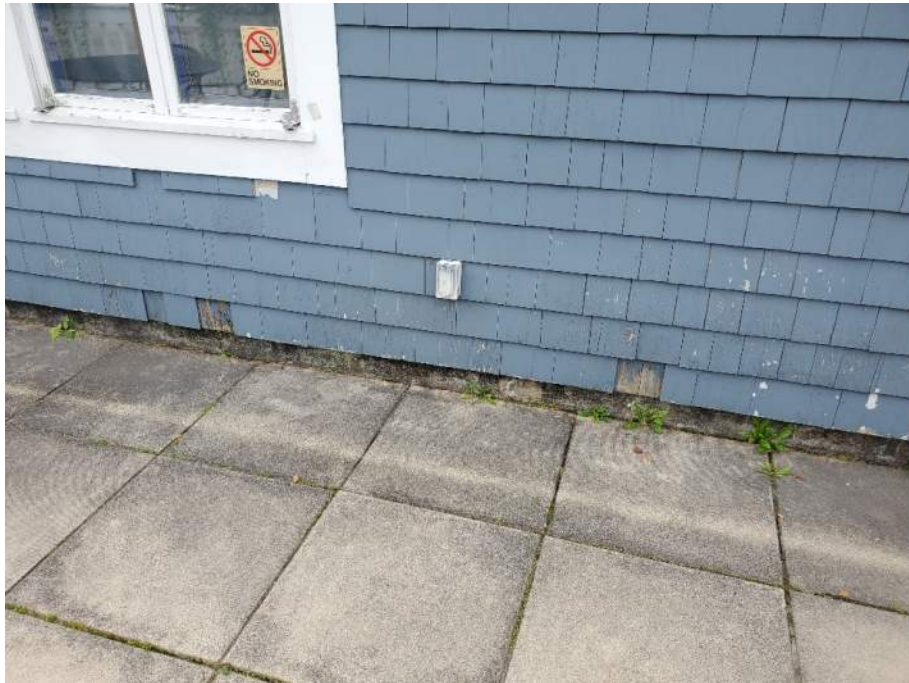
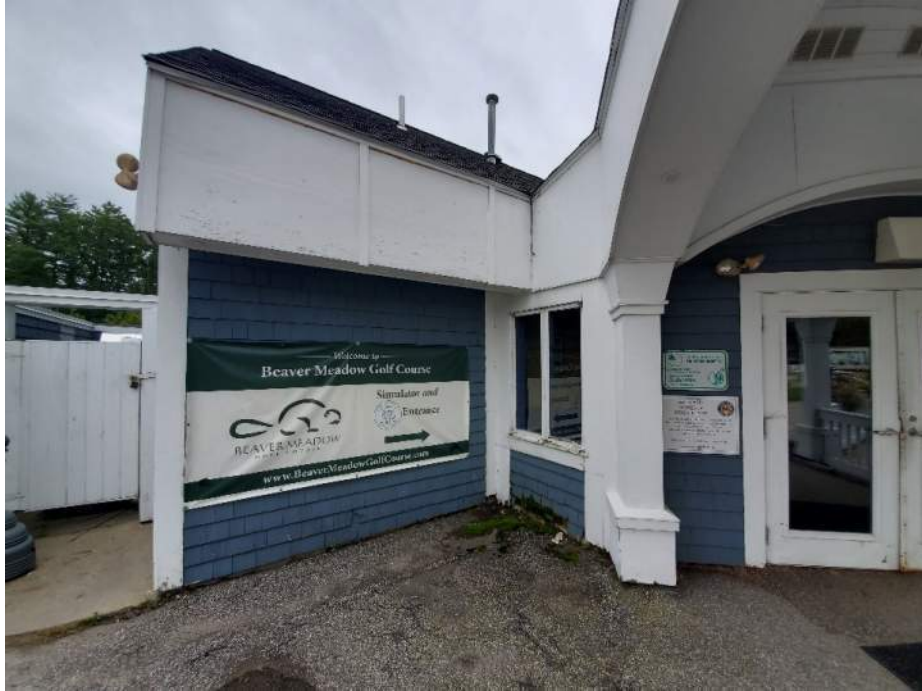
The exterior cedar wall shingles were noted to be in fair condition. There are a number of areas where the shingles have been damaged and are missing. Some of the shingles where the roof water hits pavement and splashes back are rotted and should be replaced.

There is almost an entire row of shingles missing at the base of the wall adjacent to the main front entry door. In this same area there is moss growing on the remaining shingles near the base of the wall.

Damaged Siding on North Side

Due to the condition of the exterior siding throughout the building, and considering the number of maintenance issues with painted or solid-stained wood siding, the recommendation is to replace the siding in its' entirety with a vinyl product that does not require painting and will not rot or deteriorate.

The siding should be removed to allow a visual inspection of the exterior wall sheathing for any damage, mold or rot and replaced as required.

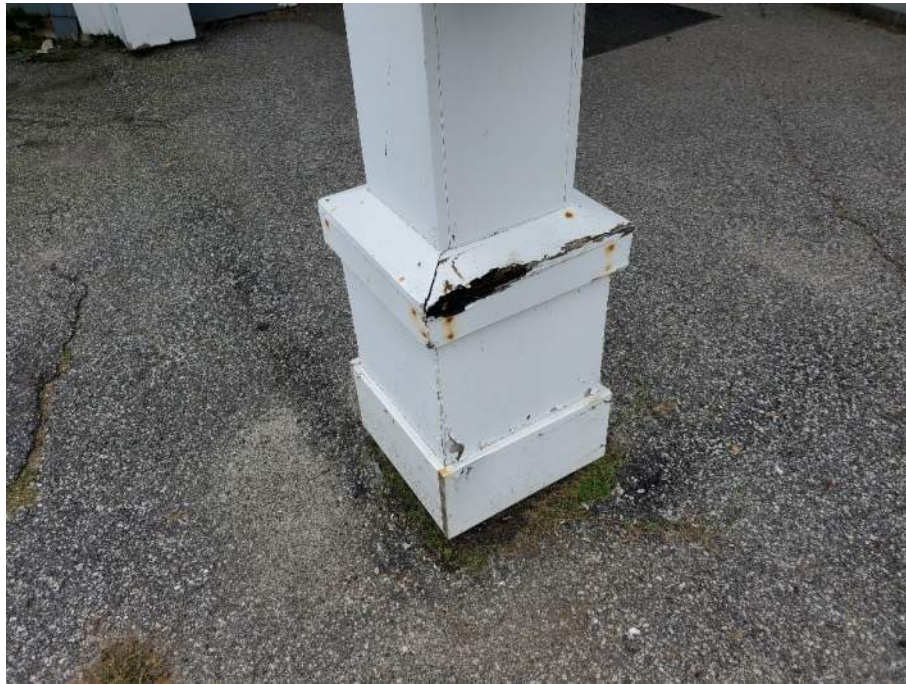
The painted finish on the projected wood roof fascia around the perimeter of the building are badly worn in need of refinishing.
The painted wood finish on the cladding for the base of the posts located at the front entry exterior canopy area are badly worn and showing signs of rotting from moisture.

Rotted Trim at Column on North Side

Due to the condition of the exterior trim throughout the building, and considering the number of maintenance issues with painted wood trim, the recommendation is to replace the painted wood trim in its' entirety with a PVC trim that does not require painting and will not rot or deteriorate.

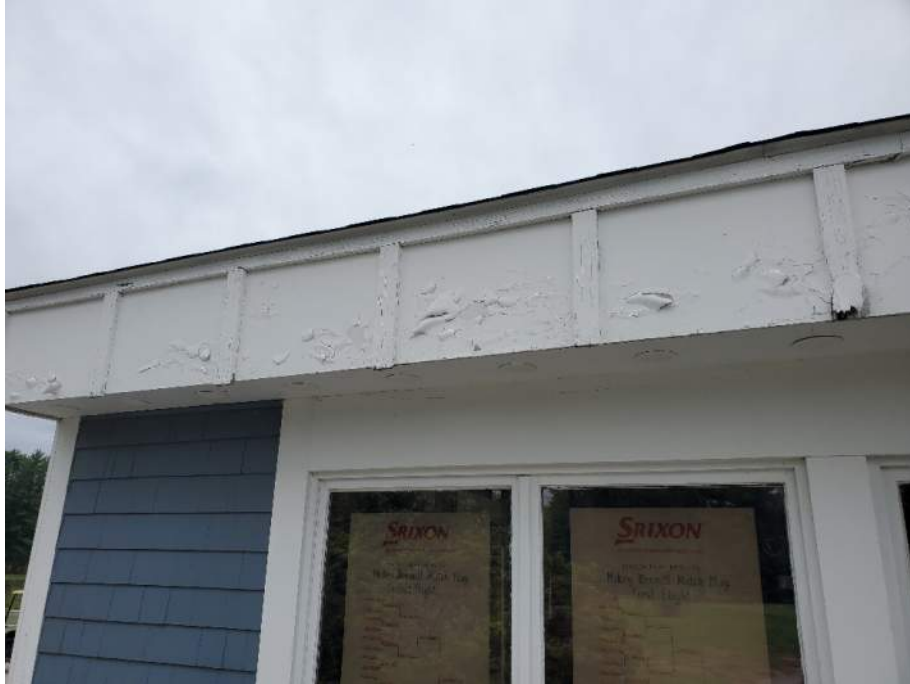
Roof Fascia on North Side

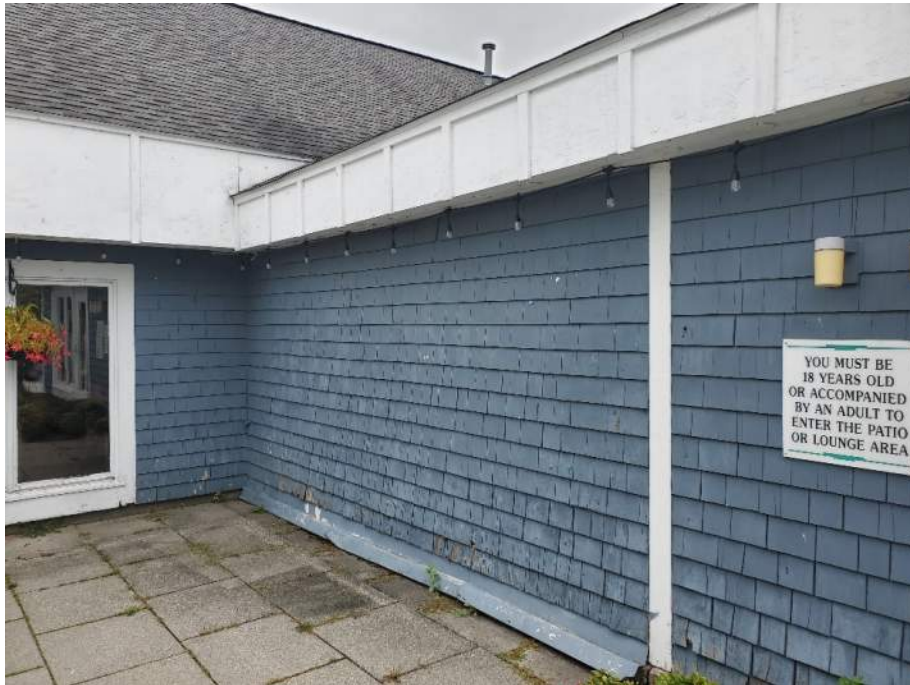
Damaged Siding & Roof Fascia

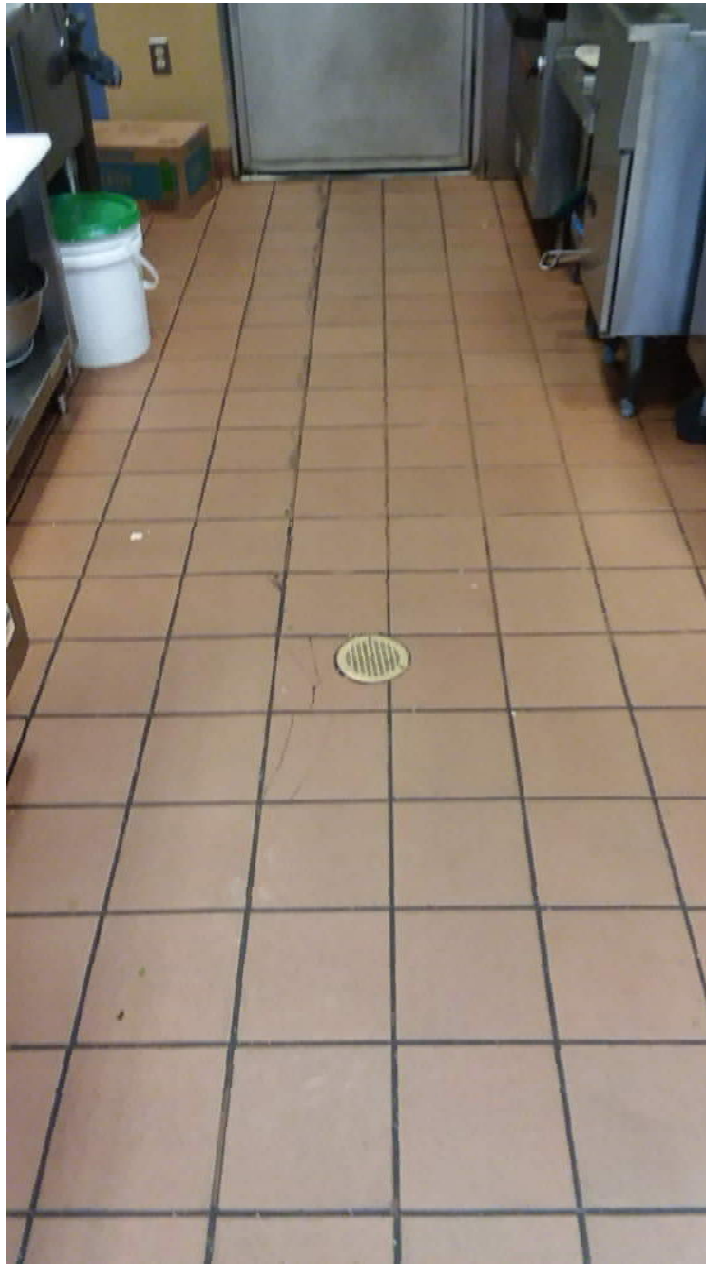
The tile flooring in Kitchen is cracking along a tile joint.

Tile Flooring in Kitchen

Remove and replace the cracked tile flooring in the Kitchen.

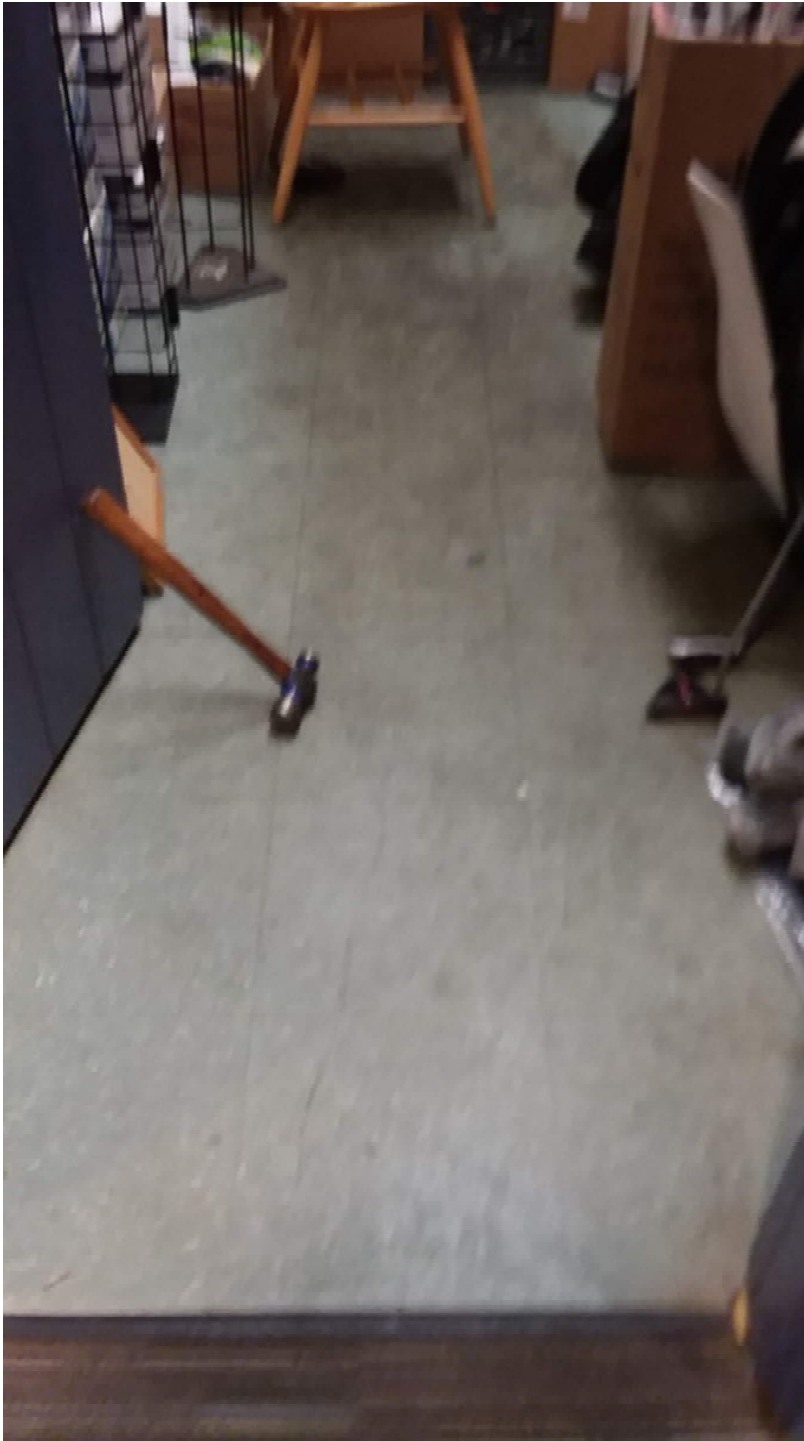
The vinyl tile flooring in the workroom is soiled, stained and dirty.

Vinyl Tile Flooring in Workroom

Replace the vinyl tile flooring in the workroom.

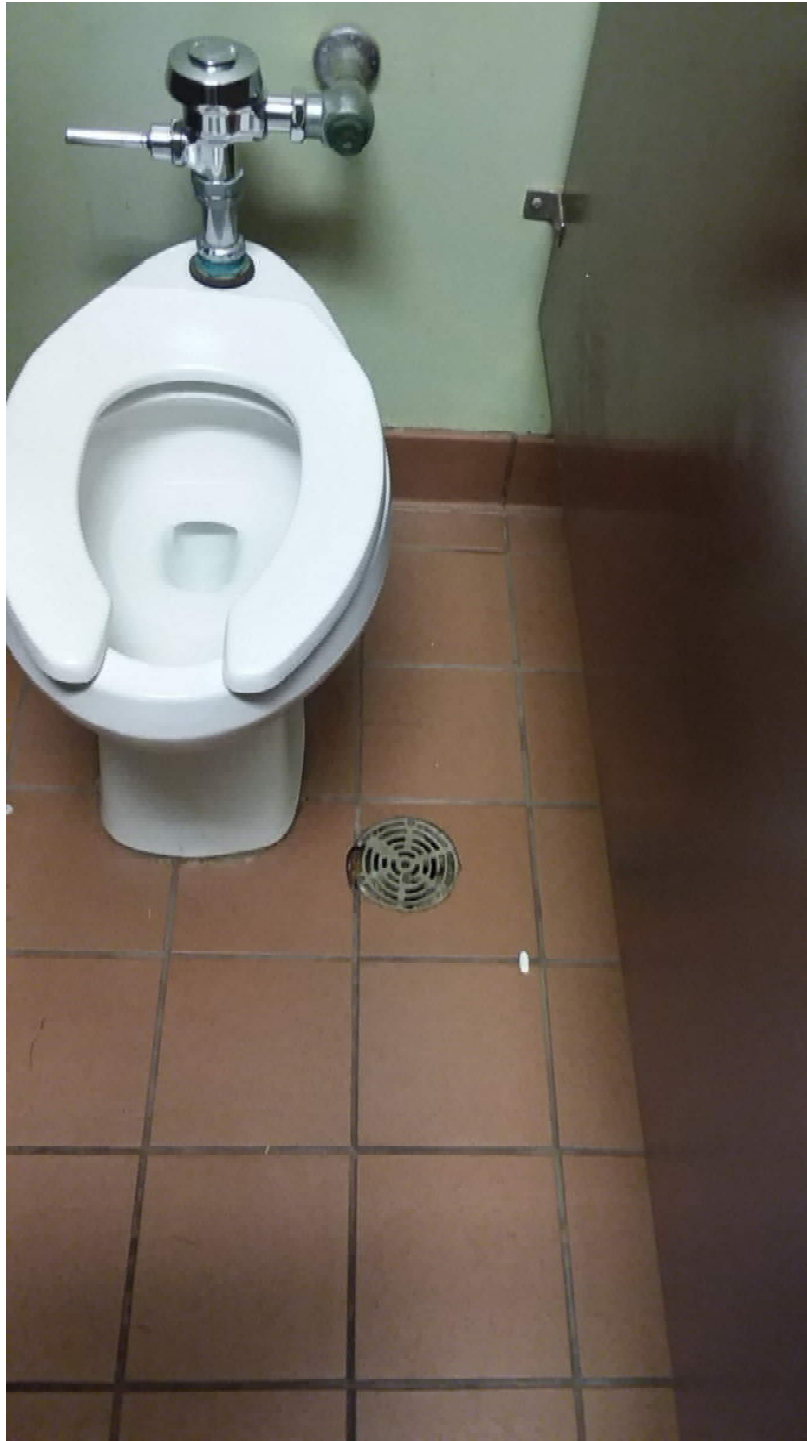
The tile flooring at the floor drain in the Men's restroom is chipped or broken.

Tile Flooring and Floor Drain in Men's Restroom

Replace the tile flooring at the floor drain in the Men's Restroom.

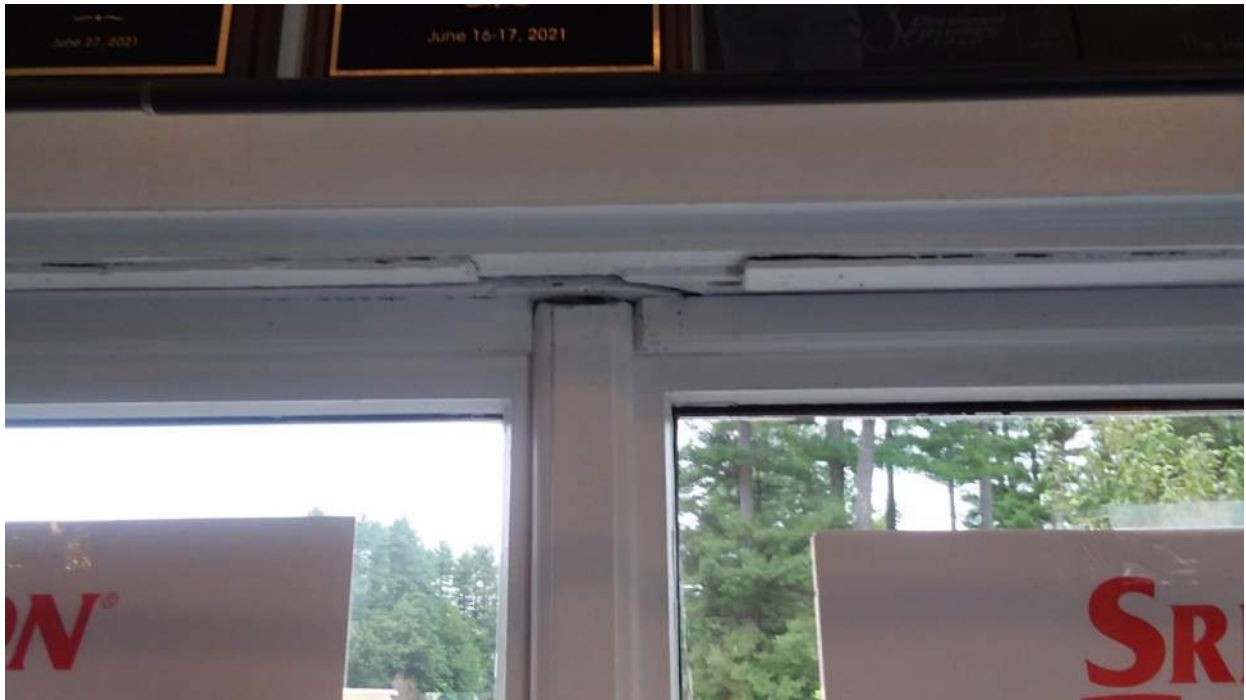
Inoperable Sliding Window in Pro Shop

Due to the number of issues with the windows in the Pro Shop, the recommendation is to replace these windows in their entirety.

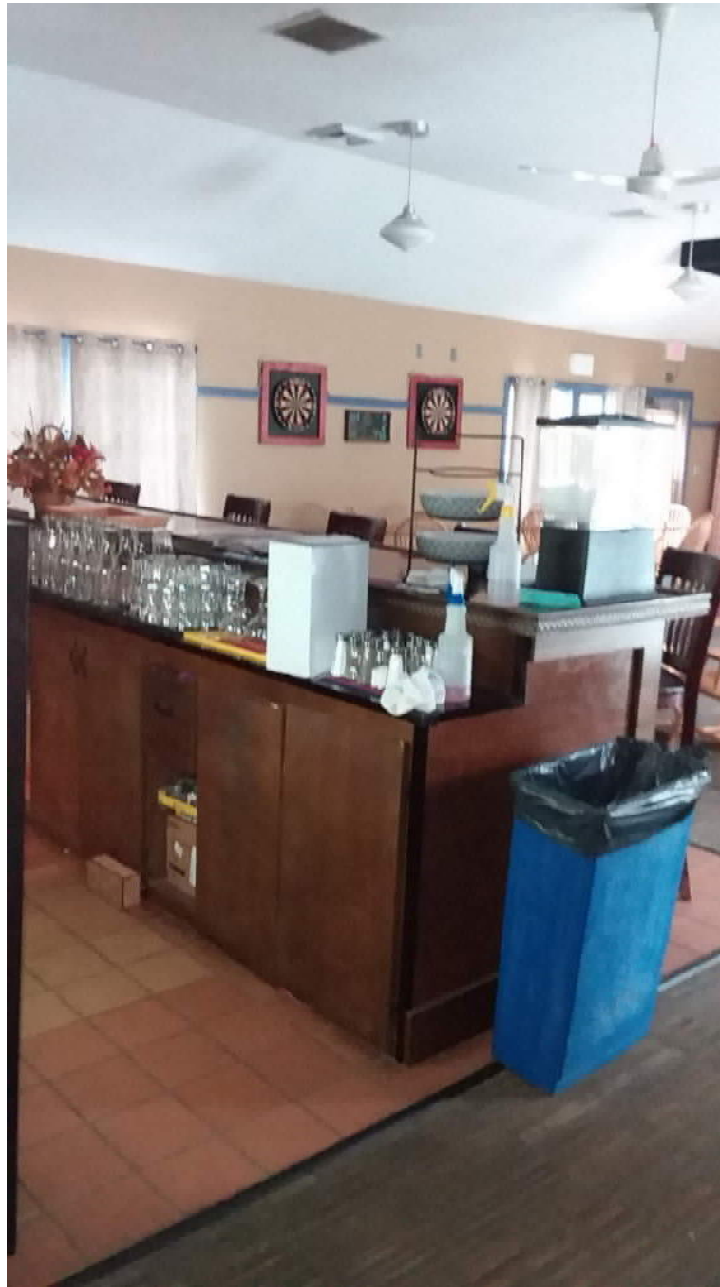
The condition of the finishes on the casework behind the clubhouse bar are worn and soiled.

Condition of Finishes on Casework Behind Clubhouse Bar

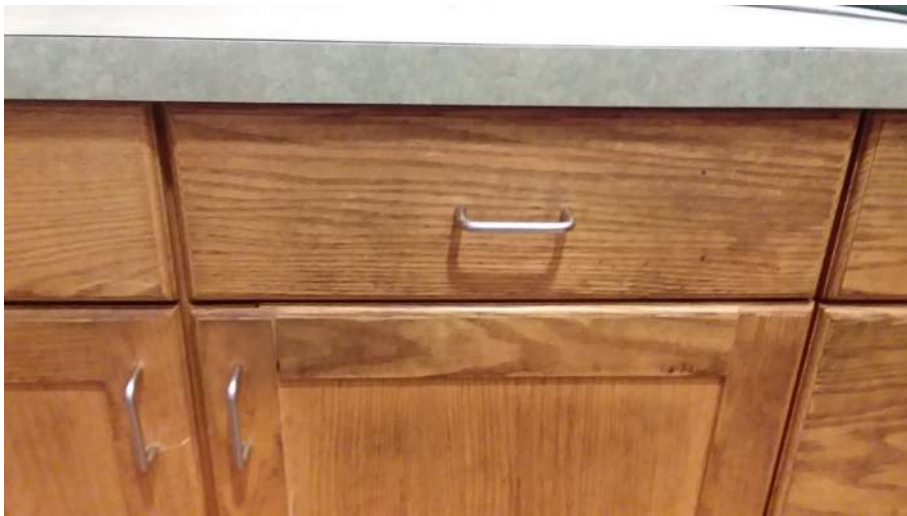
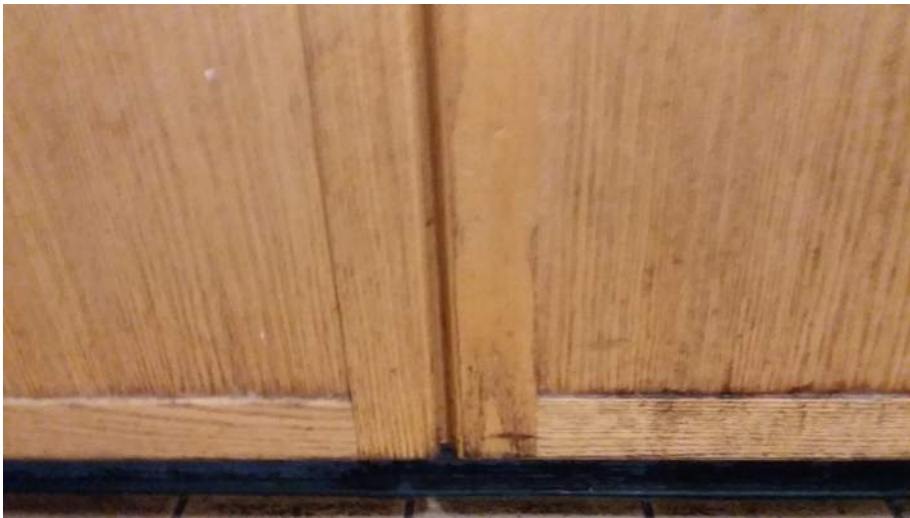
The condition of the finishes on the casework behind the public bar are worn and soiled.

Condition of Finishes on Casework Behind Public Bar

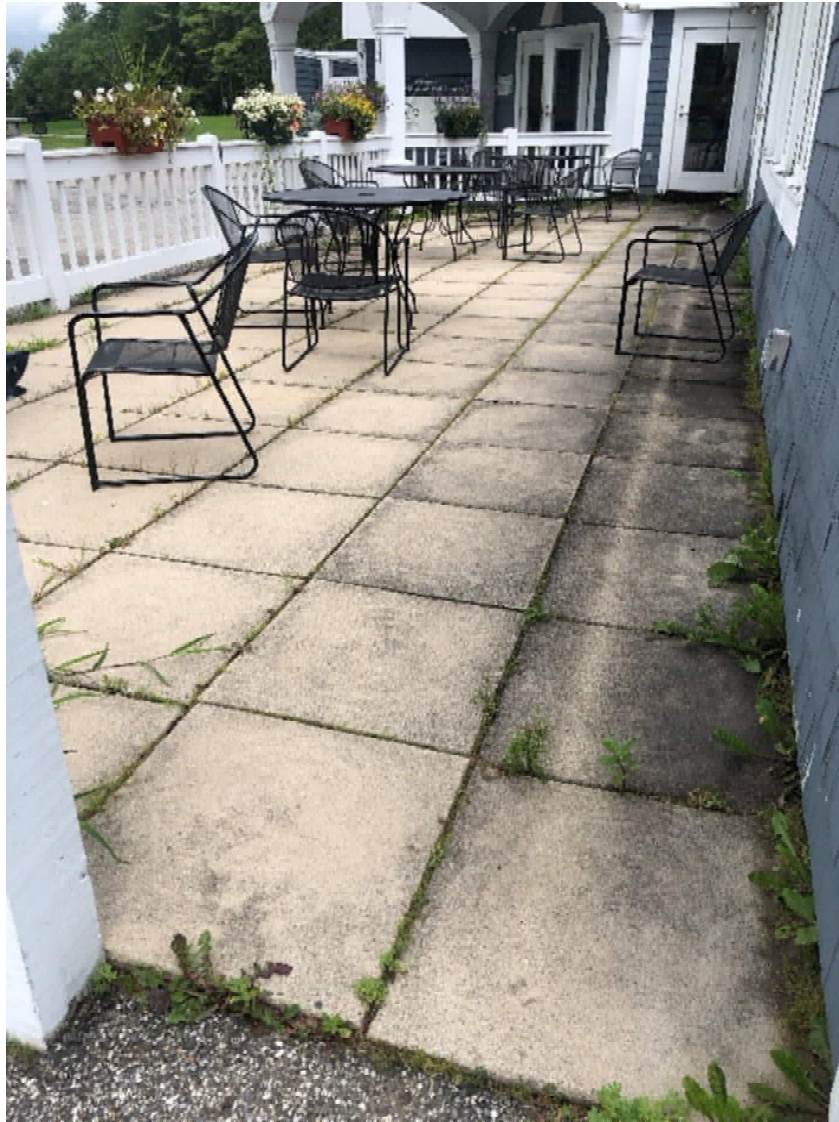
Patio Inaccessible from Interior of Building
Interior of Building Inaccessible from Patio

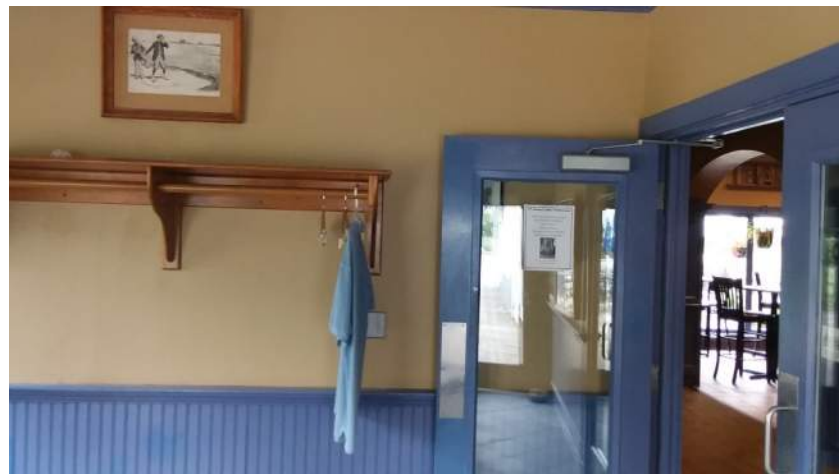
Non-compliant Headroom Clearance in Accessible Path of Travel

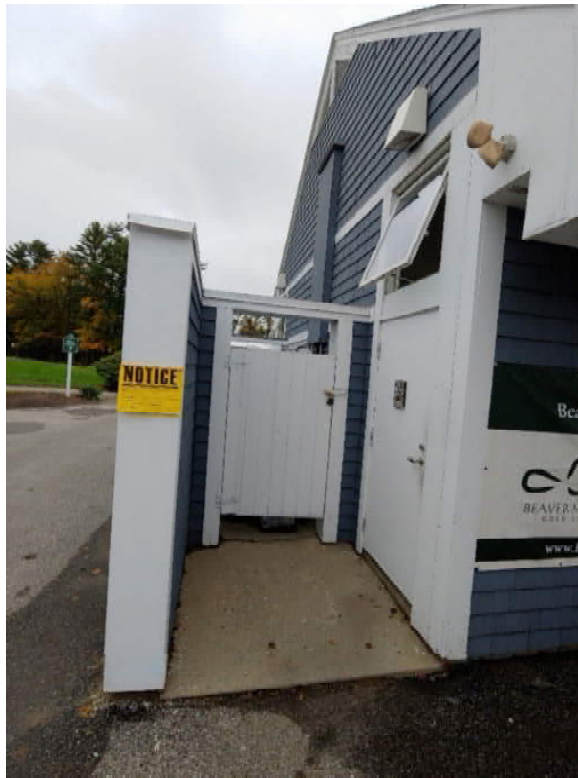
Public Restrooms Inaccessible from Exterior

Provide an accessible means of entry to the restrooms from the exterior of the building.

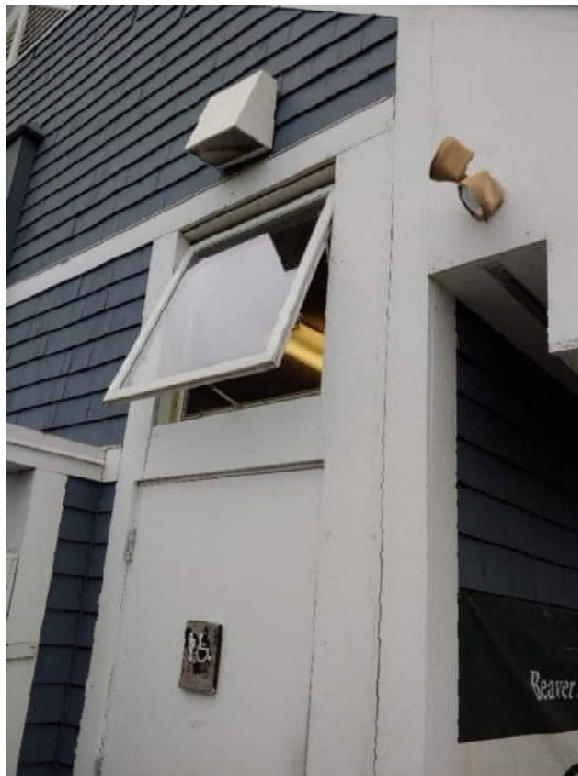
Incorrect Signs on Inaccessible Restroom Entrance

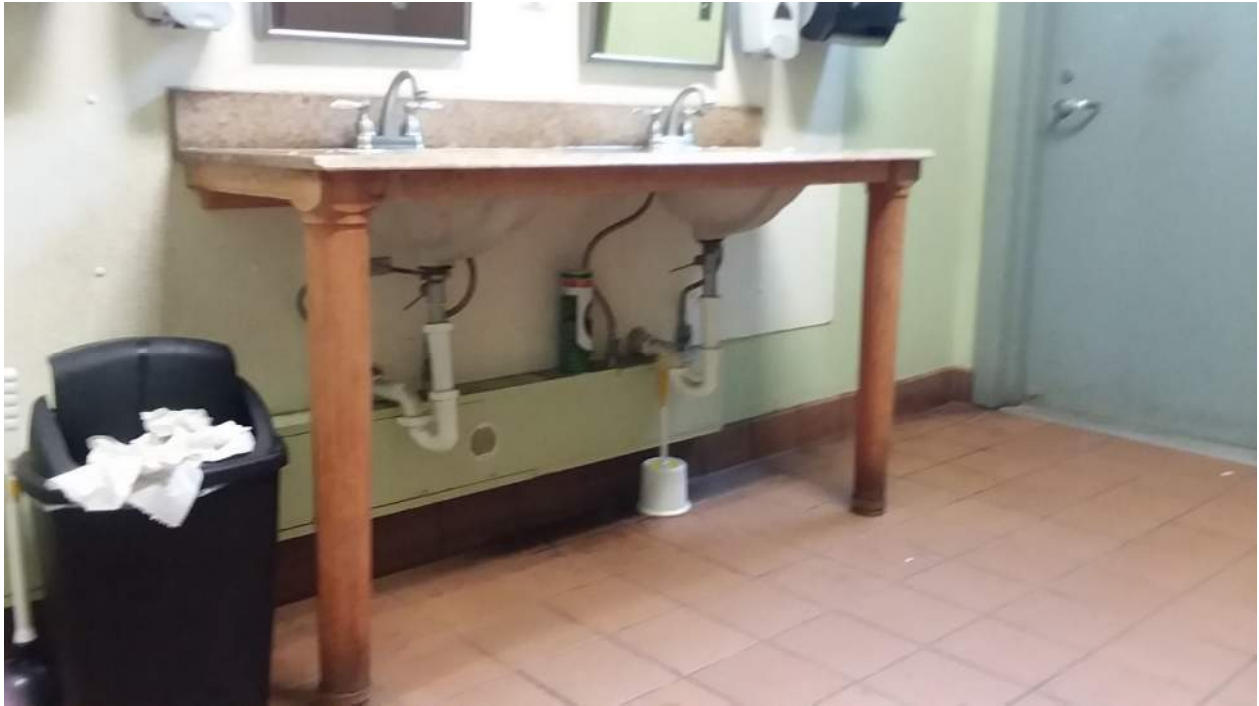
Plumbing Pipes Unprotected from Contact by Persons in Wheelchairs

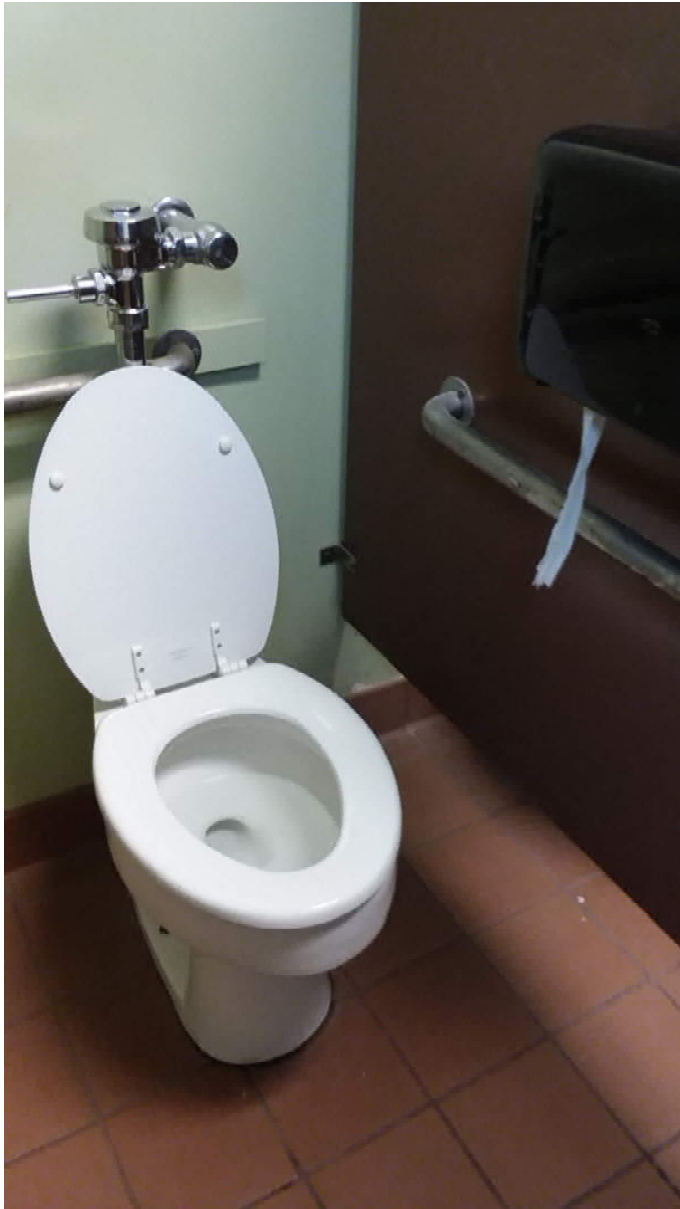
One end of the rear wall grab bars in the accessible toilet stalls in the restrooms are improperly installed and impaired by the toilet flush valve. There is not a vertical grab bar in the accessible toilet stalls.

Missing Vertical Grab Bar & Non-compliant Rear Grab Bar Impairments

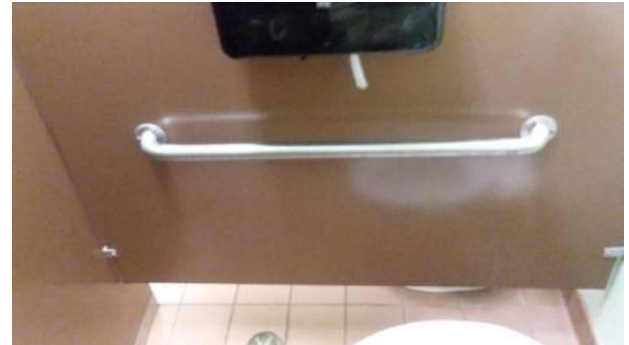
Missing Vertical Grab Bar

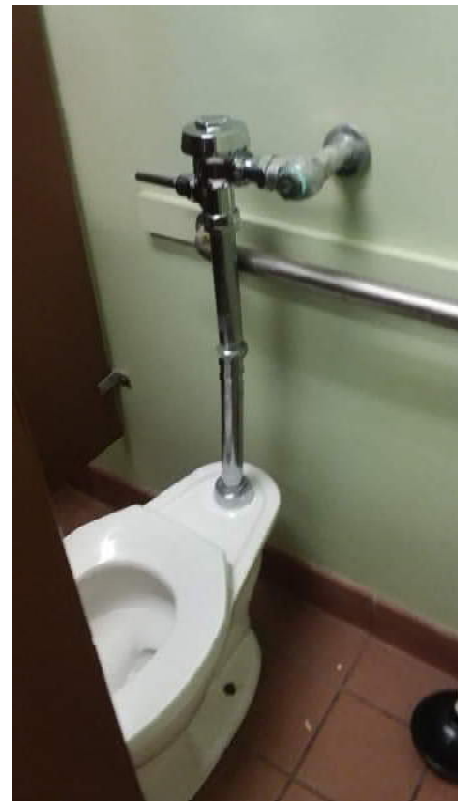
Non-compliant Rear Grab Bar Impairments
