CITY OF CONCORD, NEW HAMPSHIRE FACILITY CONDITIONS ASSESSMENT

BEAVER MEADOW GOLF COURSE CLUB HOUSE

NOVEMBER 5, 2021

TTG PROJECT No. 4980

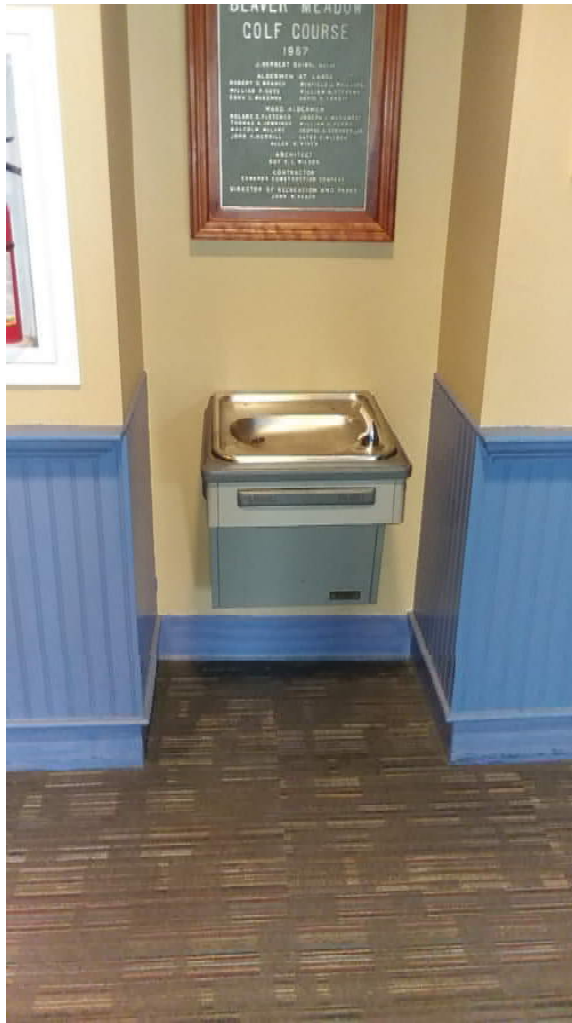
Single Drinking Fountain – Required to be High-Low Model

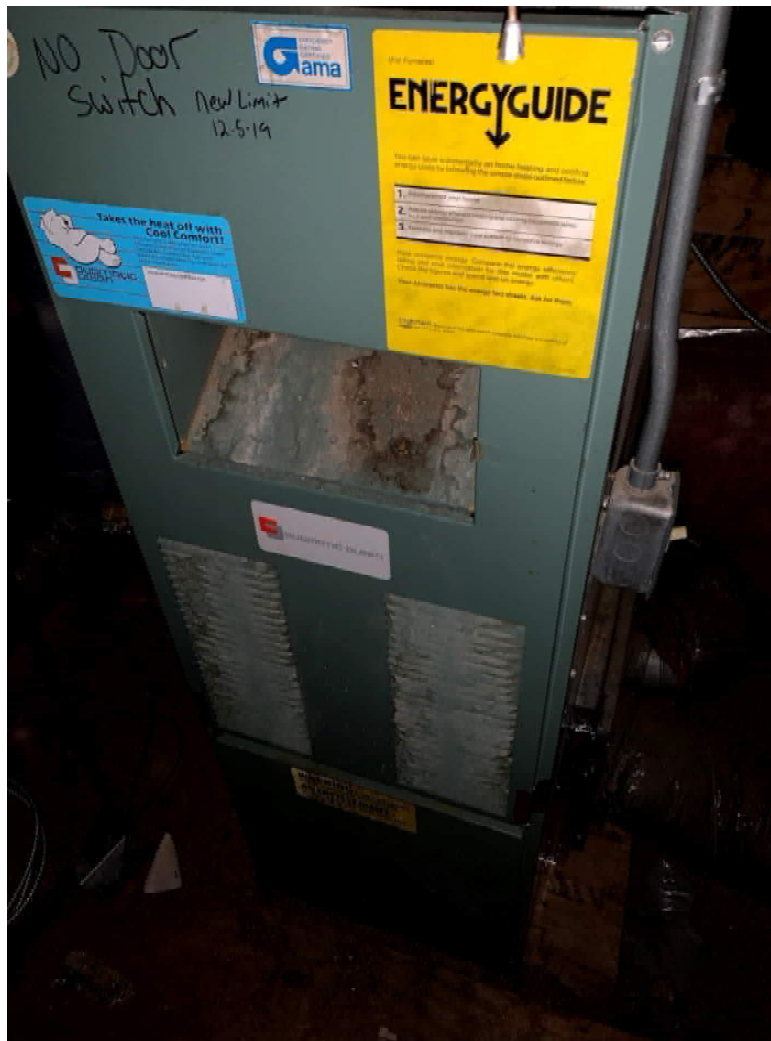
Bathroom furnace

We recommend replacement of the bathroom furnace unit, along with improved access. Outside air should be introduced to the remaining two heat/air conditioning units. We also recommend that the bathroom exhaust fan be repaired or replaced. If work is done that affects the kitchen hood exhaust system, we recommend adding a vented extension to the roof curb.

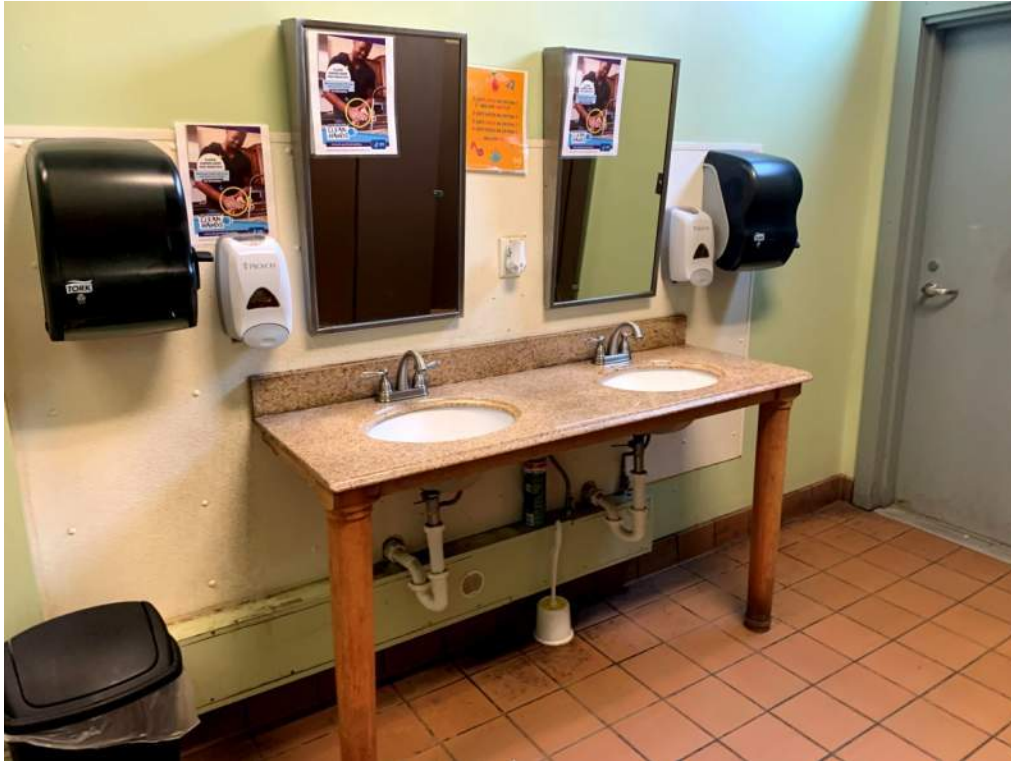
The fixtures in the rest rooms appear old and need replacement in the near future.

Rest room fixtures

The bathroom fixtures should also be replaced in the next five years.

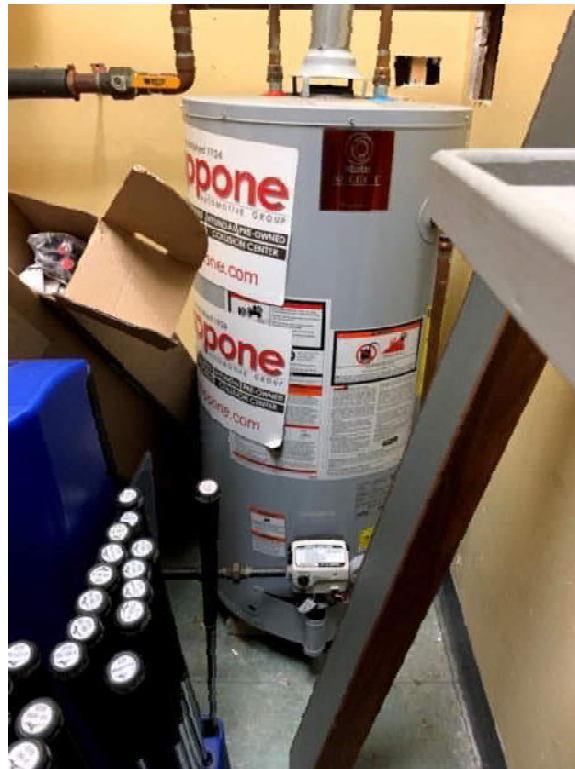
Water heater

The water heaters should be replaced in about ten years.
