January 6, 2026

SUBJECT: Memorial Field Bleacher Assessment  
Concord, New Hampshire

## Memorial Field Bleachers

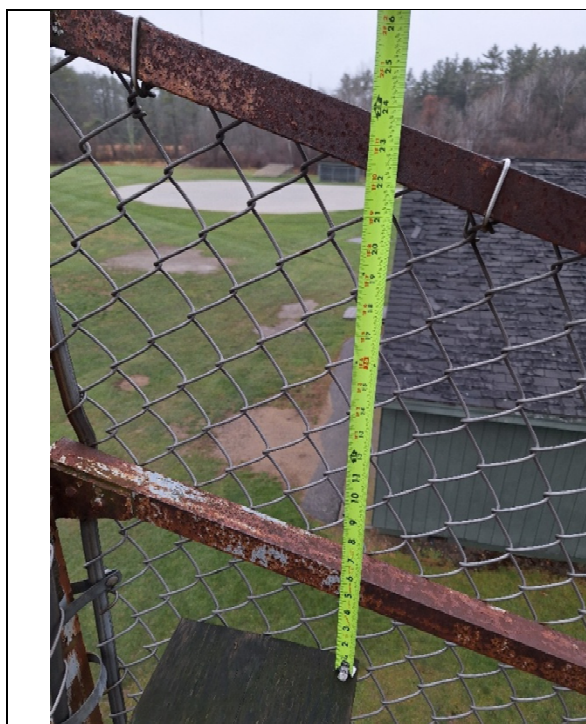
Photo 1: Railing is 24" from the top of the bench. NFPA 102 5.6.1 says no less than 36" from the center of the seat board and 42" from the floor board, typically all around.

As previously recommended in our 2019 assessment, it is our professional opinion that the main field bleachers should be removed and replaced with new, code-compliant bleachers. While the overall condition of the bleachers may be characterized as fair, there are numerous safety concerns and code deficiencies that make continued use and repair impractical.

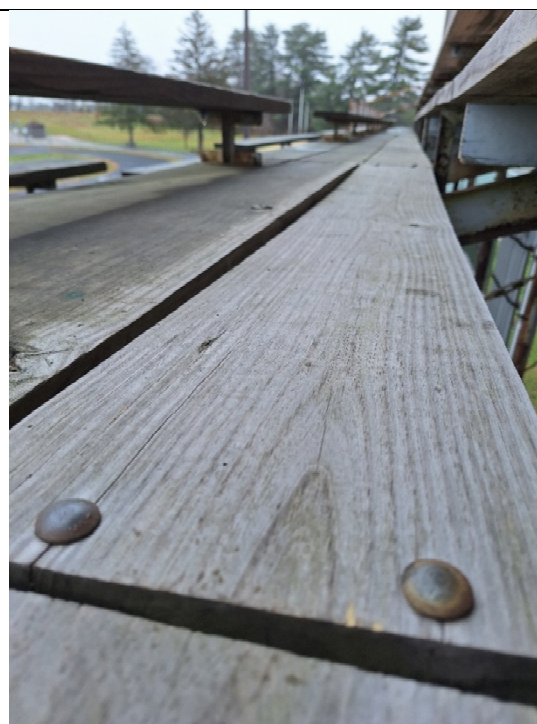
Photo 2: Wooden floorboards noticeably deflect.

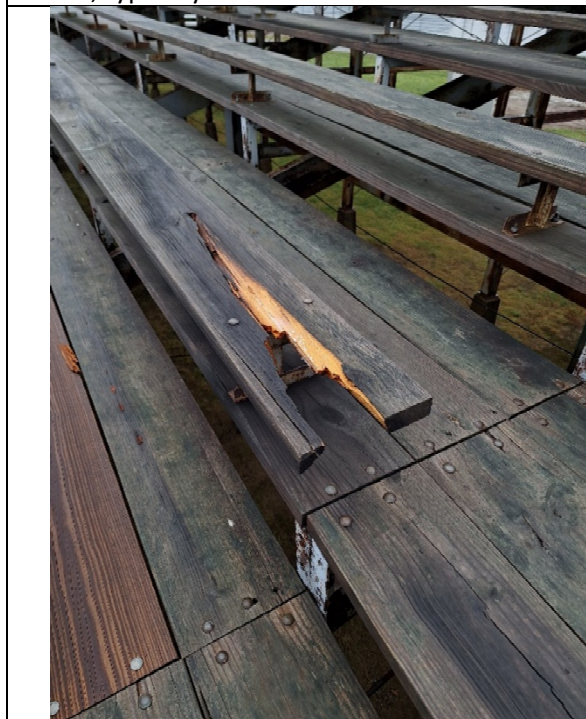
Photo 3: Broken wood bench.

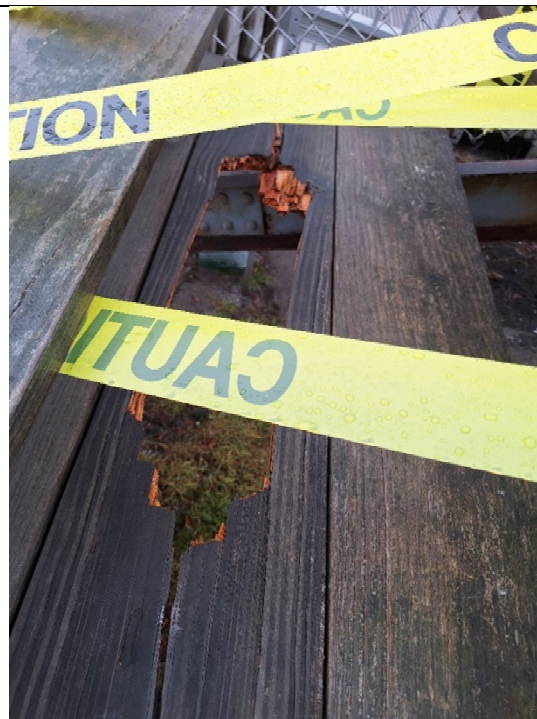
Photo 4: Broken wood footboard.

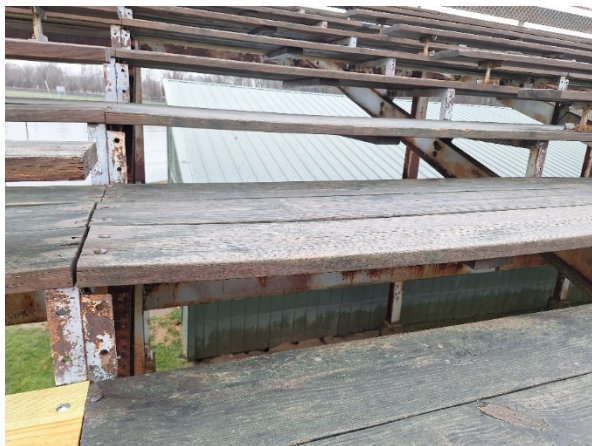
Photo 5: The stair board is loose and deflects.

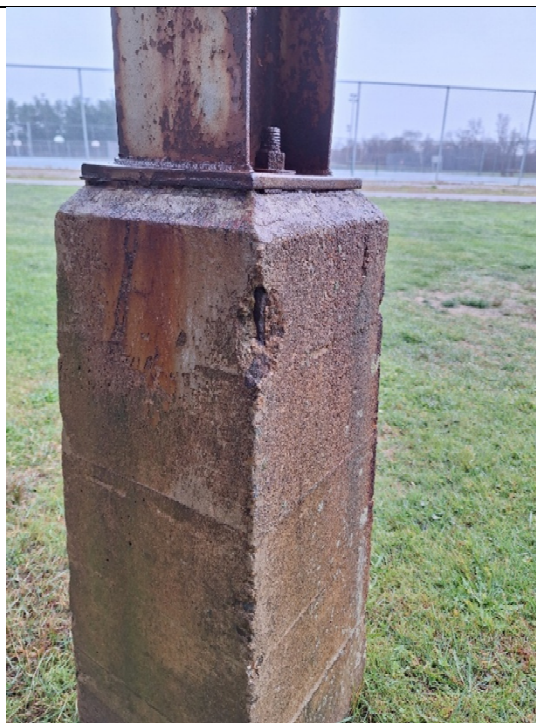
Photo 6: Rebar exposed in concrete pier.

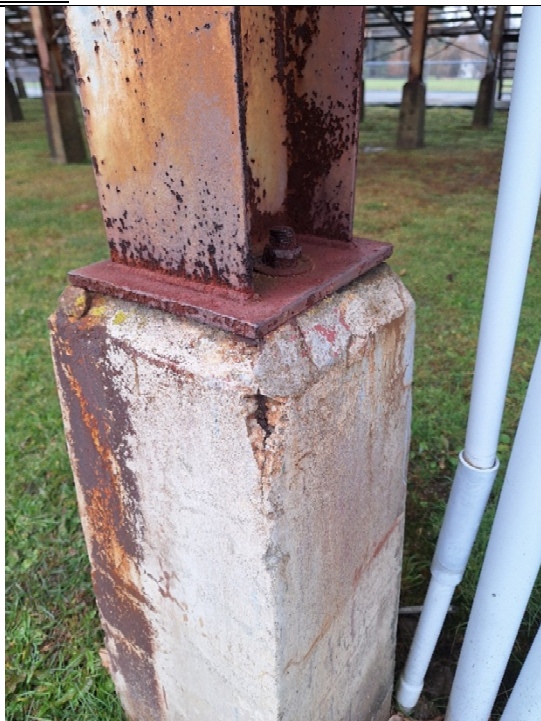
Photo 7: Rebar exposed in concrete pier.

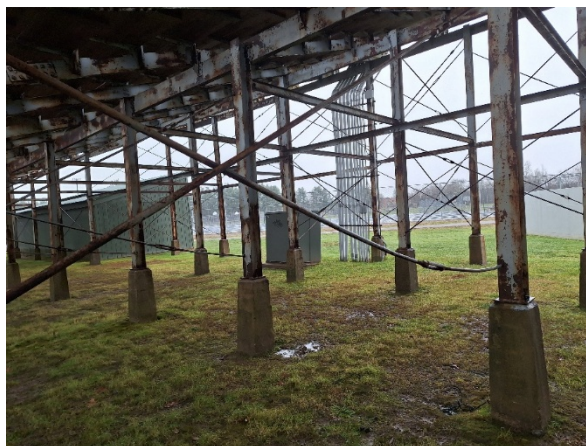
Photo 8: X Bracing bent in many places.

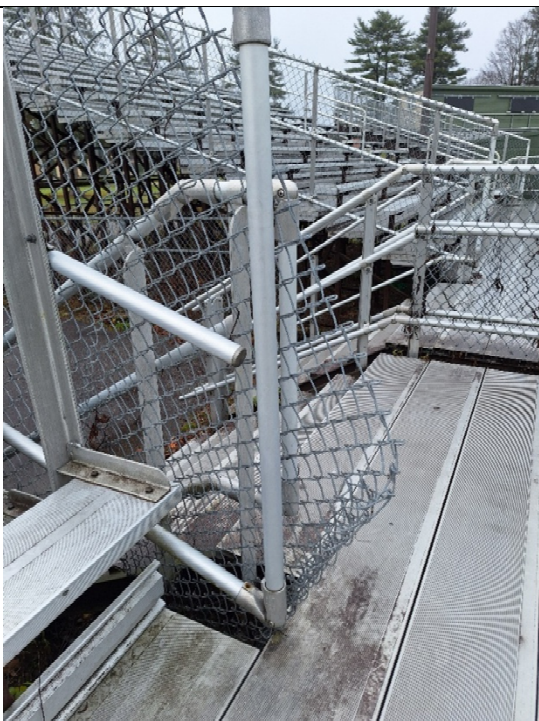
Photo 9: Chain-link is loose and extending past vertical support.

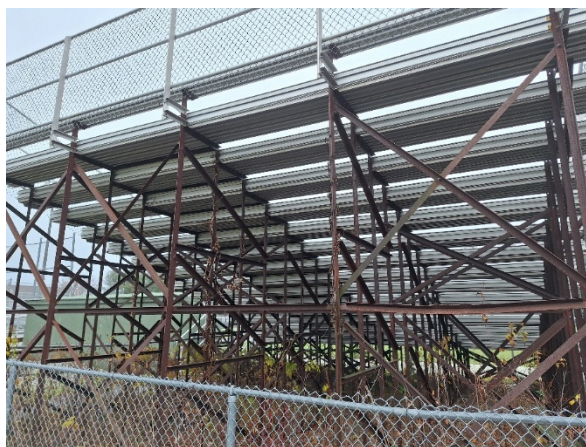
Photo 10: X Bracing is bent in many places.

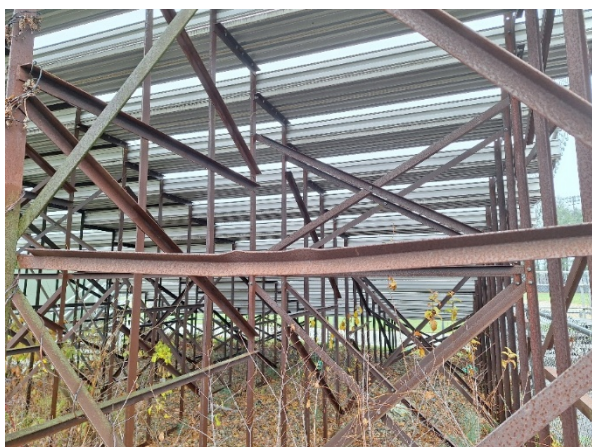
Photo 11: X Bracing is bent in many places.

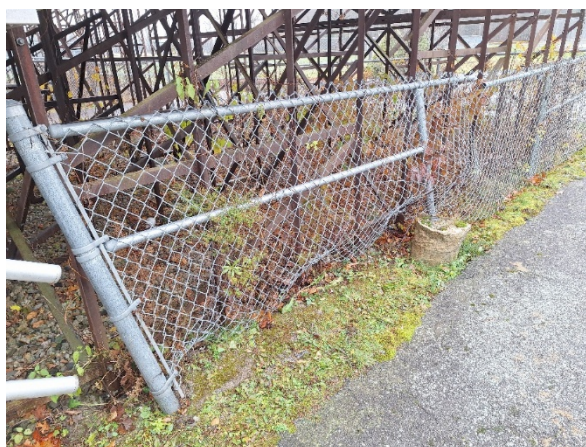
Photo 12: Chain-link is broken and posts are loose in many places.

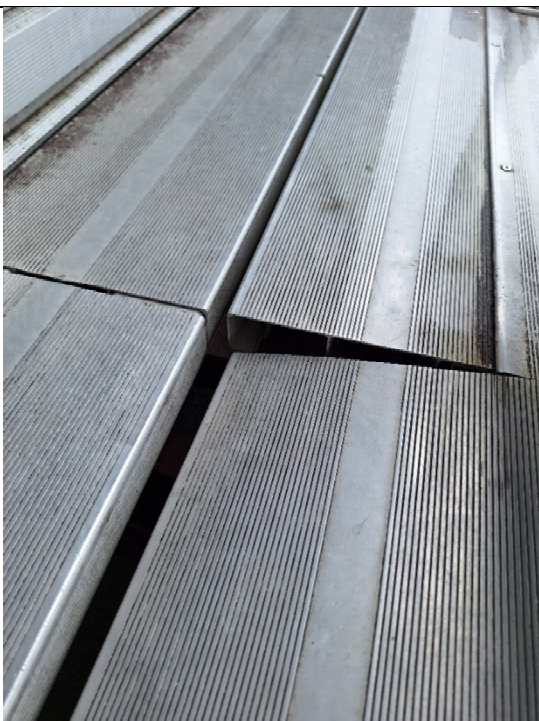
Photo 13: The metal floorboard is loose and deflecting. Occurs in multiple places.

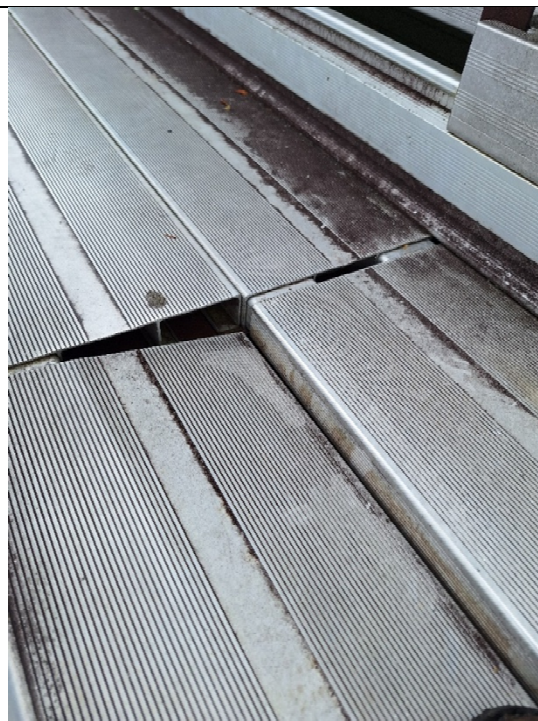
Photo 14: The metal floorboard is loose and deflecting.

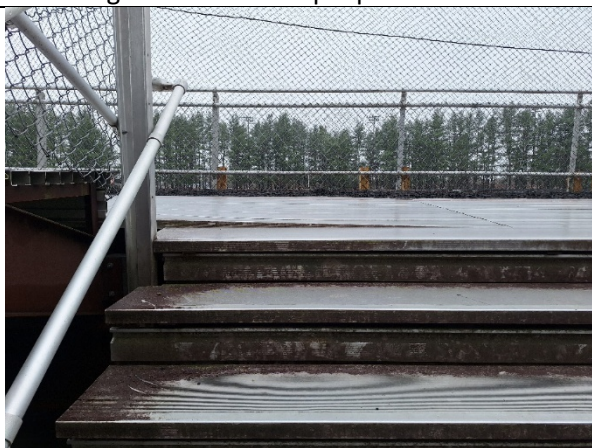
Photo 15: The top of the stairs does not align with the top of the decking.

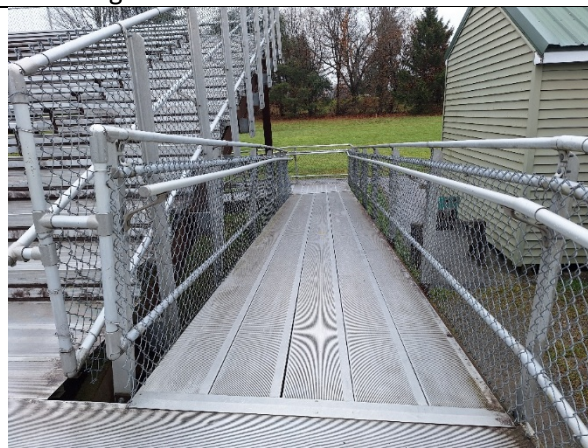
Photo 16: Ramp skews significantly to the right.

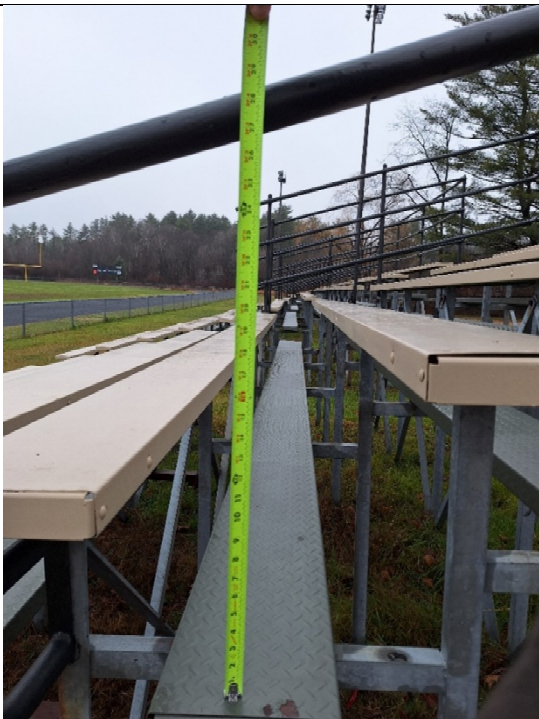
Photo 17: Opening larger than 4". NFPA 102 5.6.7 says no more than a 4" sphere can pass through the opening. NFPA 102 5.5.6 applies to the opening between the footboard and seats as well.

Given the age of the visitor bleachers, their overall condition, and the number of observed code deficiencies, it is our recommendation that these bleachers also be removed and replaced with a new, compliant seating system.

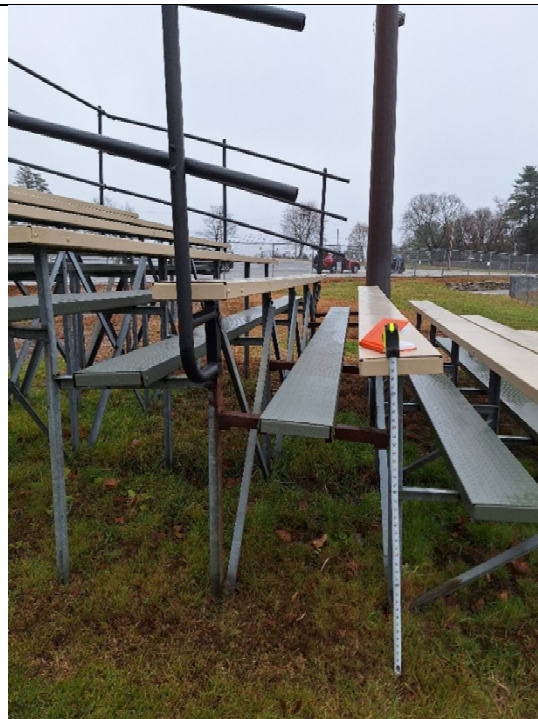
Photo 18: Railing does not extend low enough per NFPA 102 5.6.1.

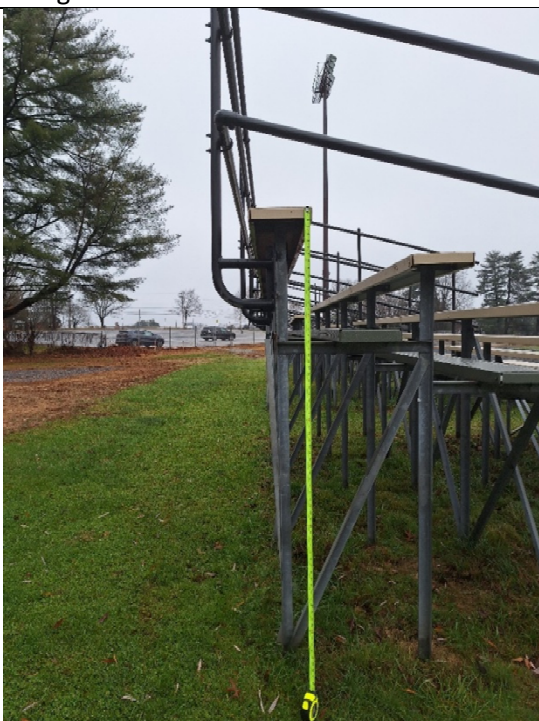
Photo 19: NFPA 102 5.5.7 Openings greater than 4".

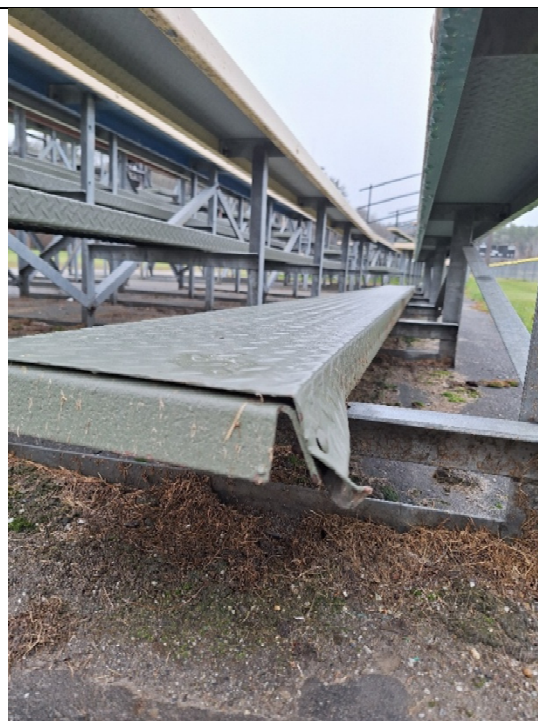
Photo 20: The edge of the floorboards and seating is loose or bent in many places.

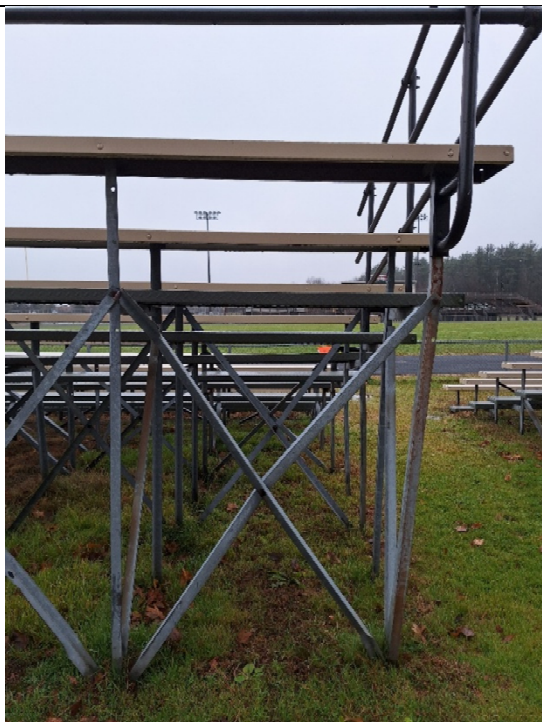
Photo 21: Bent X Bracing, typical in many places.

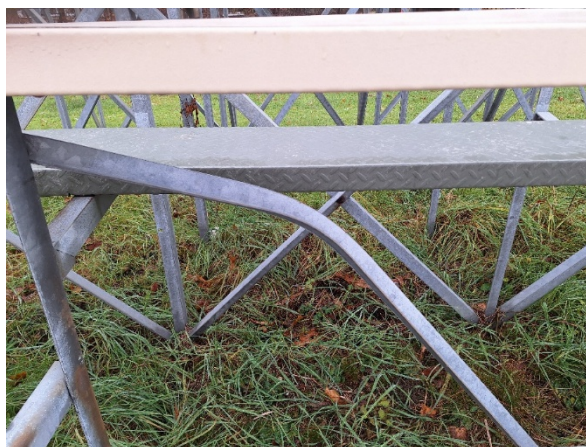
Photo 22: Bent bracing. Typical in many places.

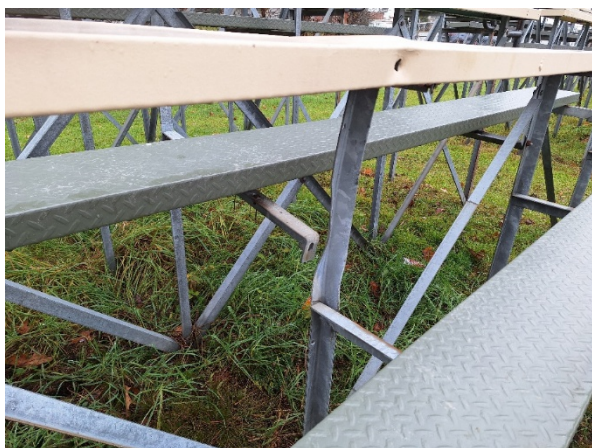
Photo 23: Bent bracing and seating.

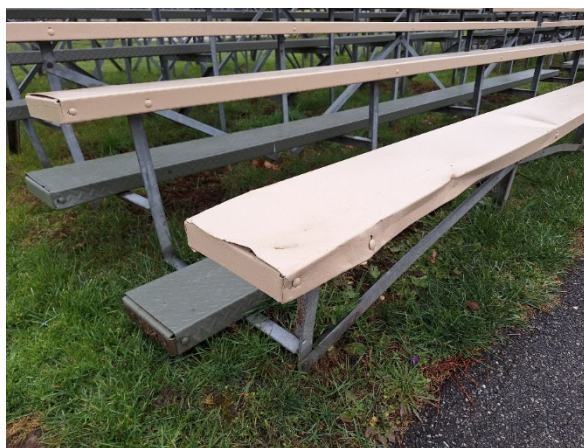
Photo 24: Bent seating, typical in many places.
