January 6, 2026

SUBJECT: Memorial Field Bleacher Assessment  
Concord, New Hampshire

The Turner Group is pleased to provide the following letter report regarding the existing bleachers at Memorial Field and Doane Diamond Field, both located on South Fruit Street in Concord, New Hampshire. The scope of our work was to perform a visual assessment of the conditions of the existing bleachers at both fields.

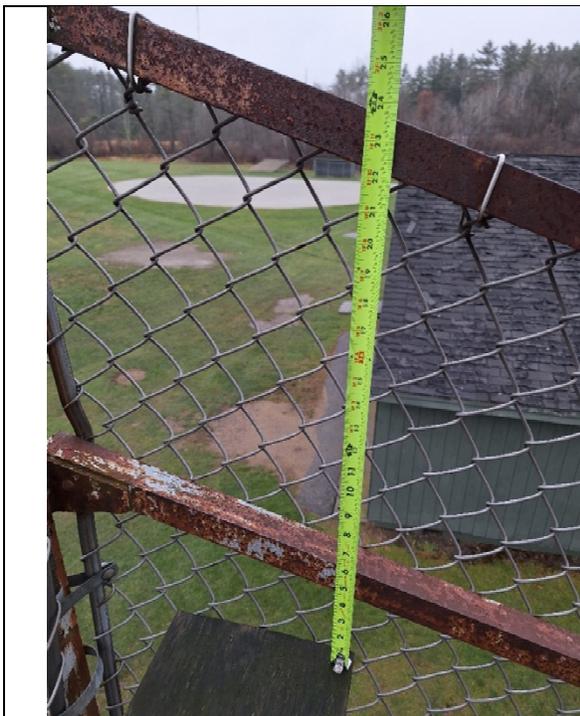
1. Guardrails are approximately 24 inches above the top of the bench. NFPA 102 Section 5.6.1 requires guardrails to be a minimum of 36 inches above the centerline of the seat board and 42 inches above the floorboard. This condition is typical throughout the bleachers.
2. Wooden floorboards exhibit noticeable deflection in multiple locations.
3. Wooden seating and floorboards are broken or deteriorated in several areas.
4. Several stair treads are loose and deflect when stepped on.
5. Several concrete piers show significant deterioration, with exposed reinforcing steel observed.
6. Steel X-bracing members are bent and deformed in numerous locations throughout the structure.

Photo 1: Railing is 24" from the top of the bench. NFPA 102 5.6.1 says no less than 36" from the center of the seat board and 42" from the floor board, typically all around.

As previously recommended in our 2019 assessment, it is our professional opinion that the main field bleachers should be removed and replaced with new, code-compliant bleachers. While the overall condition of the bleachers may be characterized as fair, there are numerous safety concerns and code deficiencies that make continued use and repair impractical.

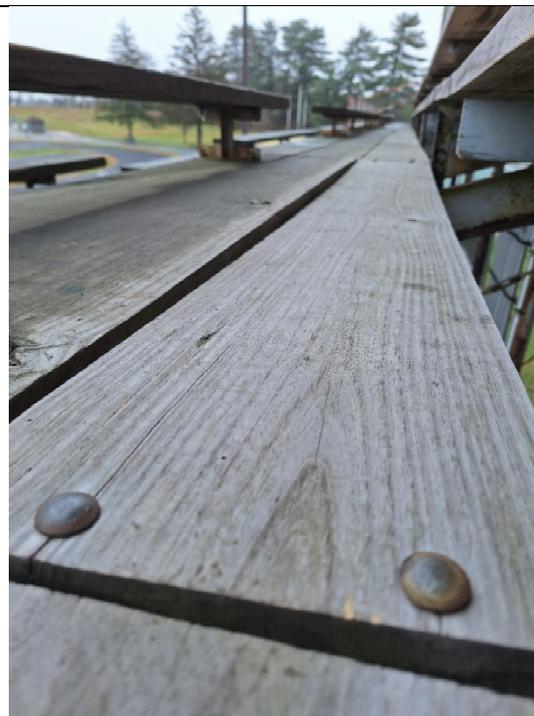
Photo 2: Wooden floorboards noticeably deflect.

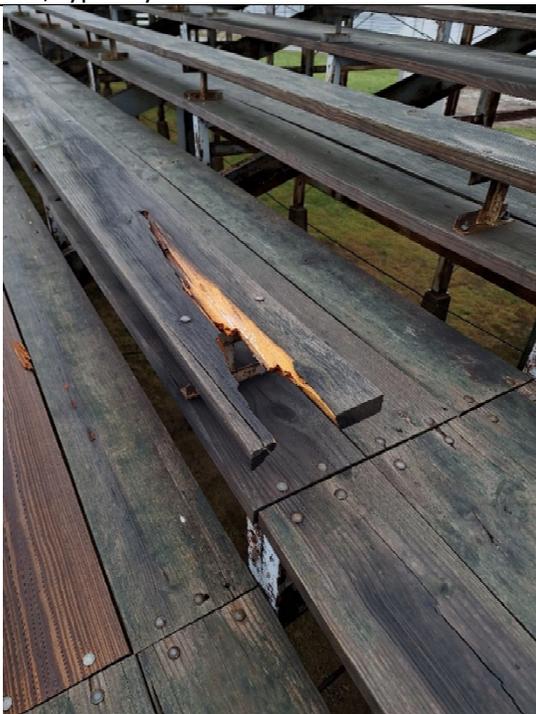
Photo 3: Broken wood bench.

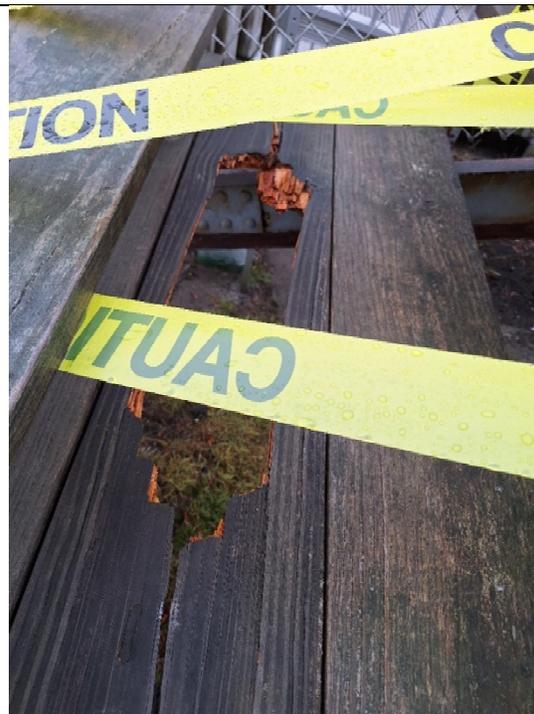
Photo 4: Broken wood footboard.

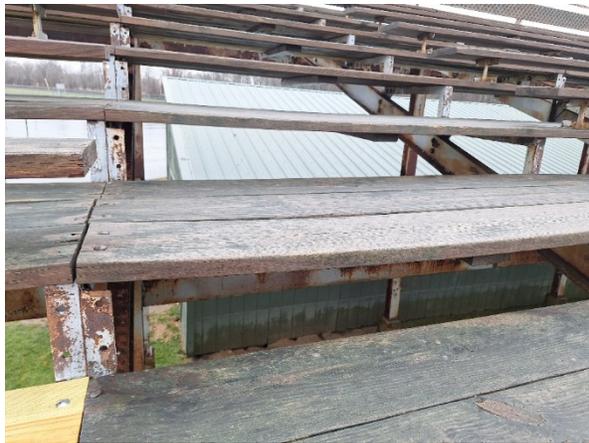
Photo 5: The stair board is loose and deflects.

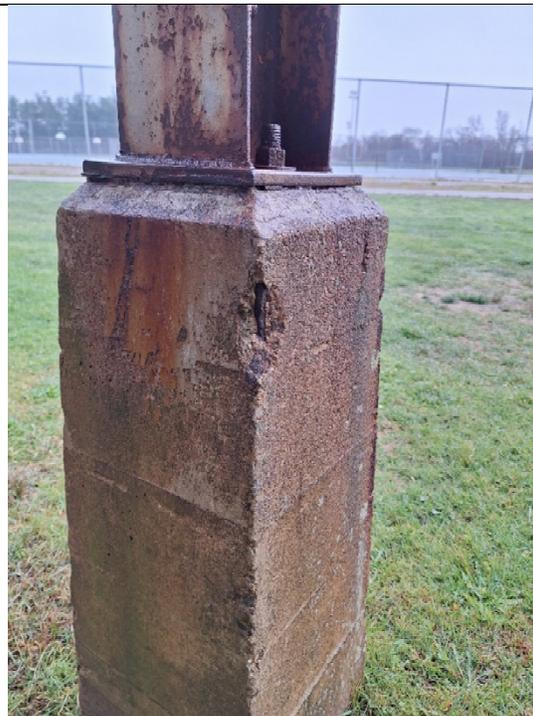
Photo 6: Rebar exposed in concrete pier.

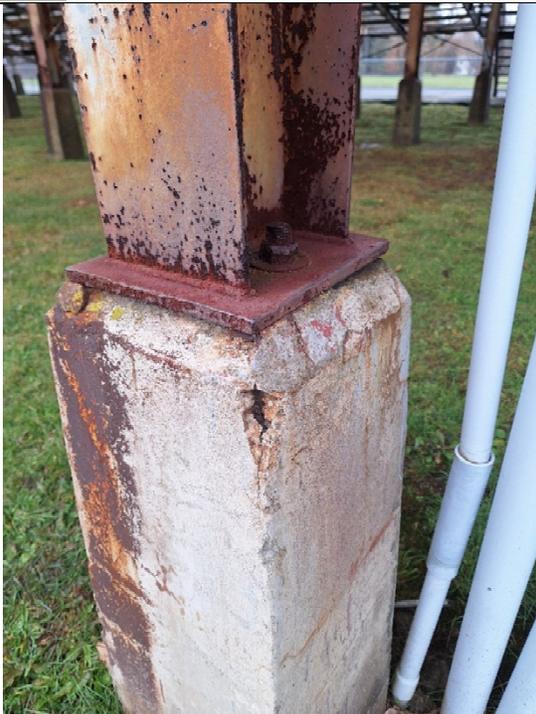
Photo 7: Rebar exposed in concrete pier.

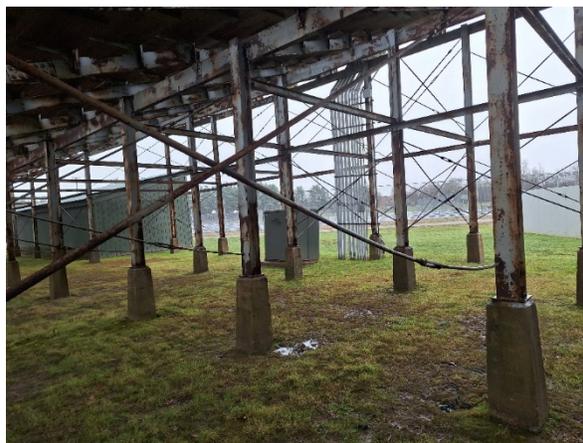
Photo 8: X Bracing bent in many places.

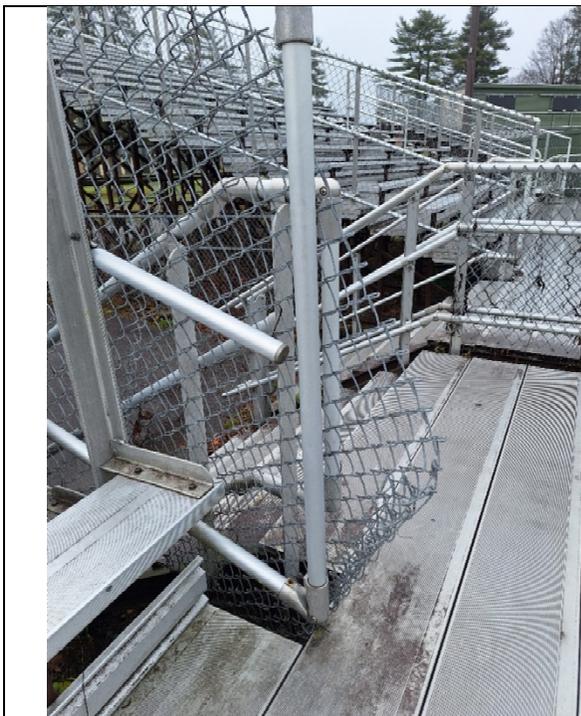
Photo 9: Chain-link is loose and extending past vertical support.

It is our opinion that the existing bleacher superstructure could be removed and reinstalled on a new, properly designed foundation system. The existing foundations should be removed and replaced. The observed settlement and heaving of the current foundations have resulted in multiple structural, accessibility, and code-compliance issues.

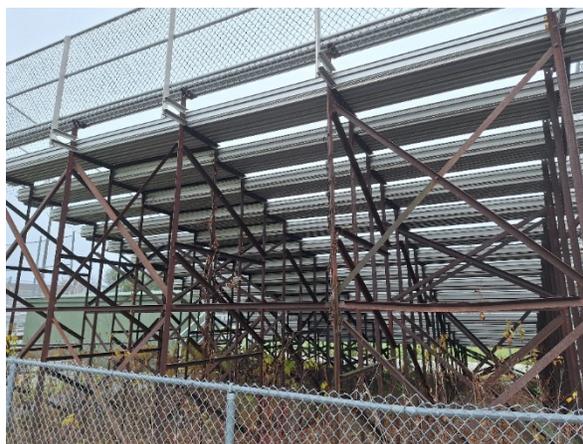
Photo 10: X Bracing is bent in many places.

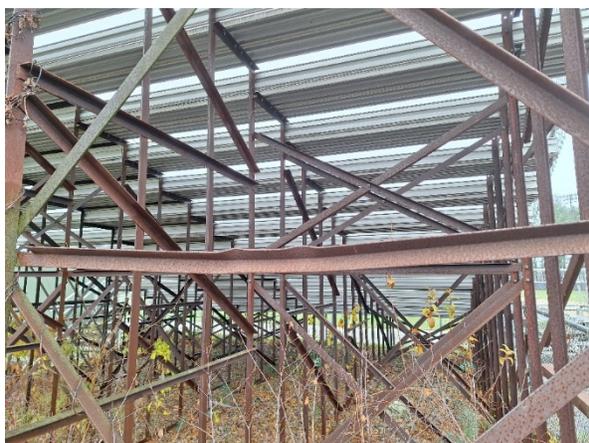
Photo 11: X Bracing is bent in many places.

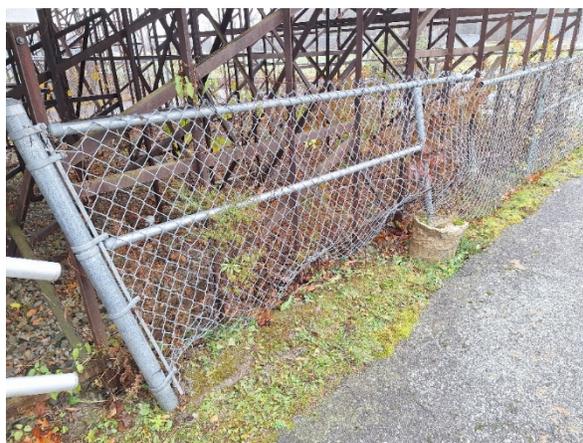
Photo 12: Chain-link is broken and posts are loose in many places.

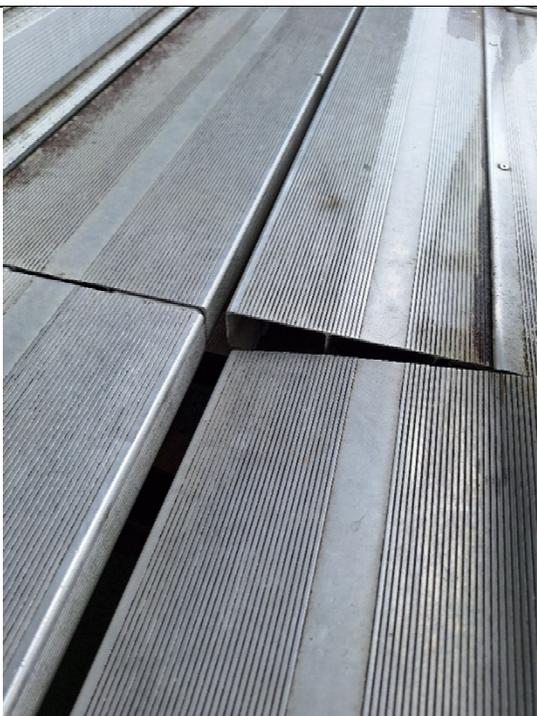
Photo 13: The metal floorboard is loose and deflecting. Occurs in multiple places.

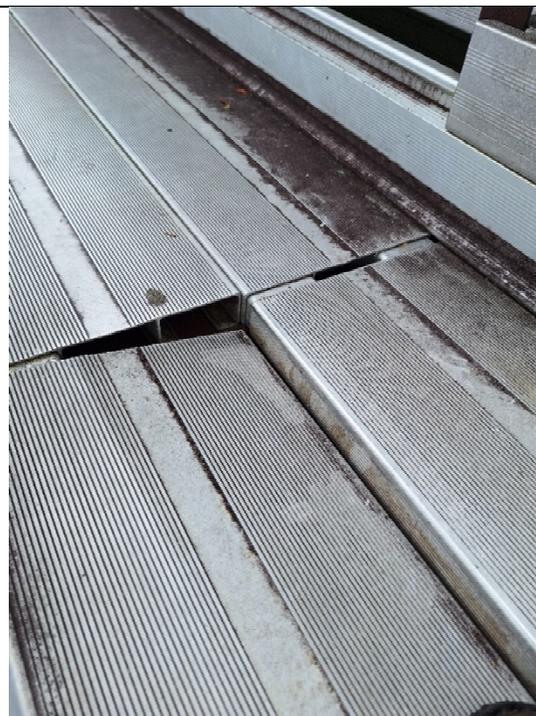
Photo 14: The metal floorboard is loose and deflecting.

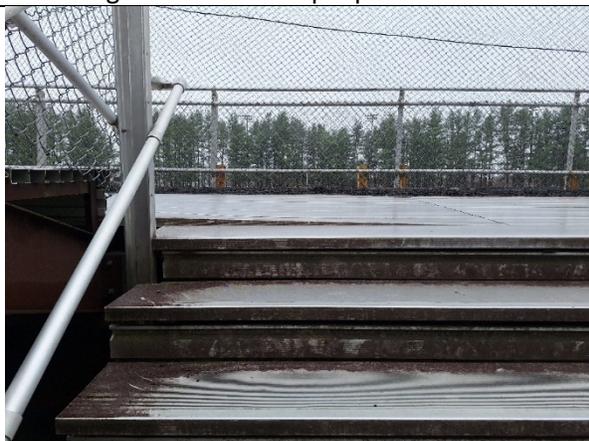
Photo 15: The top of the stairs does not align with the top of the decking.

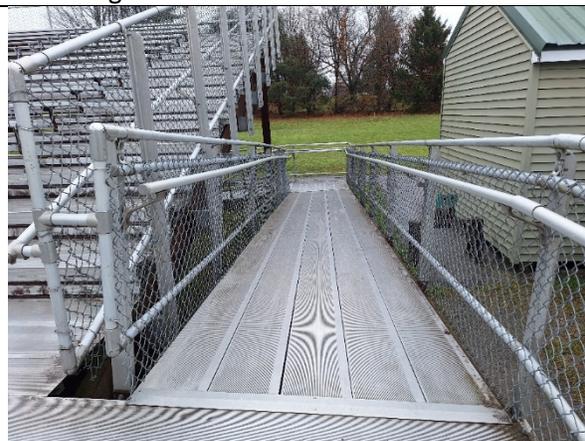
Photo 16: Ramp skews significantly to the right.

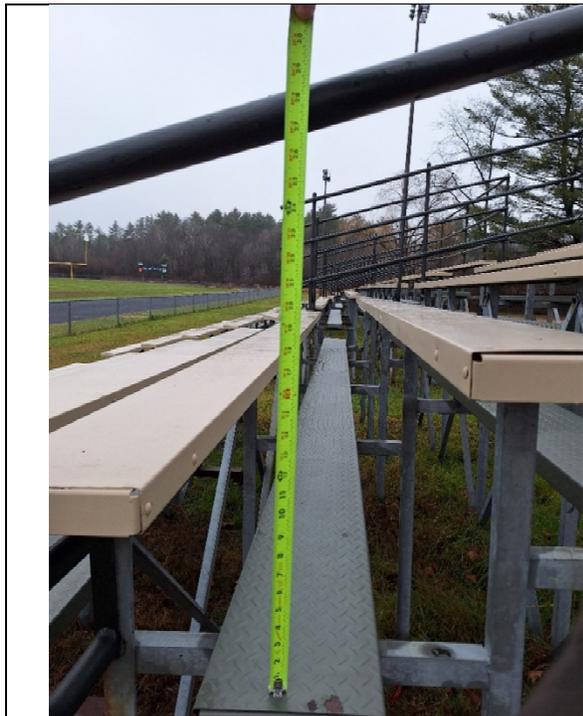
1. Openings greater than 4 inches were observed in guardrails and seating areas across all bleacher sections. NFPA 102 Section 5.6.7 limits openings such that a 4-inch sphere may not pass through. NFPA 102 Section 5.5.6 applies similar requirements to openings between footboards and seats.
2. Guardrails do not extend low enough to meet the requirements of NFPA 102 Section 5.6.1. This condition is typical across all visitor bleacher sections.
3. Floorboard and seating edges are loose, bent, or damaged in multiple locations, with sharp edges exposed.
4. Structural framing and bracing members are bent or damaged in several locations across all sections.
5. Seating and footboards are damaged and/or bent in numerous locations throughout the bleachers.

Photo 17: Opening larger than 4". NFPA 102 5.6.7 says no more than a 4" sphere can pass through the opening. NFPA 102 5.5.6 applies to the opening between the footboard and seats as well.

Given the age of the visitor bleachers, their overall condition, and the number of observed code deficiencies, it is our recommendation that these bleachers also be removed and replaced with a new, compliant seating system.

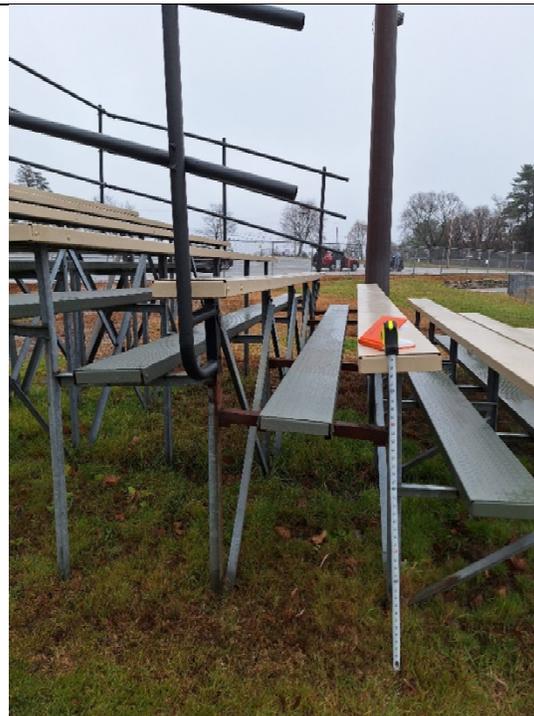
Photo 18: Railing does not extend low enough per NFPA 102 5.6.1.

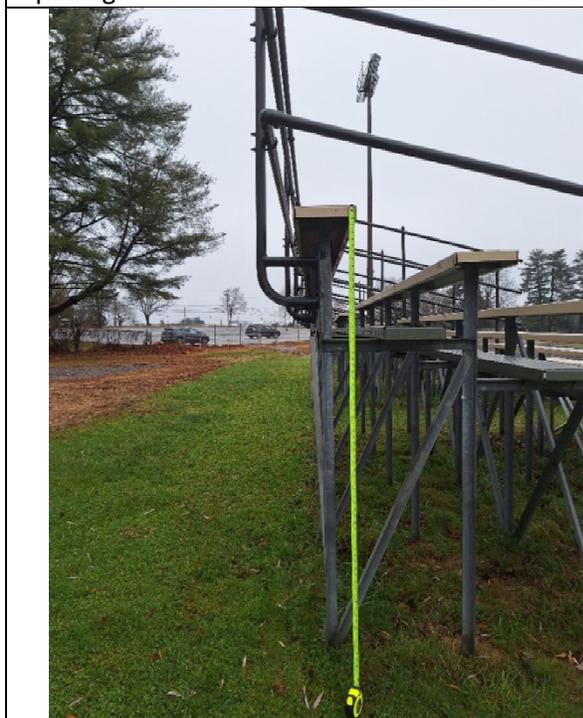
Photo 19: NFPA 102 5.5.7 Openings greater than 4".

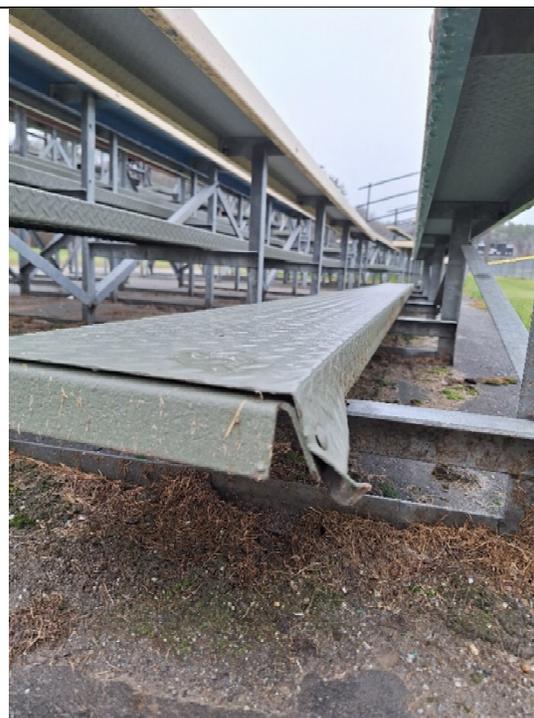
Photo 20: The edge of the floorboards and seating is loose or bent in many places.

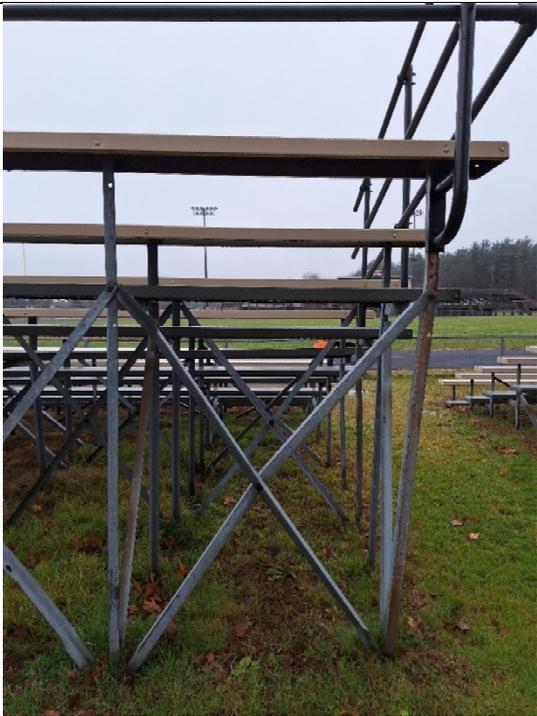
Photo 21: Bent X Bracing, typical in many places.

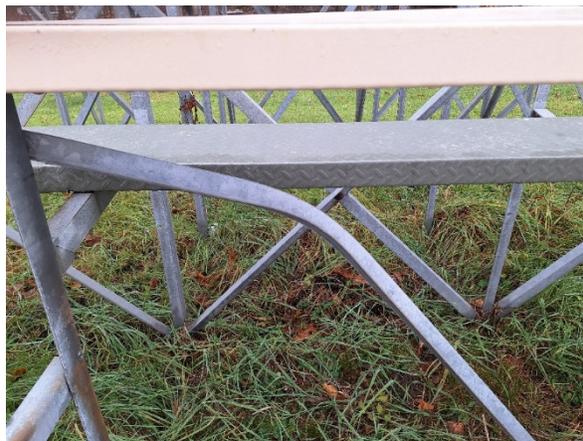
Photo 22: Bent bracing. Typical in many places.

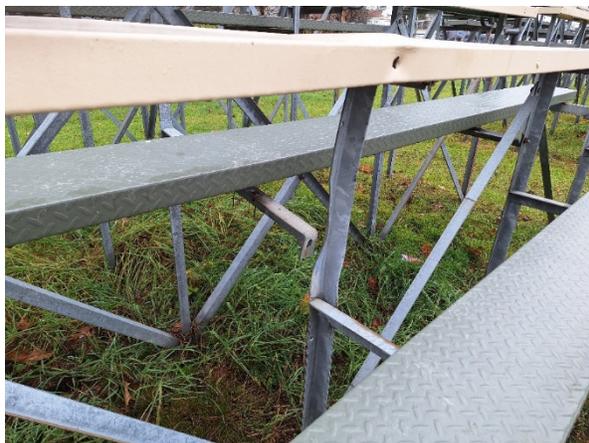
Photo 23: Bent bracing and seating.

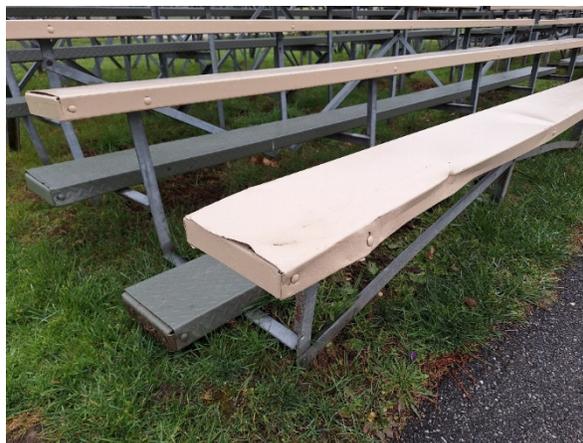
Photo 24: Bent seating, typical in many places.
