RE: Abbott Village, Subdivision Approvals

Re: Field Investigation of 382 North State Street – Concord, NH.

Date of Site Visit: December 6, 2016

ABBOTT HOUSE 382 NORTH STATE STREET CONCORD, NH

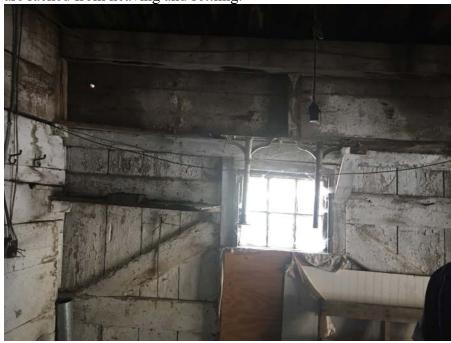
Photo 1

The subject building is a three story wood framed structure with a 1 ½ story cape style wing, a partial basement and an attached garage. The main three story home is a federalist style with a low pitch hip roof. The garage is attached to the main house. It does not have a frost protected foundation and has experienced significant settlement in some areas. The garage wing is subject to frost heave and the walls are racked from heaving and settling.

The Abbott house has deteriorated beyond repair and it is not a suitable candidate for renovation. Most of the major structural elements, roof sheathing floors and ceilings would need to be replaced. The foundation would need major repairs and the garage would need a frost protected foundation. The cost of such work would far exceed any possible financial return for the property. Currently, the building is unsafe to occupy. There is a danger that children or vandals could enter the building and be injured by falling through unsafe floors. It is my recommendation that the building be demolished.

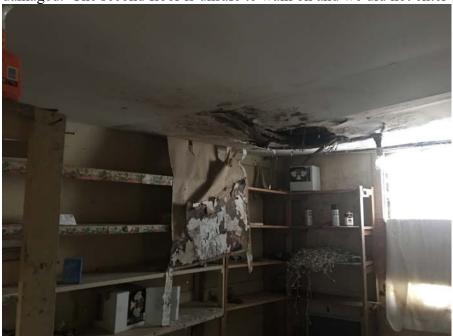
Photo 2

Upon entering the cape style wing I discovered severe deterioration due to water intrusion through the roof. The first floor ceiling has come down in large sections and the floor is warped and rotting from the

presence of water. The second ceiling has similar areas where the ceiling and floor are significantly damaged. The second floor is unsafe to walk on and we did not enter the rooms.

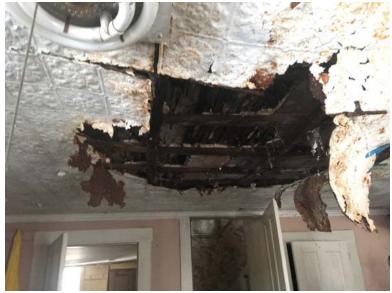
Photo 5

In the main area of the home, the three story section, the situation is very much the same. Significant leaks in the roof have permitted the intrusion of water through all the levels. The floor and ceiling framing are rotted to the extent that they are unsafe to walk on. Much of the original finishes including plaster, wall paper, paint and trim are lost. We were required to use extreme care so as not to fall through the floor.

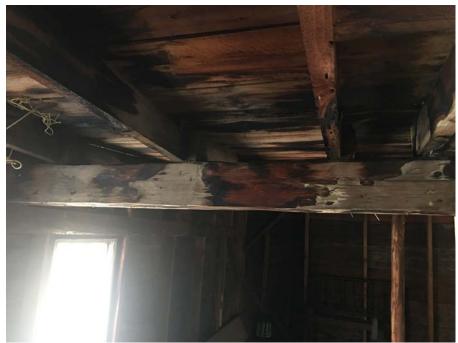
Photo 7

The roof faming and sheathing have deteriorated and are allowing water into the building. The framing members have water damage and rot. The roof is structurally compromised.

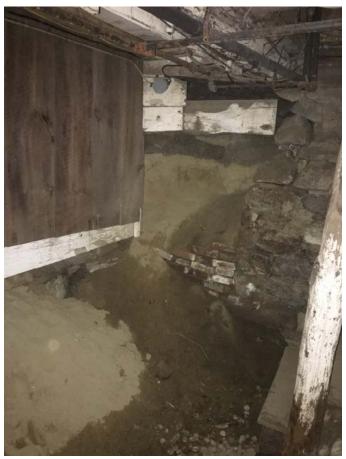
Photo 8

There is a partial basement under the main building. The foundation walls are constructed of stone rubble. The walls have collapsed in multiple areas and soil has fallen into the basement area. These areas of foundation failure have put the wood structure at risk of collapse.
