Turtle Pond, ConcordExisting Conditions Normal View

Turtle Pond, ConcordProposed Conditions Normal View

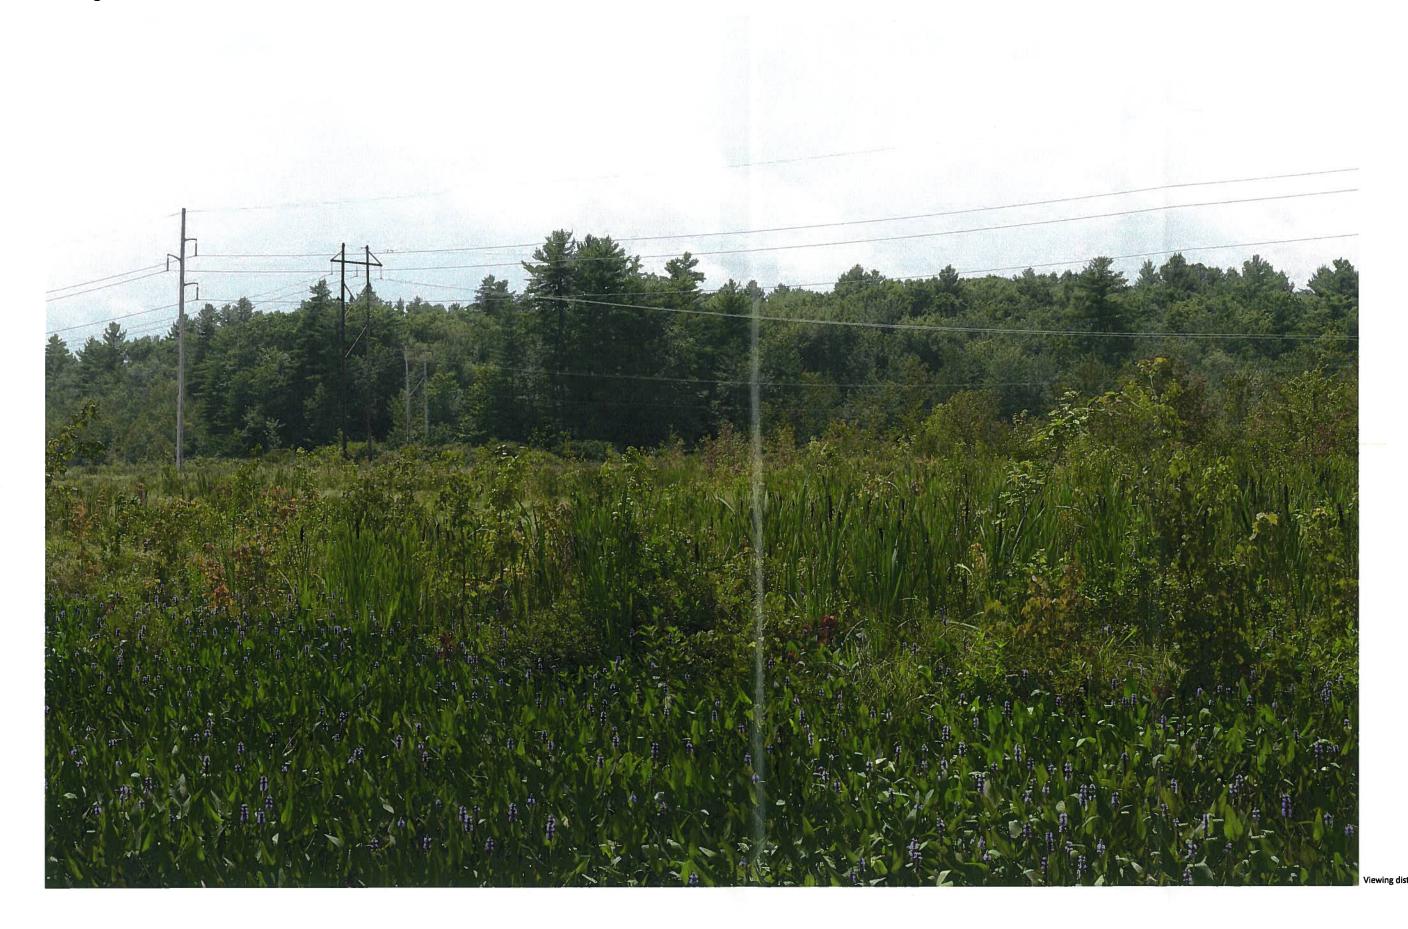
Transmission Line	Proposed structure type (visible): N/A	
Information	Height range of existing transmission structures (visible): 43' to 97'	
	Height range of proposed transmission structures (visible): N/A	
	Right of way width: 257.5'	
Photograph Information	Date and time: 8/1/14 at 12:55pm	
	Location: facing South/Southeast 43.255135° N, -71.521292° W	
	Weather conditions: Overcast	
	Distance to visible structures: 0.13 to 0.63 miles	
	Focal length (50mm equivalent): 35mm	
	Camera Make/Model: Nikon D7100	
	Source: TJD&A

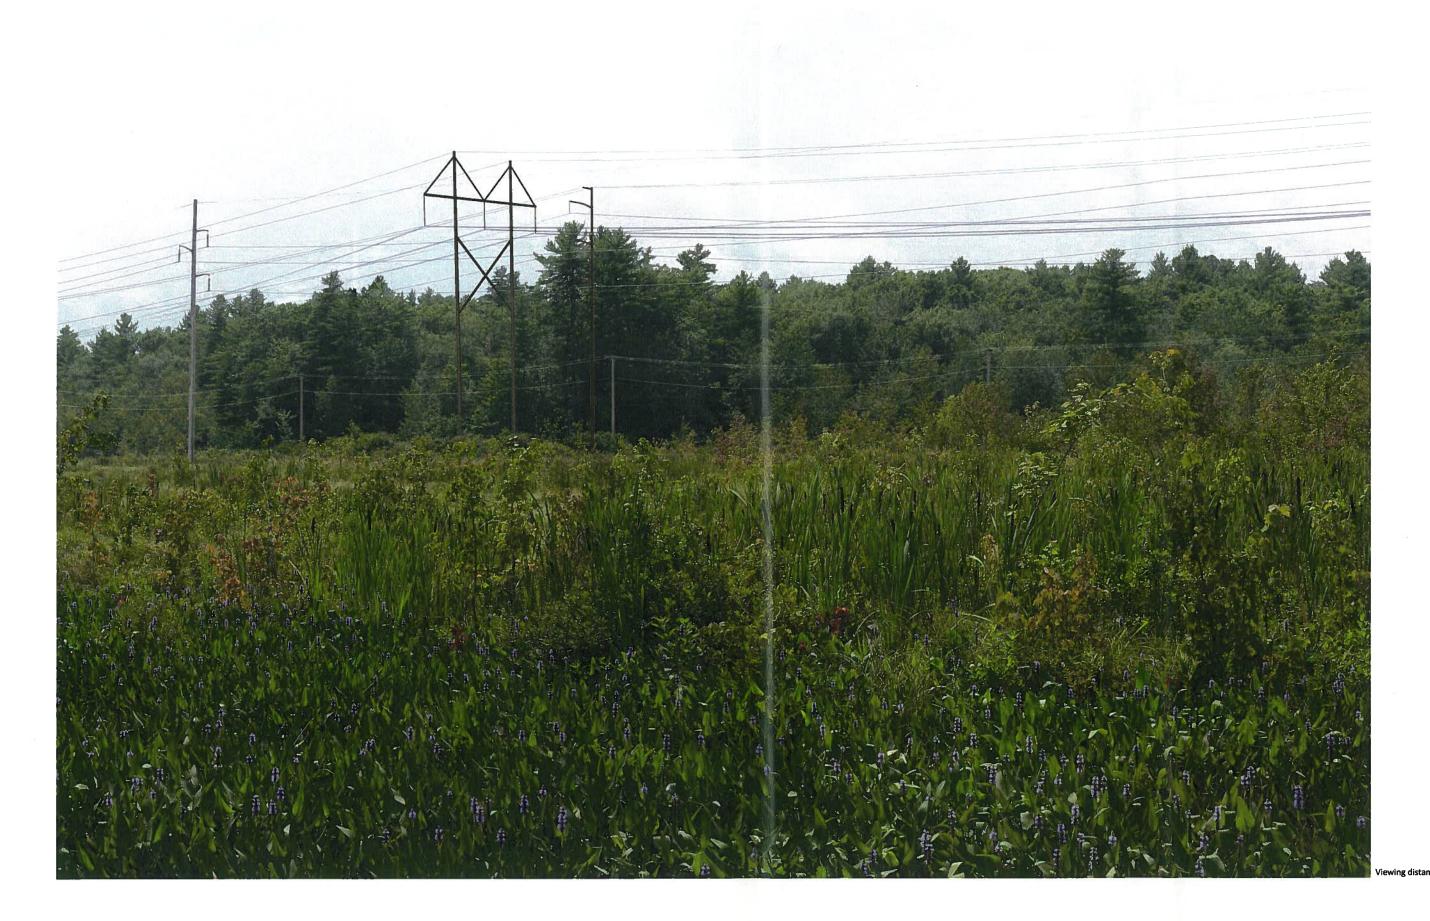
Transmission Line Information	Proposed structure type (visible): 345 kV H-Frame 115kV Monopole		
	Height range of existing transmission structures (visible): 43' to 97'		
	Height range of proposed transmission structures (visible): 345 kV: 90' to 110' 115 kV: 90' to 115'		
	Right of way width: 257.5'		
Photograph Information	Date and time: 8/1/14 at 12:55pm		
	Location: facing South/Southeast 43.255135° N, -71.521292° W		
	Weather conditions: Overcast		
	Distance to visible structures: 0.13 to 0.63 miles		
	Focal length (50mm equivalent): 35mm		
	Camera Make/Model: Nikon D7100		
	Source: TJD&A
