**MEMORANDUM**

**RE:** MAJOR SITE PLAN REVIEW NARRATIVE AND WAIVER REQUESTS FOR  
LIBERTY UTILITIES FACILITIES AND TESTING LAB BUILDING, 14  
BROKEN BRIDGE ROAD, CONCORD, NEW HAMPSHIRE  
(Project No. 12869)

**DATE:** JULY 17, 2019

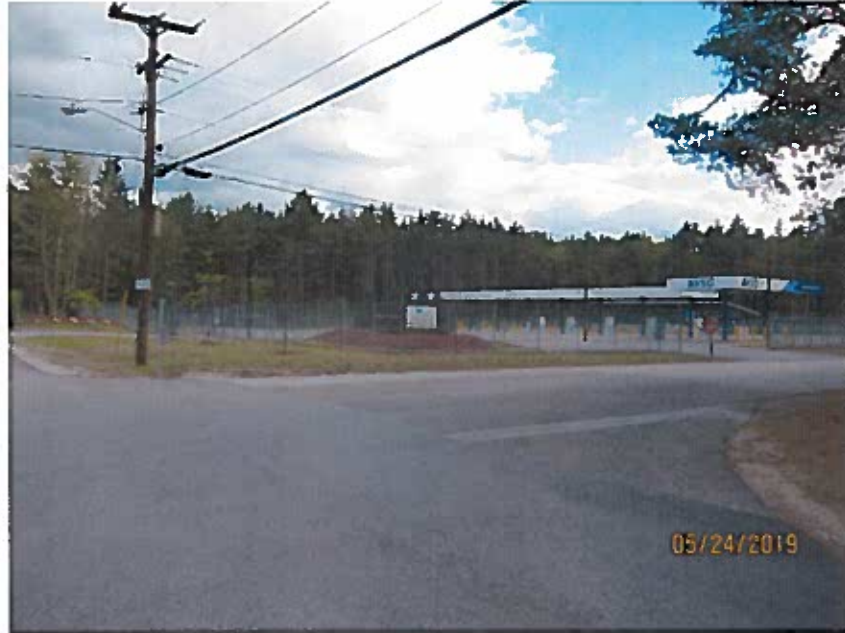
**Photograph 11: Liberty Utilities CNG facility and private drive on west side of Broken Bridge Road, looking southwest**

The other development approved in 2014 is the Compressed Natural Gas (CNG) Facility, located at 20 Broken Bridge Road on Lot 109-1-4. The CNG Facility includes a dispenser area for truck and vehicle filling, a natural gas compressor station, and associated infrastructure.

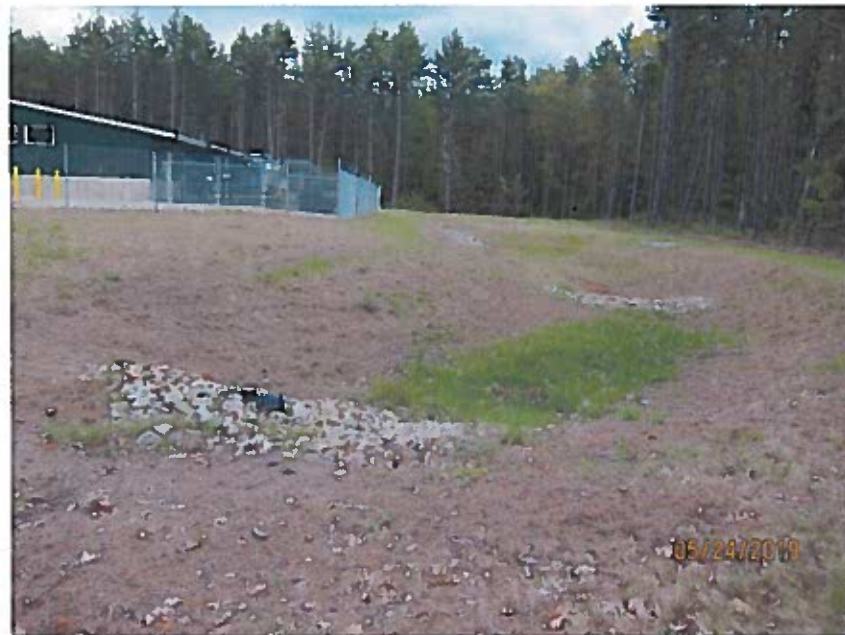
**Photograph 12: South stormwater basin of CNG facility**

Site improvements will include a paved access driveway around the building and approximately 43 standard vehicular parking spaces and 9 long truck parking spaces. The total impervious surface is approximately 49,800 square feet. Stormwater will be managed on-site using bioretention basins for filtration of off-site impervious surface from Broken Bridge Road, a sediment basin for pretreatment, and infiltration and treatment through a subsurface chamber system and filter media. Stormwater for approximately half of the site will be collected and conveyed via pipe to the abutting Liberty Utilities CNG facility on lot 109-1-4, where an existing infiltration basin will be expanded to accommodate stormwater from the proposed project.

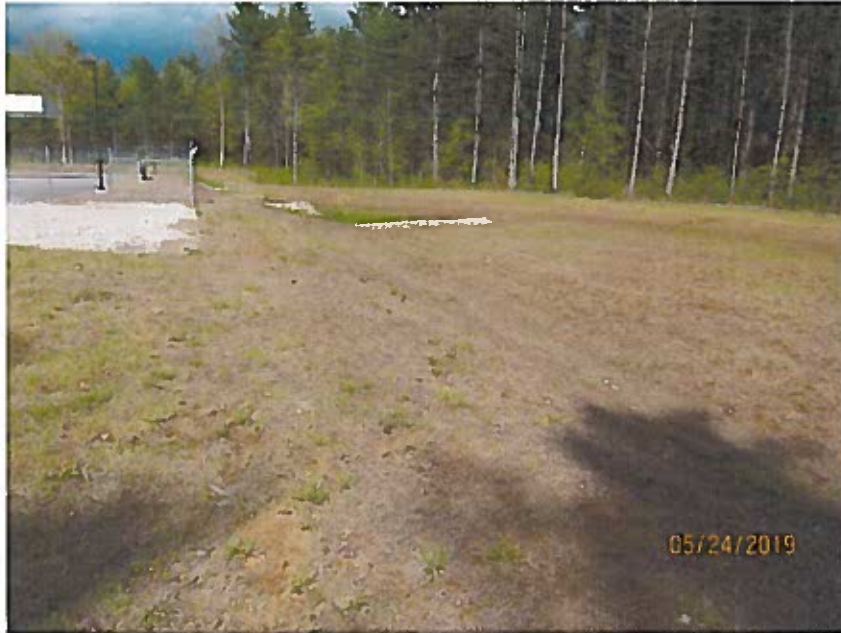
**Photograph 13: North Stormwater basin of CNG Facility**

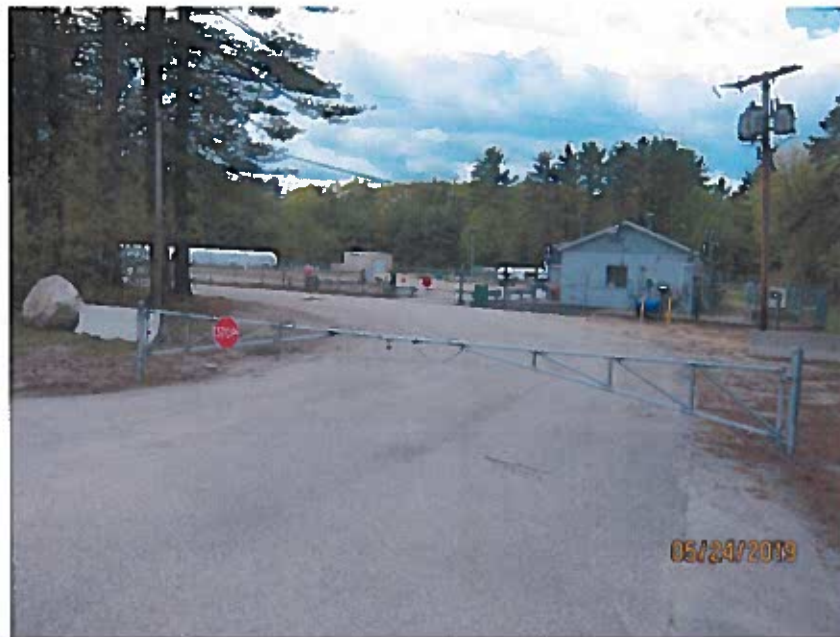
Photograph 16: Existing Liberty Utilities gas facility located behind (west of) the site

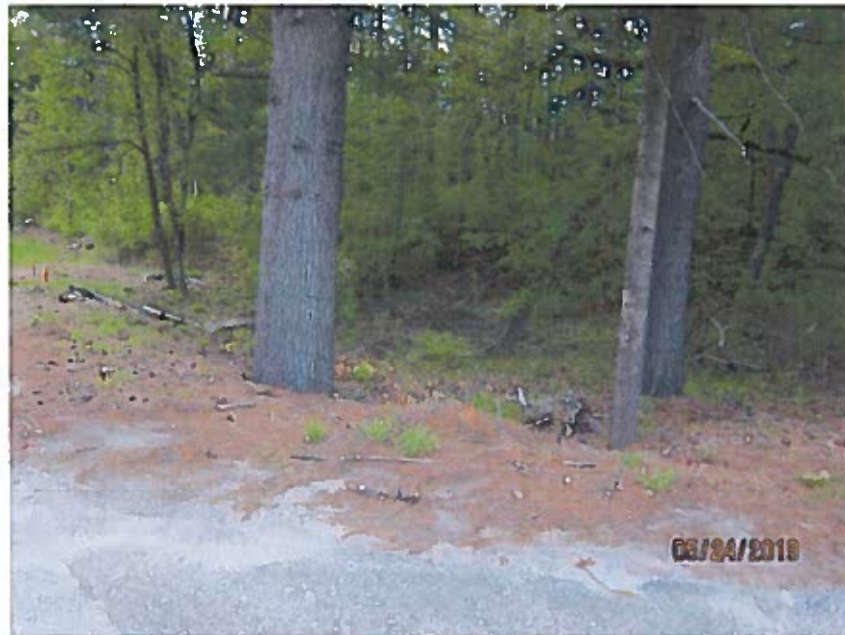
Photograph 20: Depression at the southwest corner of the site (no drainage outlet)

Existing conditions on Lot 109-1-3 are undeveloped land consisting of trees and shrubs, without any sanitary, potable water, or electrical services. The proposed part of Lot 109-1-3 to be developed consists of approximately 1.8 acres of wooded land adjacent to Broken Bridge Road and is located entirely within the IN zoning district. A Site Specific Soil Map was developed by Timothy F. McCormick, New Hampshire Certified Soil Scientist, and is provided in the Site Plans. The native soils within the proposed area of development are mapped as Windsor Loamy Sand, which are very well-drained. There is a small section of disturbed soils at the southwest corner of the project area, where the well-drained soils were removed, leaving a depression in the landscape. This area is moderately well-drained.
