CITY OF CONCORD, NEW HAMPSHIRE FACILITY CONDITIONS ASSESSMENT

BEAVER MEADOW GOLF COURSE CLUB HOUSE

NOVEMBER 5, 2021

TTG PROJECT No. 4980

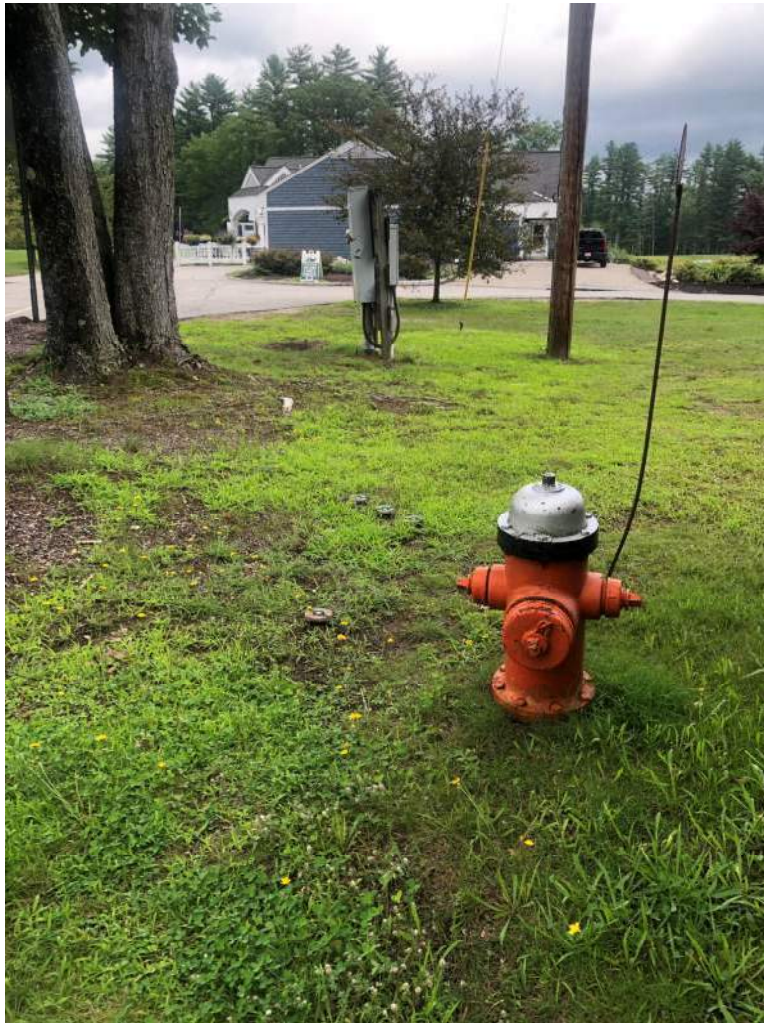
Water Hydrant and Electrical Service Located Southwest of Club House

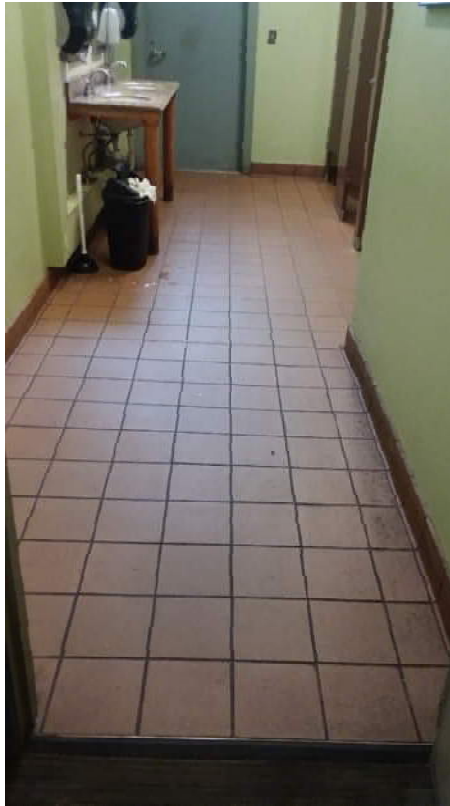
Tile Flooring in Restrooms

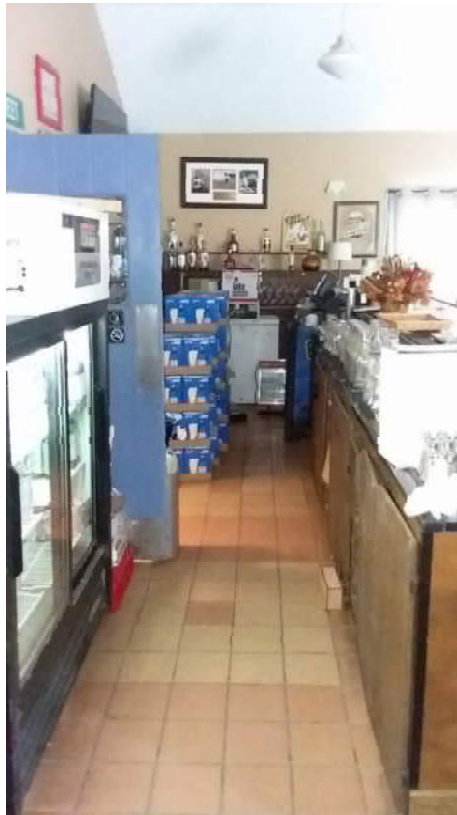
Tile Flooring Behind Clubhouse Bar

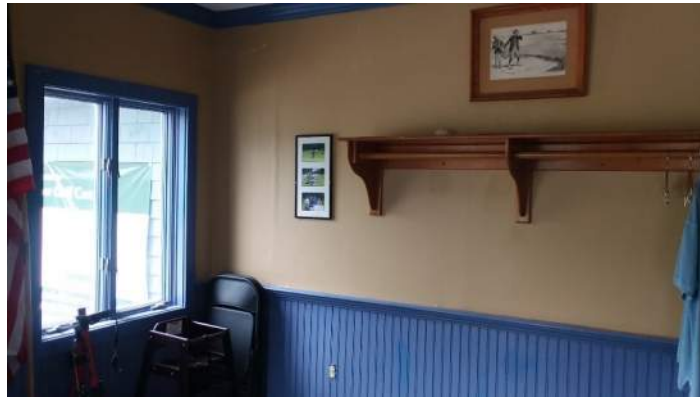
Wall Finish in Entry Vestibule

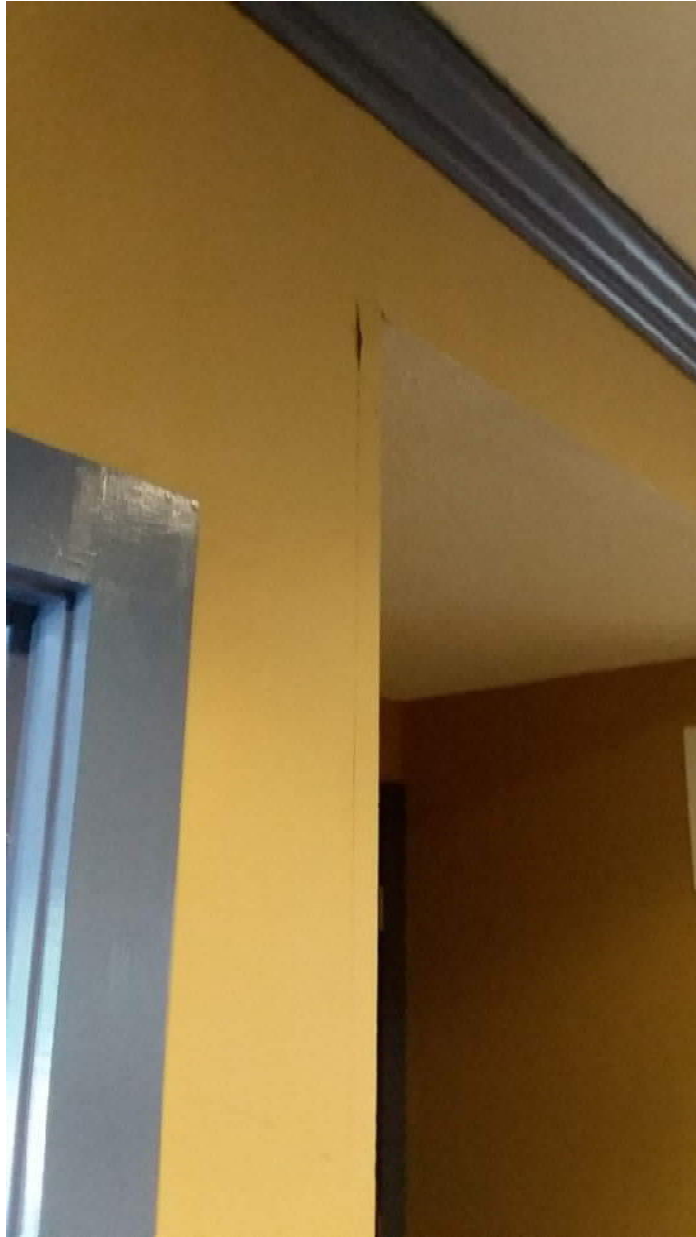
Wall Finish at Corner in Entry Hallway

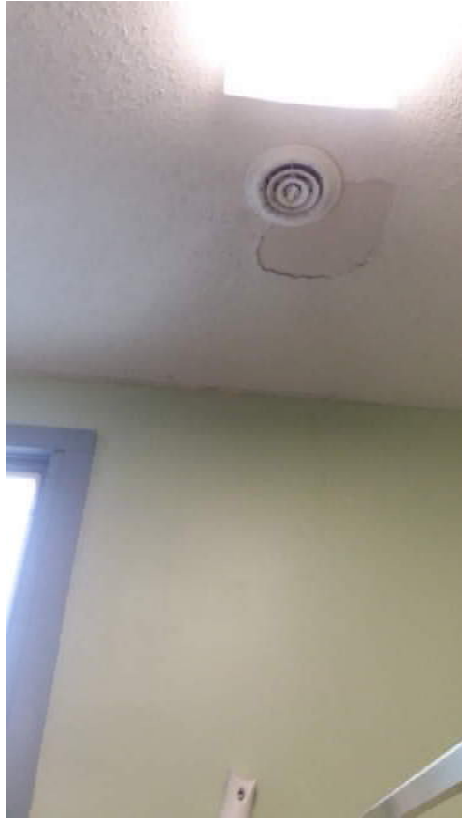
Ceiling Finish in Men's Restroom

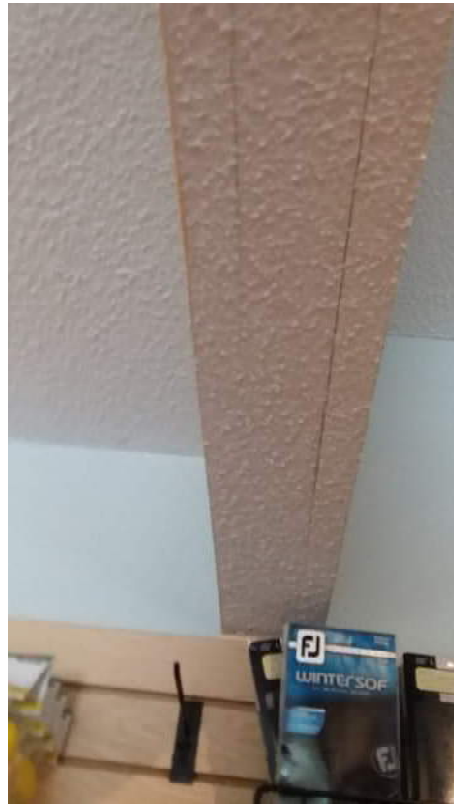
Beam Cladding Finish in Pro Shop

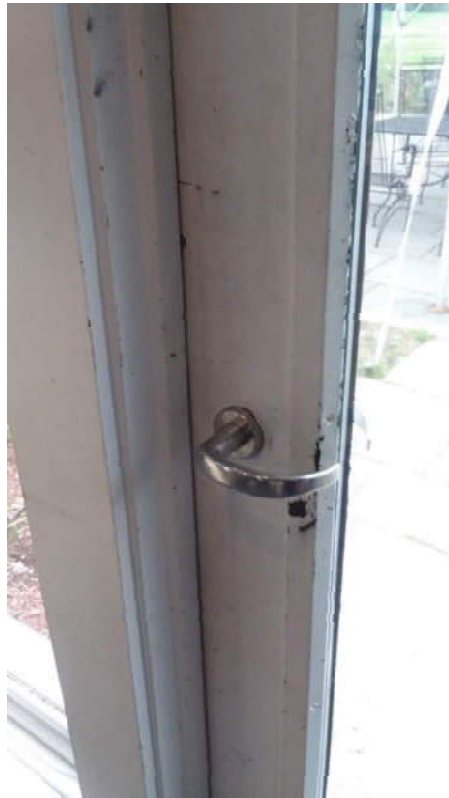
Interior of Exterior Door in Pro SHop

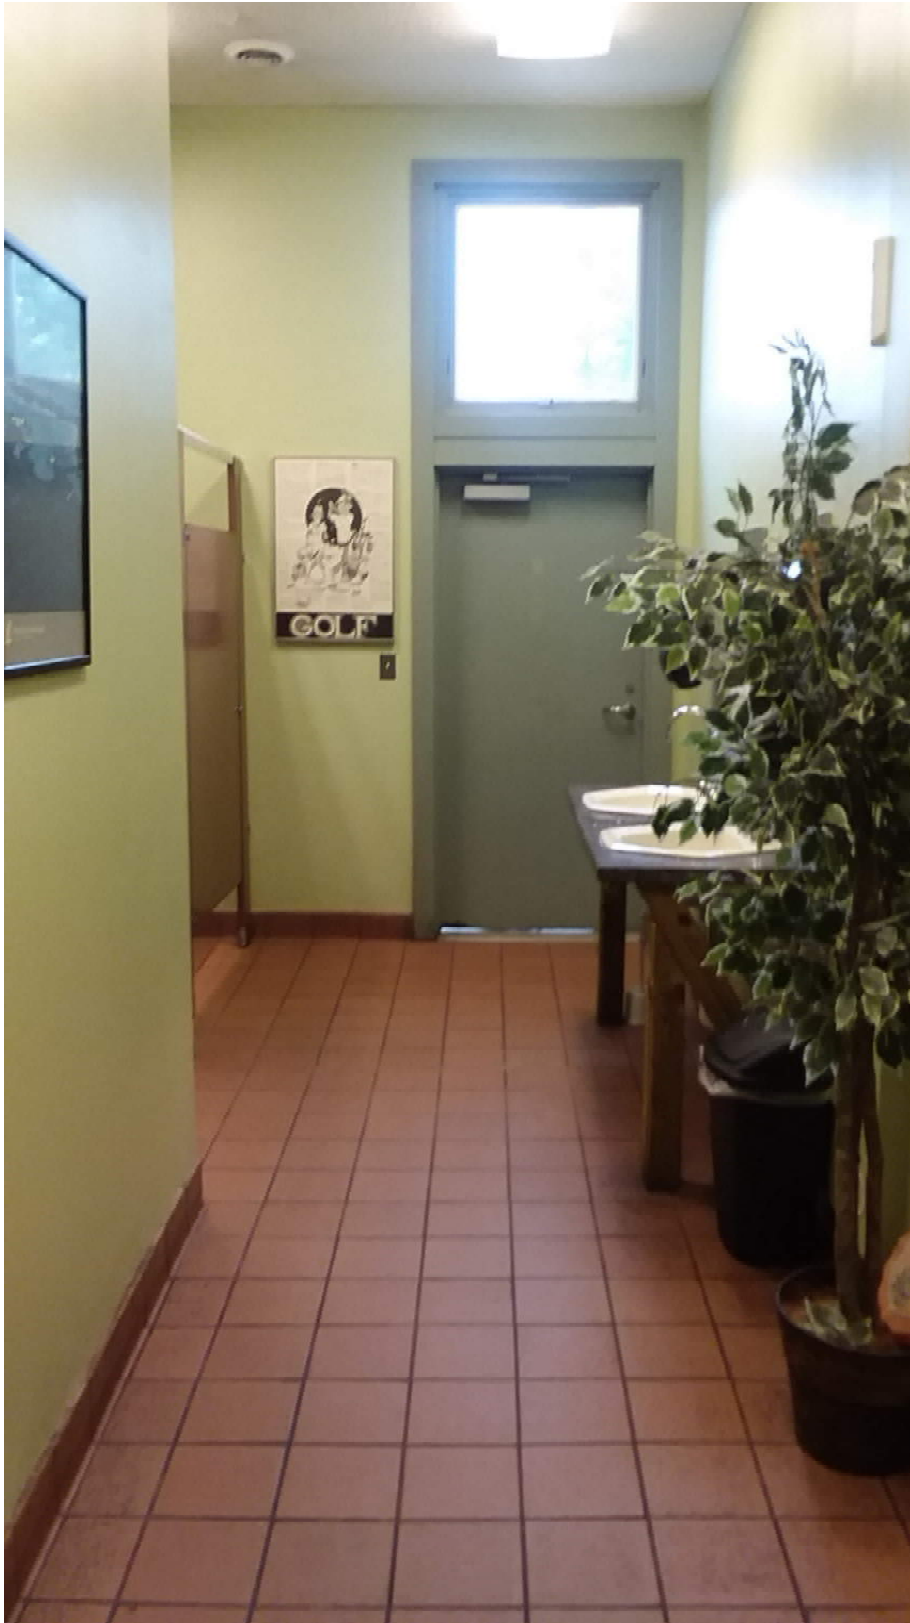
Exterior Door Threshold in Women's Restroom

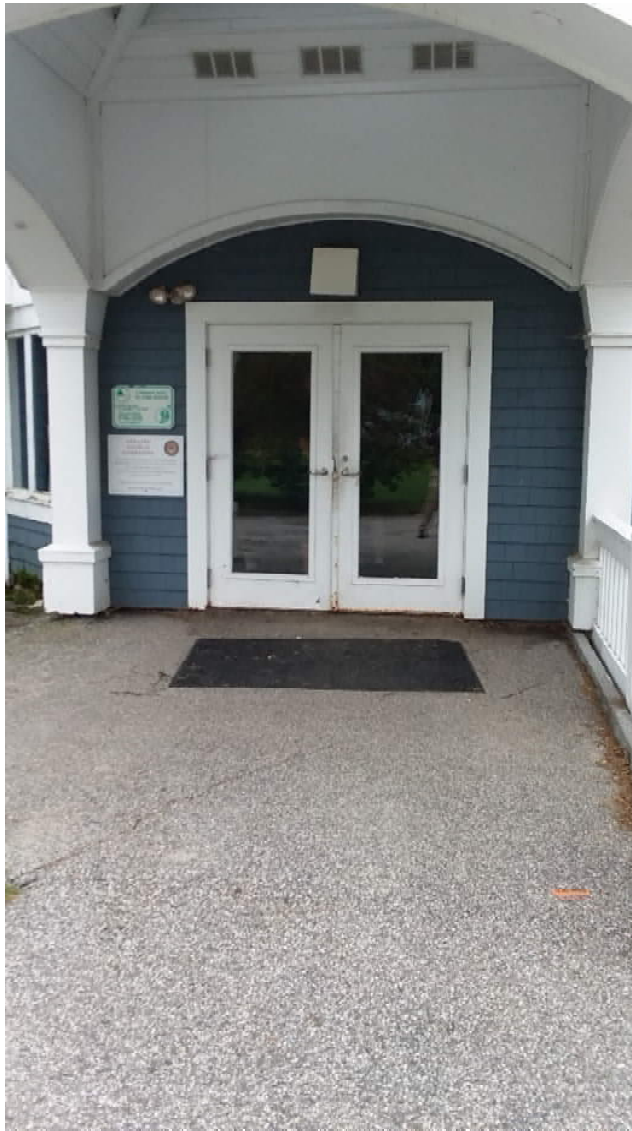
Accessible Entrance Sign Required

Provide an accessible means of entry to the restrooms from the exterior of the building.

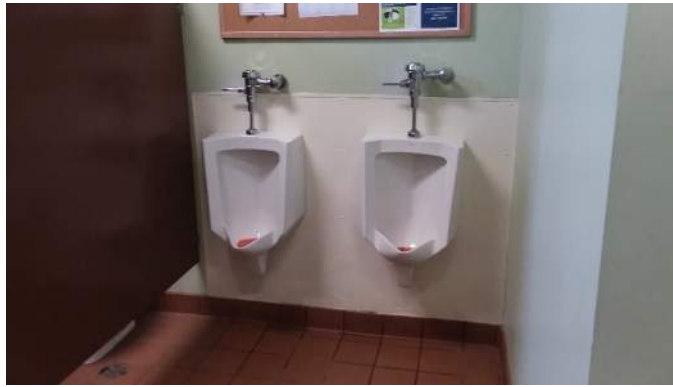
One Urinal Required to be Accessible when More Than One is Provided

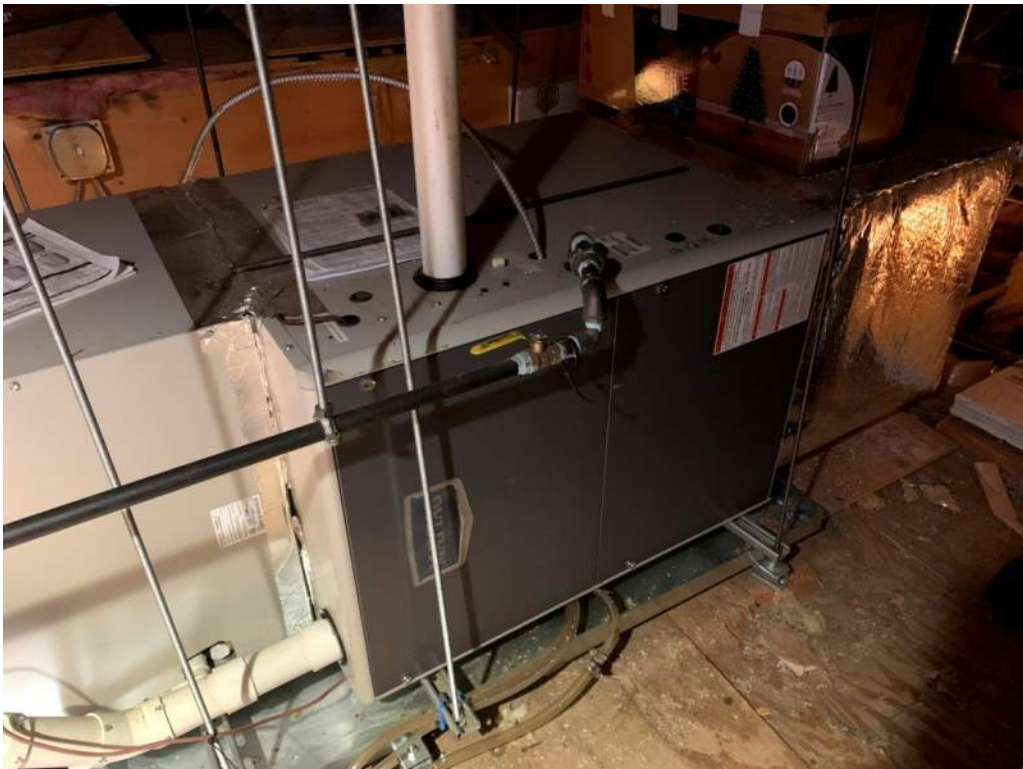
The York (Function Room) and Maytag (Bar, Pro Shop) 5 ton air handling units appear in good condition and should operate for many more years.

Bar/Pro Shop 5 ton air handler

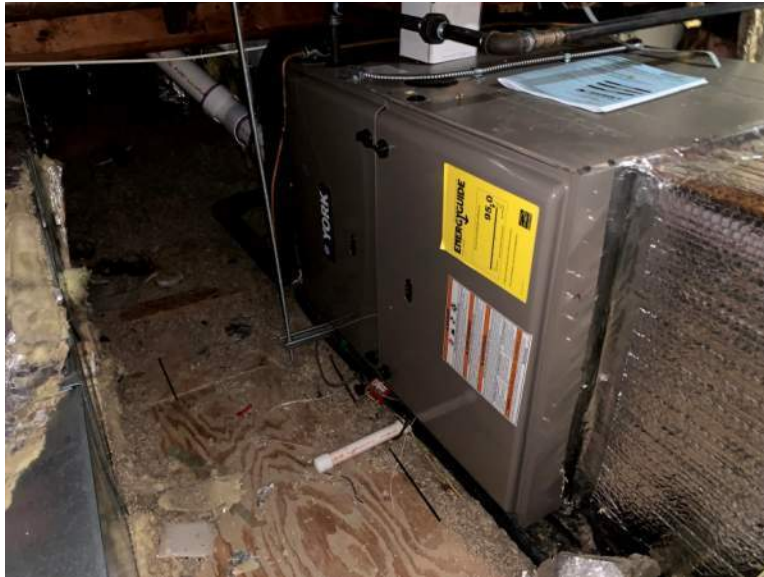
Function Room 5 ton air handling unit
