CONCORD POLICE DEPARTMENT— SPACE ANALYSIS

CONCORD, NEW HAMPSHIRE
PROJECT NO 5099

July 15, 2021

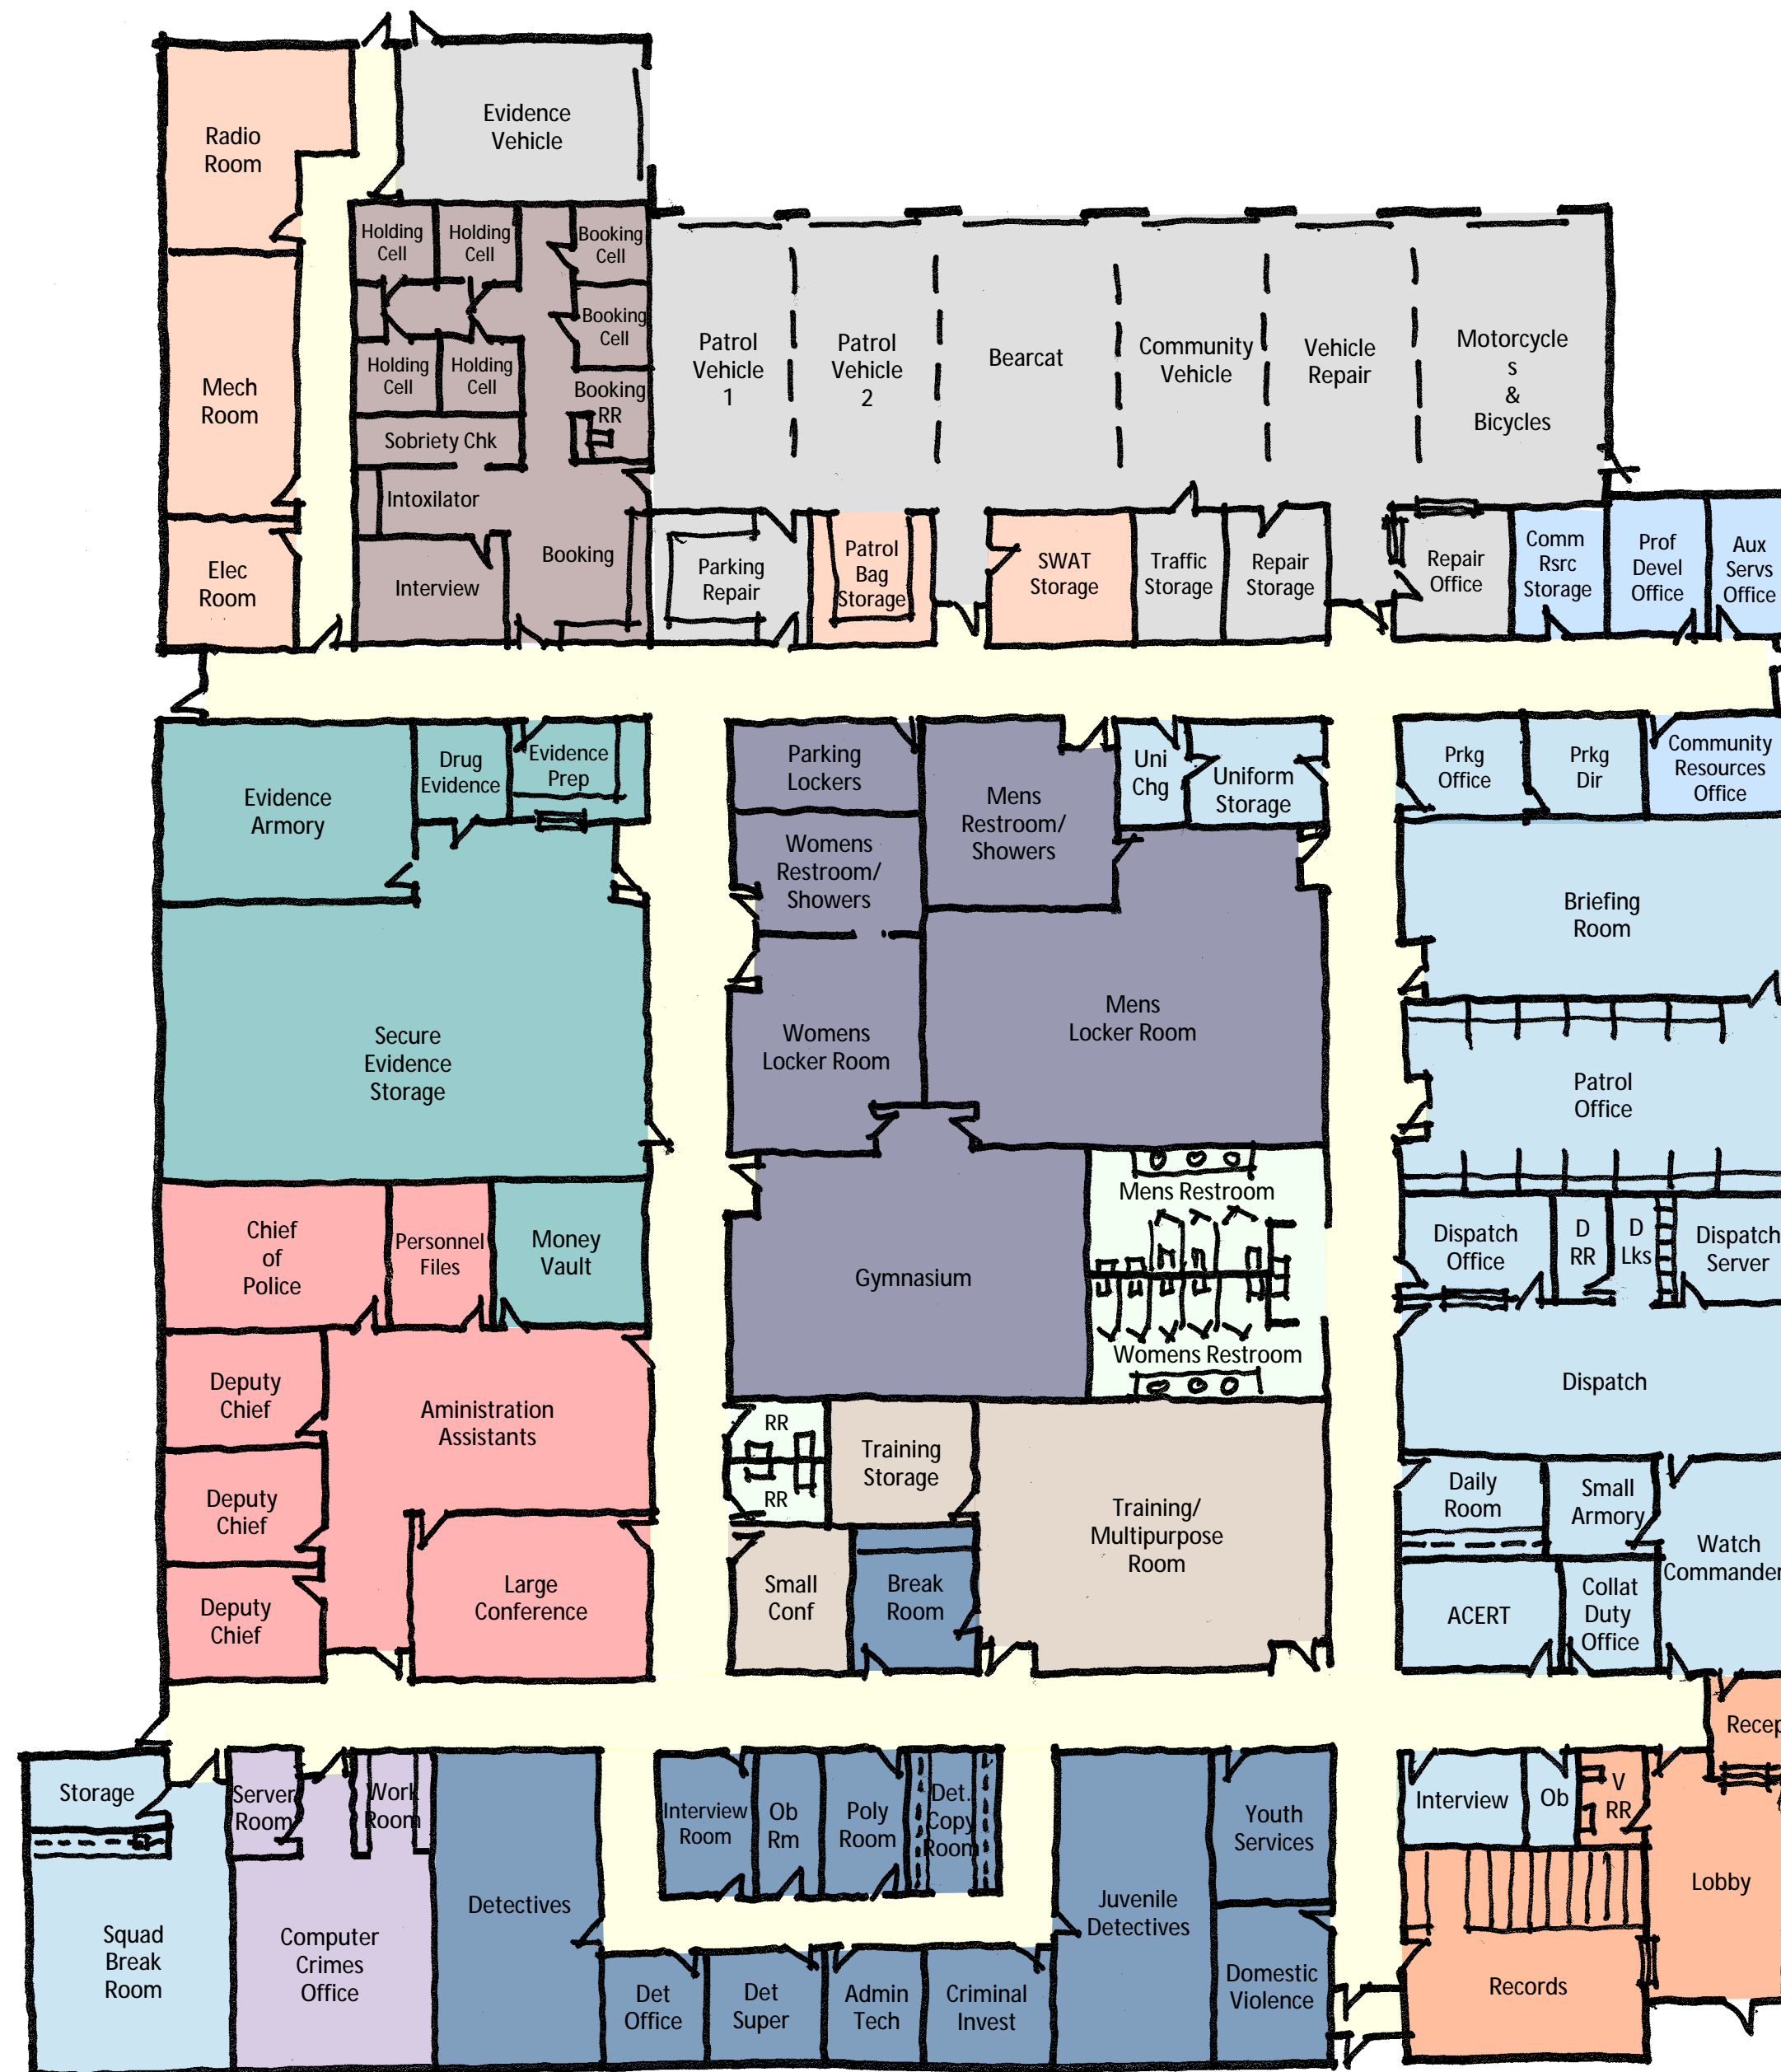
Conceptual Plan

1/16" = 1' - 0"

As part of the study a new single story conceptual plan was developed to test the required space adjacencies of the program and the resulting size of a new building. The site is an existing City of Concord lot located off of Terrill Park Drive, which was selected simply as an existing open property located close to the center of town. There are not many open lots in Concord that could handle the space or geographic location requirements of the police department. This lot was selected for a space test, and we do not suggest that this is an optimal location for the new facility. The lot number is 754/Z-6 Please refer to the following concept.
