LOUDON ROAD

PRUNE EXISTING OVERGROWN TREES, SHRUBBERY

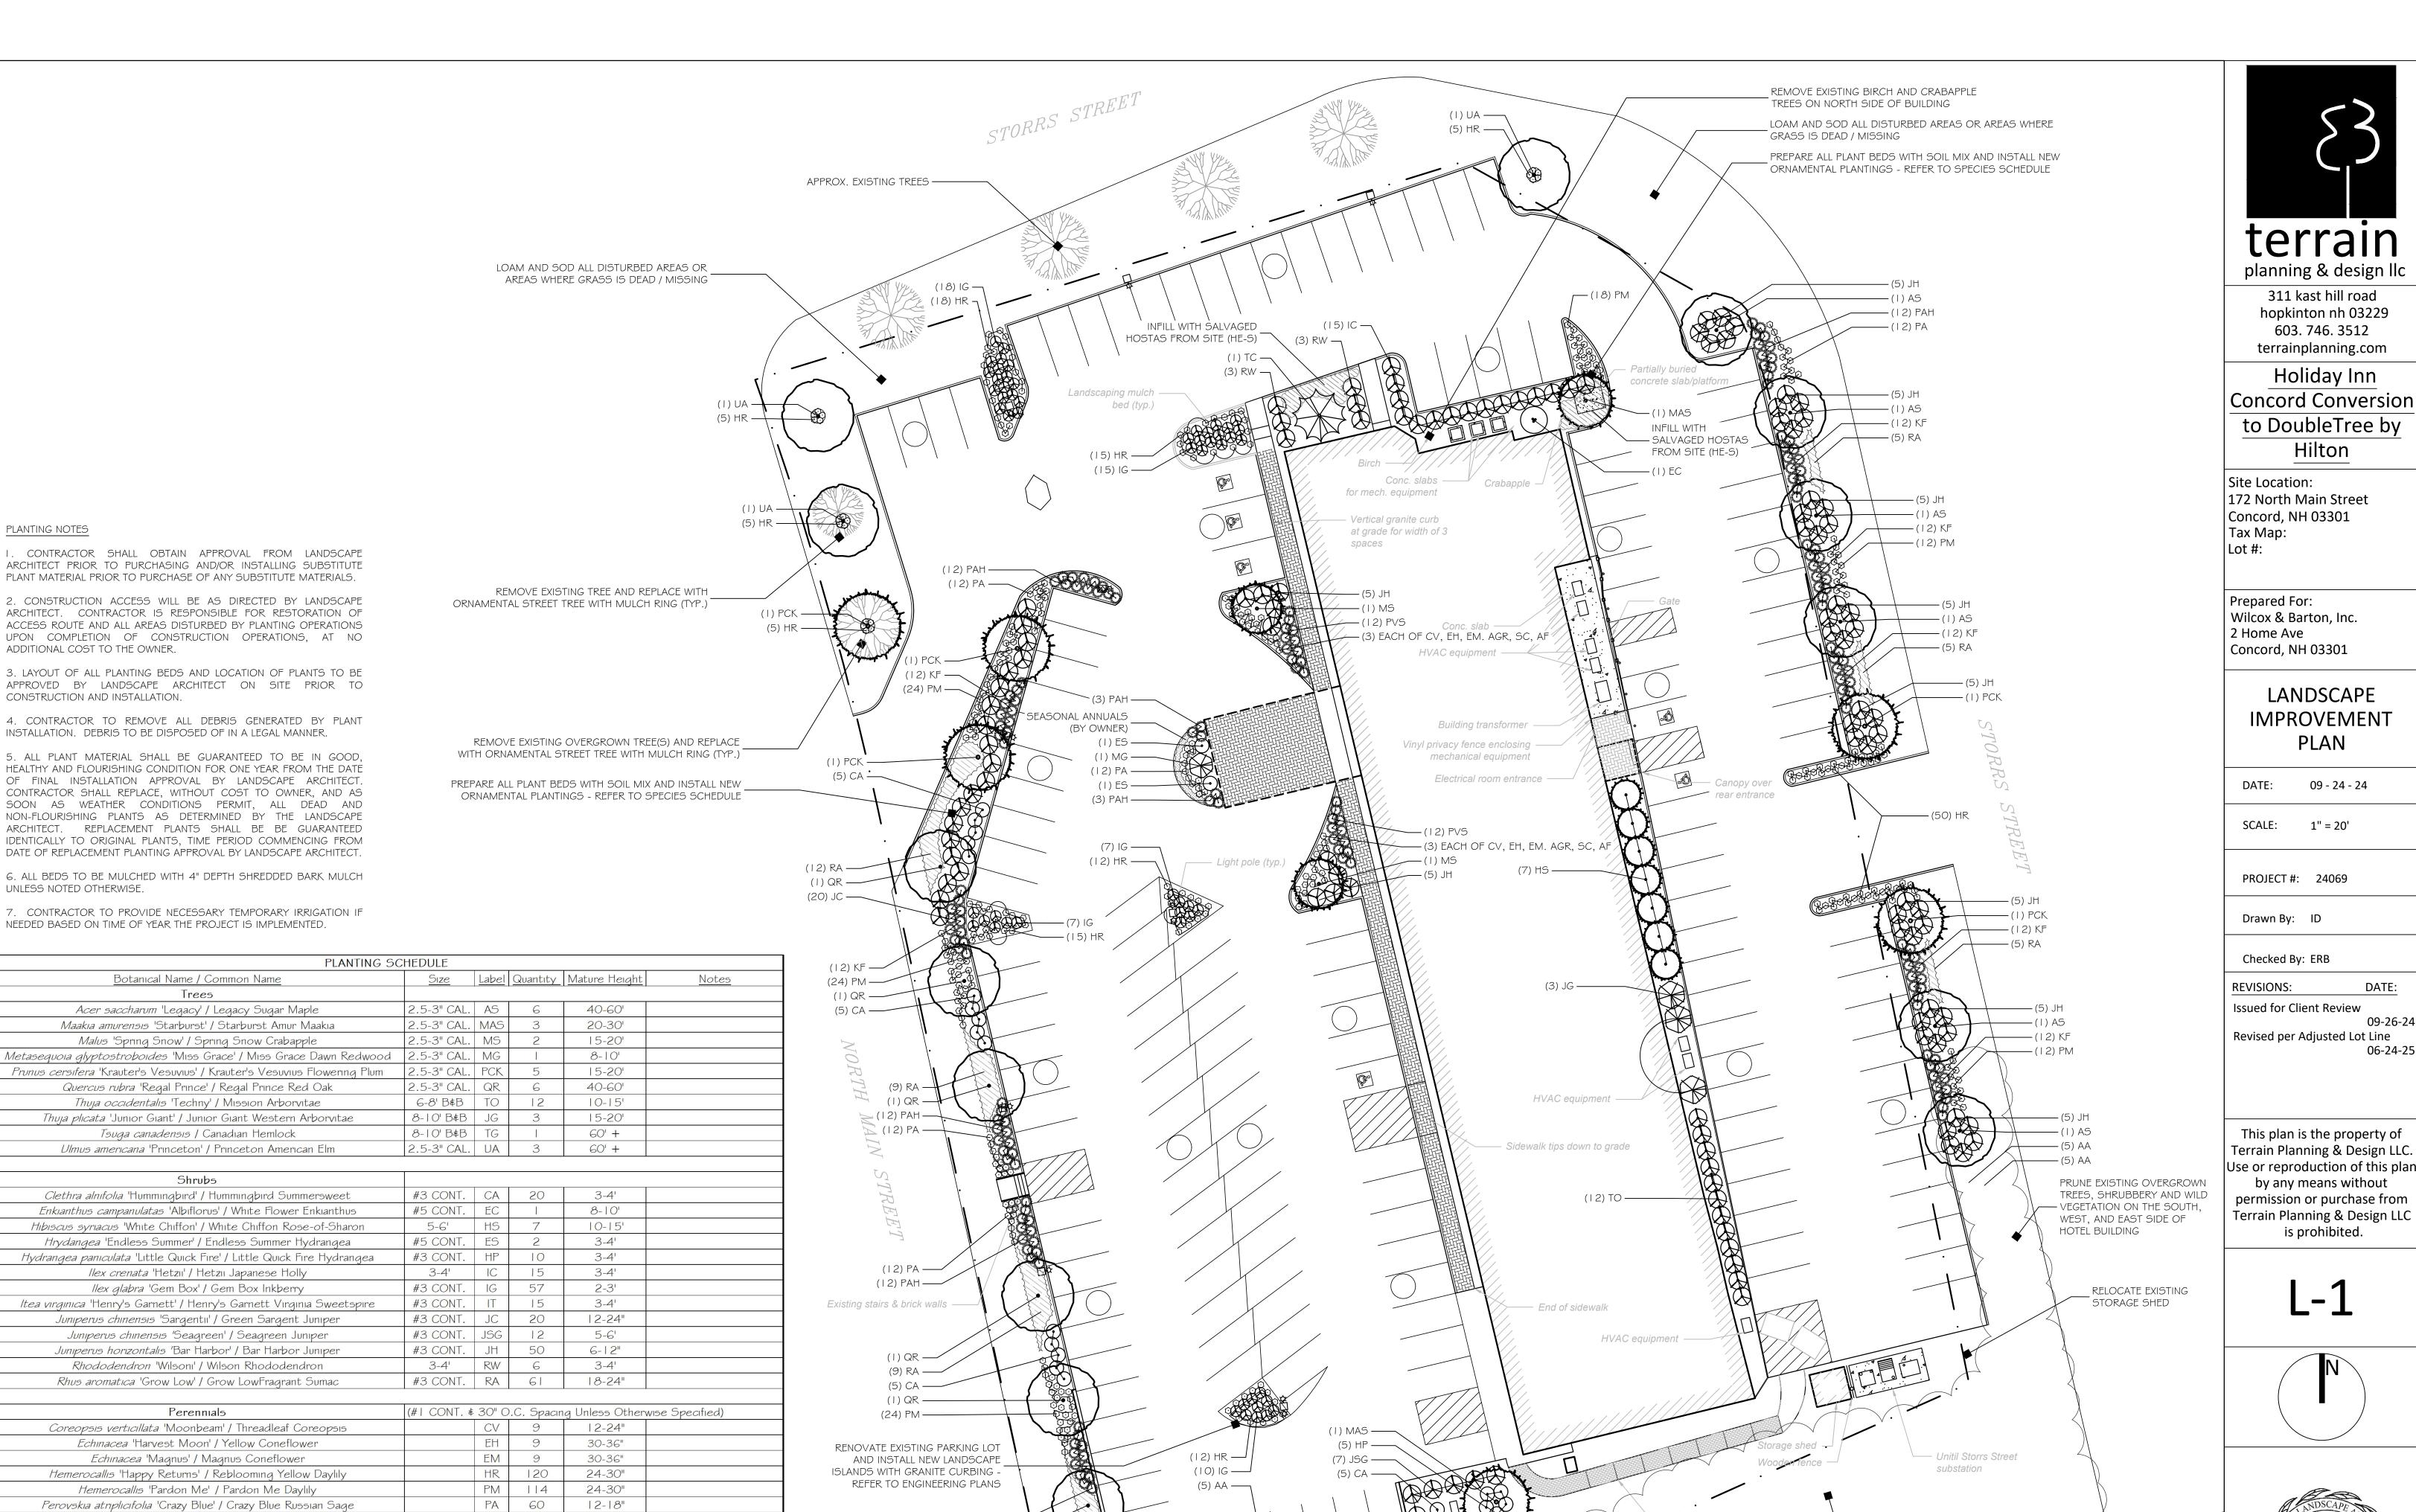
AND WILD VEGETATION ON THE SOUTH, WEST, AND

EAST SIDE OF HOTEL BUILDING

Rudbeckia 'American Gold Rush' / American Gold Rush Black-eyed Susan

Salvia 'Caradonna' / Caradona Sage

Sedum 'Autumn Fire' / Autumn Fire Stonecrop Sedum

Ornamental Grasses

Calamagrostis x acutifolia 'Karl Foerster' / Feather Reed Grass

Panicum virgatum 'Cape Breeze' / Cape Breeze Switch Grass

Pennisetum alopecuroides 'Hameln' / Hameln Fountain Grass

Salvaged Plant Material Hosta species | Hostas

(#1 CONT. \$ 30" O.C. Spacing Unless Otherwise Specified)
