CITY OF CONCORD, NEW HAMPSHIRE FACILITY CONDITIONS ASSESSMENT

BEAVER MEADOW GOLF COURSE CLUB HOUSE

NOVEMBER 5, 2021

TTG PROJECT No. 4980

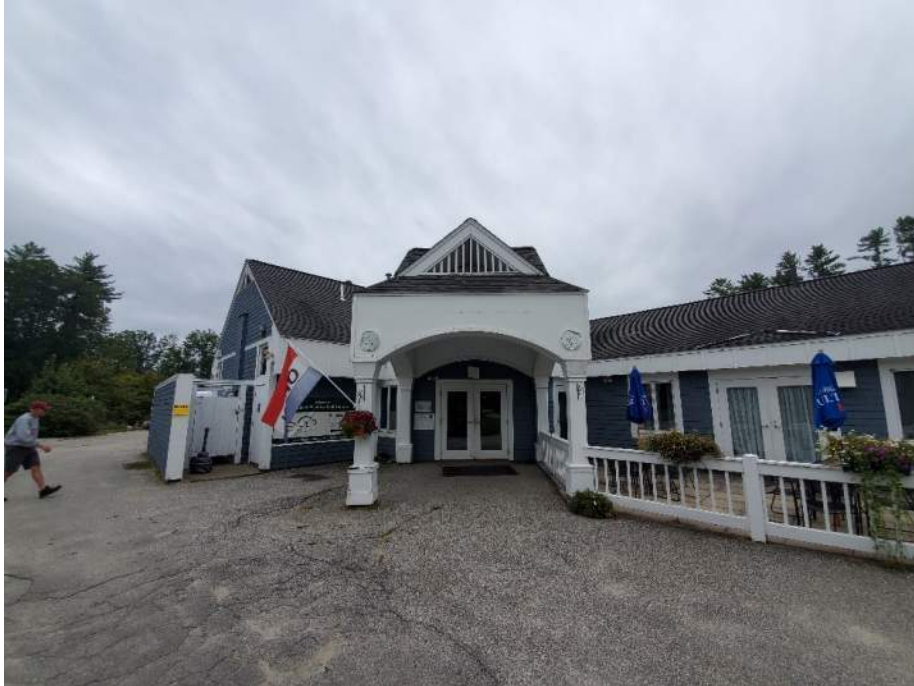
Clubhouse Front (North) Elevation

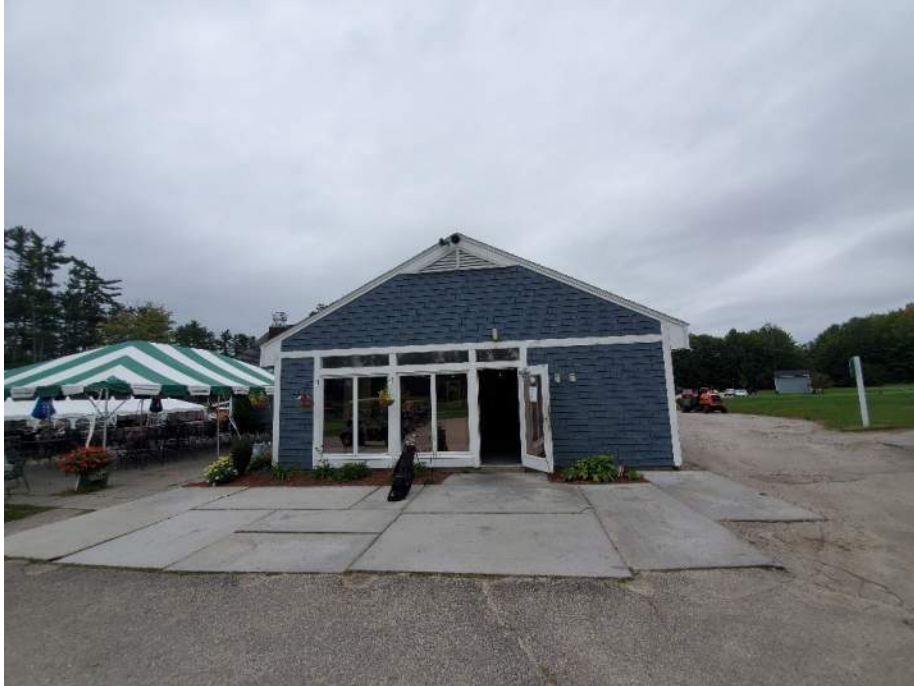
Clubhouse East Elevation

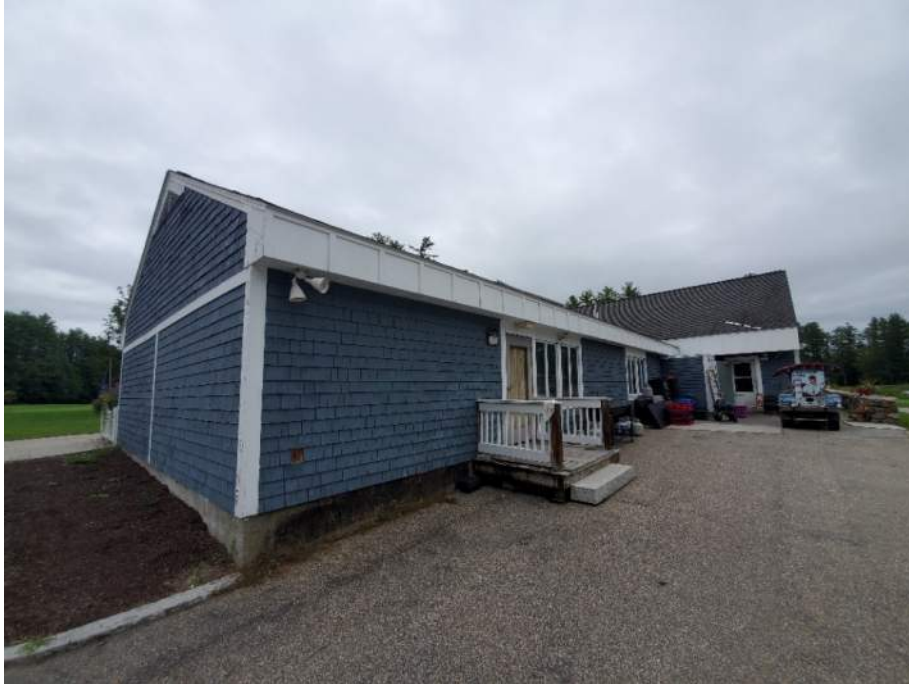
Clubhouse South and West Elevations

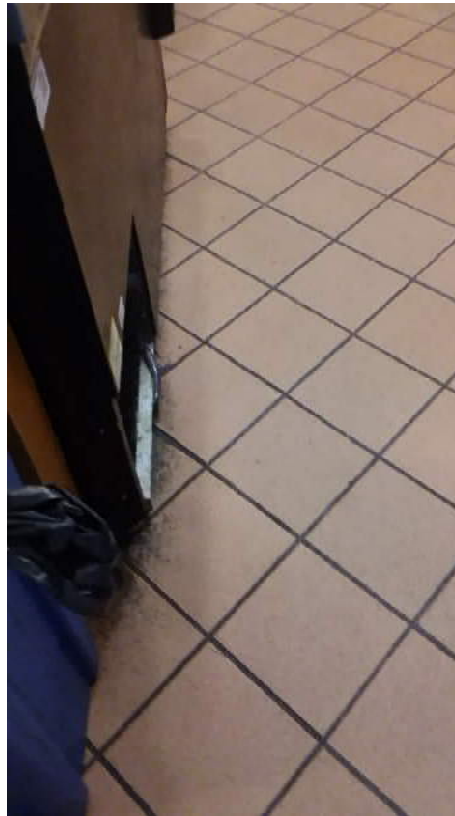
Tile Flooring Behind Public Bar

Clean or refinish the casework behind the public bar.

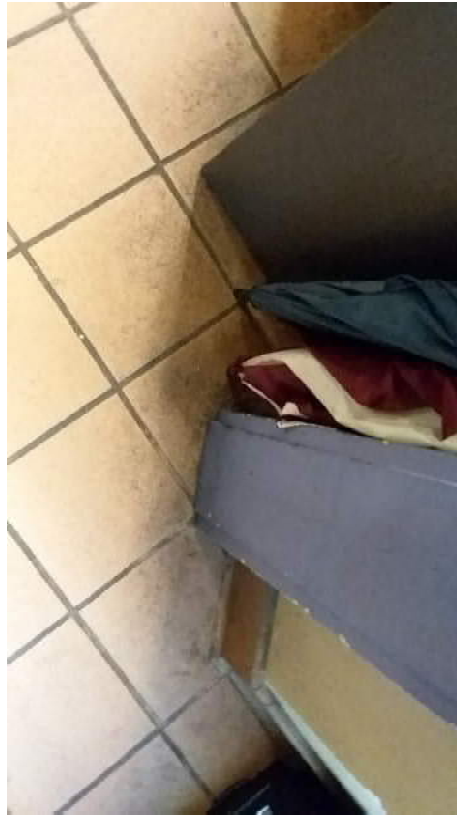
Tile Flooring in Kitchen

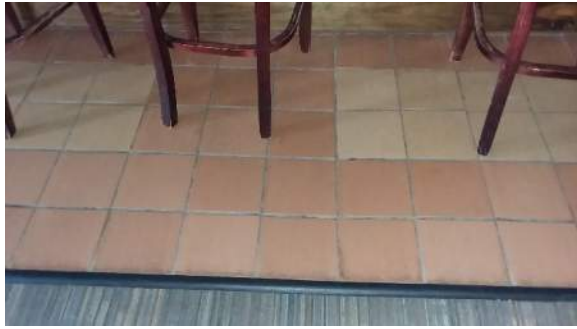
Tile Flooring in Front of Clubhouse Bar

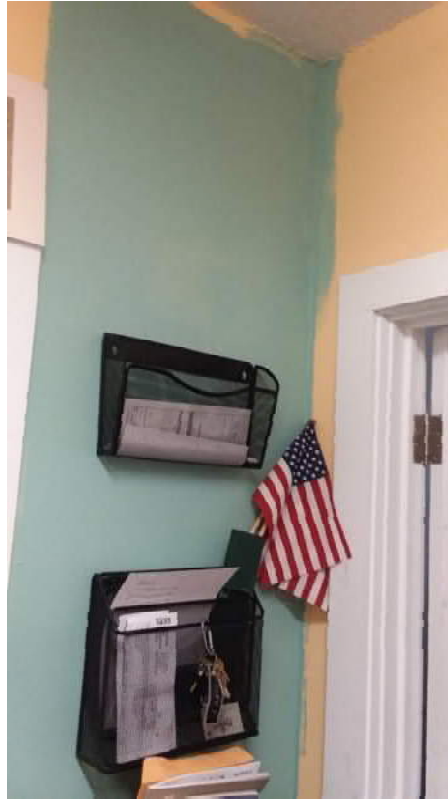
Wall Finish in Private Office

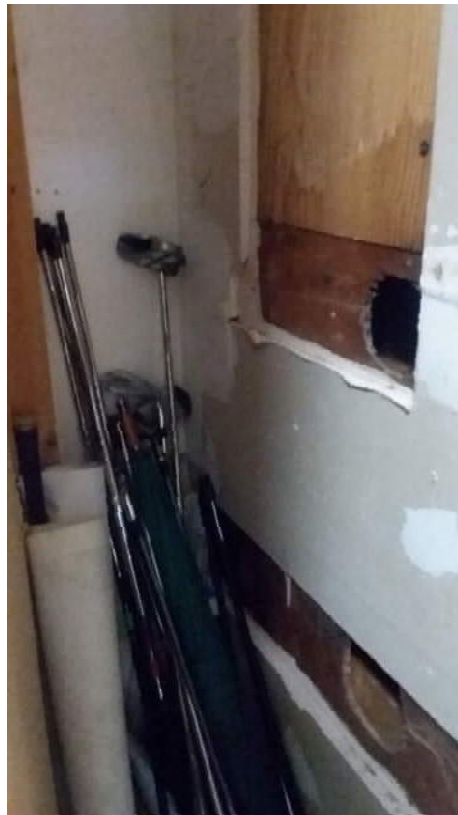
Wall Finish in Office Closet

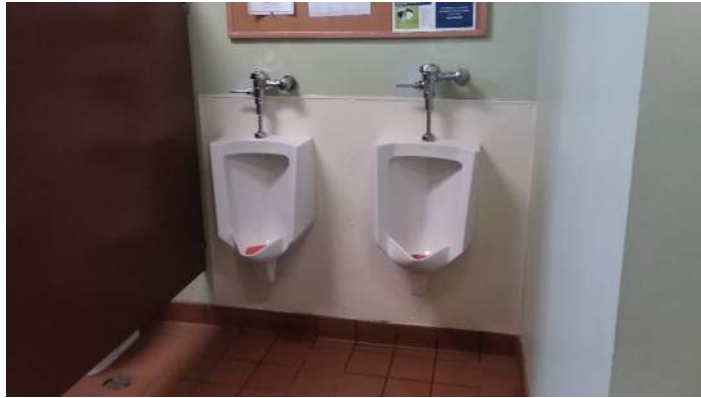
Compliant Smooth, Hard, Nonabsorbent Wall Surfaces Required within Two-Feet of Toilets & Urinals

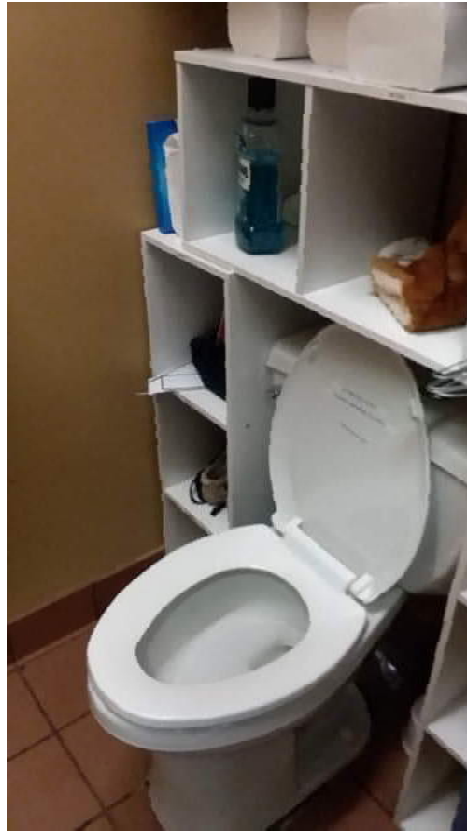
Compliant Smooth, Hard, Nonabsorbent Wall Surfaces Required within Two-Feet of Toilets & Service Sinks

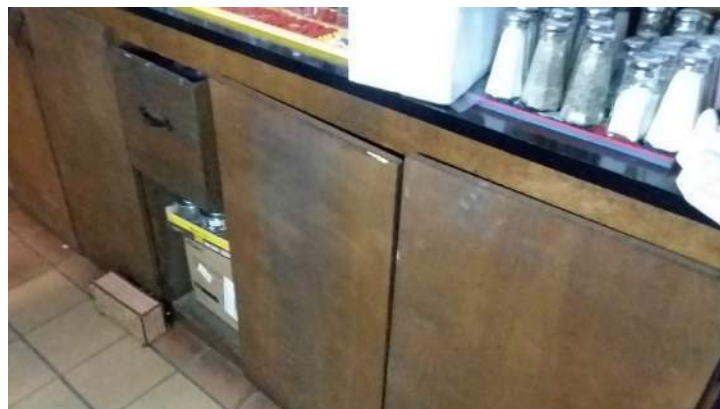
Condition of Finishes on Casework Behind Clubhouse Bar

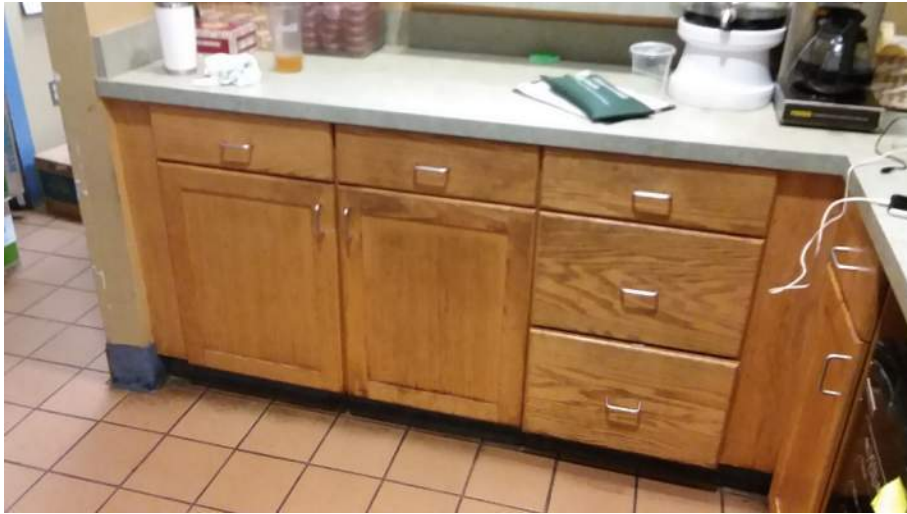
Condition of Finishes on Casework Behind Public Bar

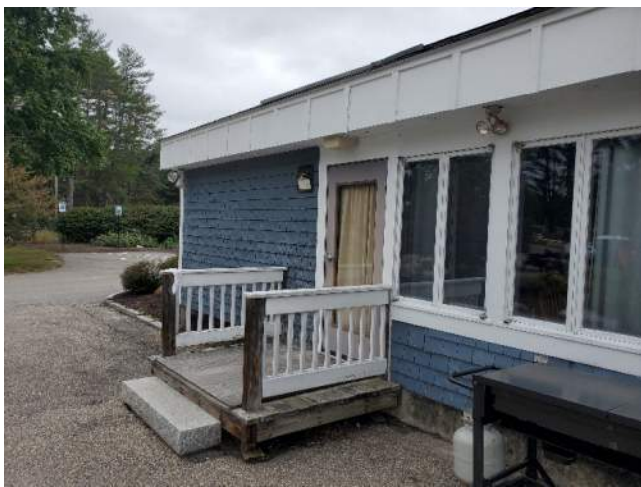
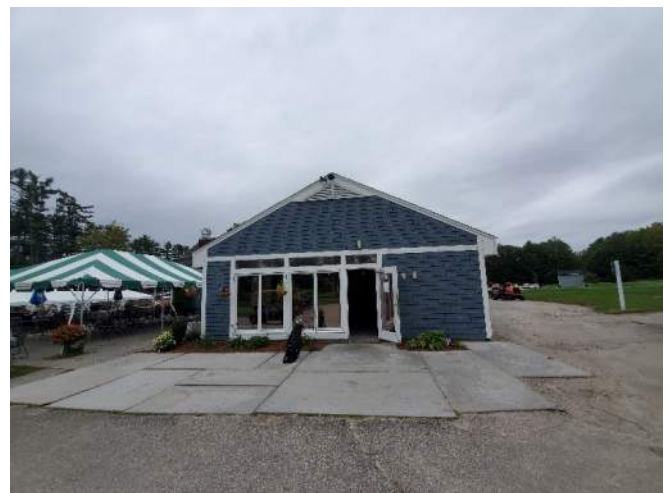
Non-Accessible Sign and Directional Sign to Accessible Entrance Required

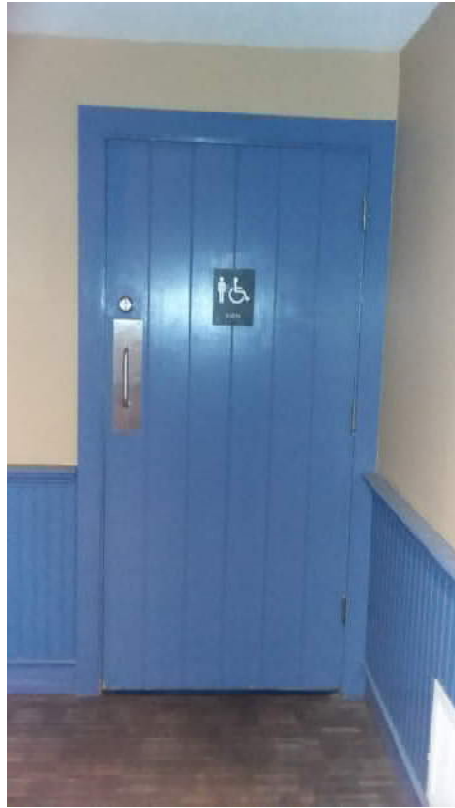
Accessible Restroom Signage Required on Wall Adjacent to Pull Side of Doors – Not Mounted on Doors

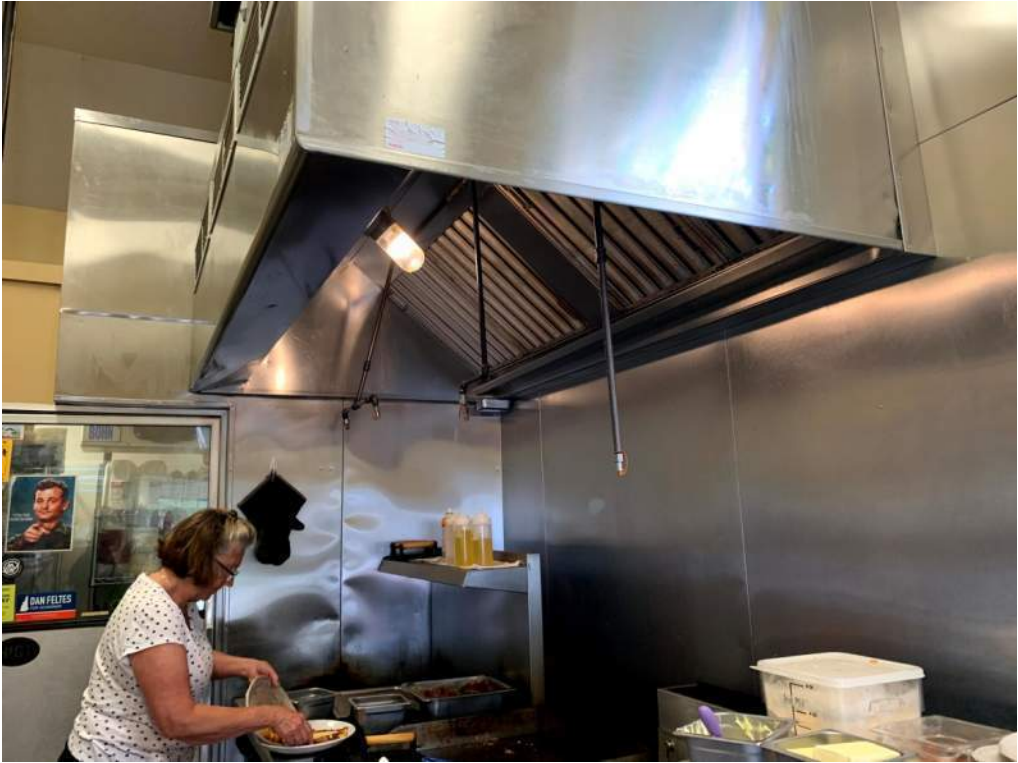
Kitchen hood

We recommend replacement of the bathroom furnace unit, along with improved access. Outside air should be introduced to the remaining two heat/air conditioning units. We also recommend that the bathroom exhaust fan be repaired or replaced. If work is done that affects the kitchen hood exhaust system, we recommend adding a vented extension to the roof curb.

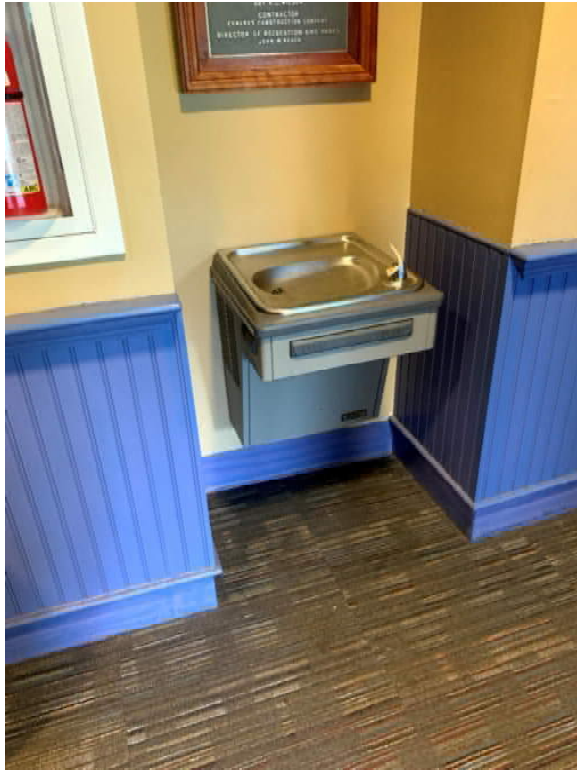
A water fountain is located near the front of the building outside the bathrooms and appears in good condition.

Water fountain

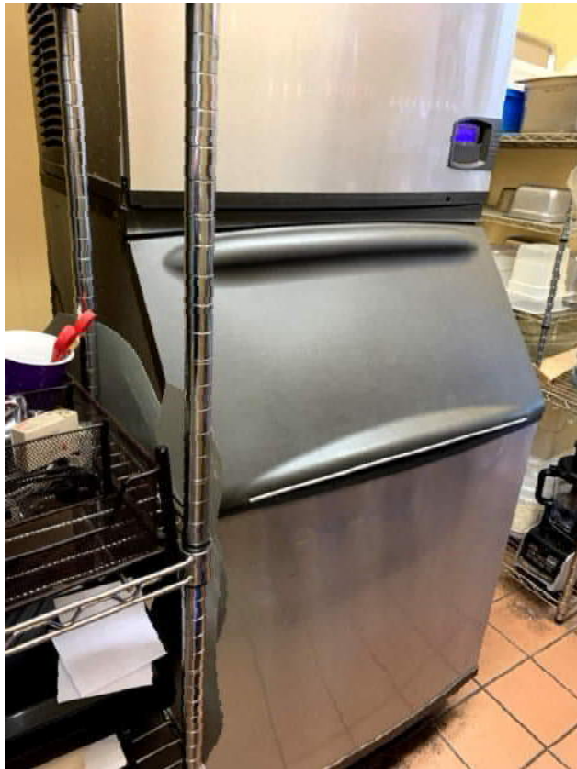
The kitchen area has an underfloor grease trap that is downstream of the kitchen floor drain and the prep sink. The kitchen also has an ice maker that appears in good condition.

Ice Maker
